# S.B. Knitting Ltd.

Baipal Notunpara, New DEPZ, Savar, Dhaka  
(23.94544, 90.27674)  
15<sup>th</sup> April 2014

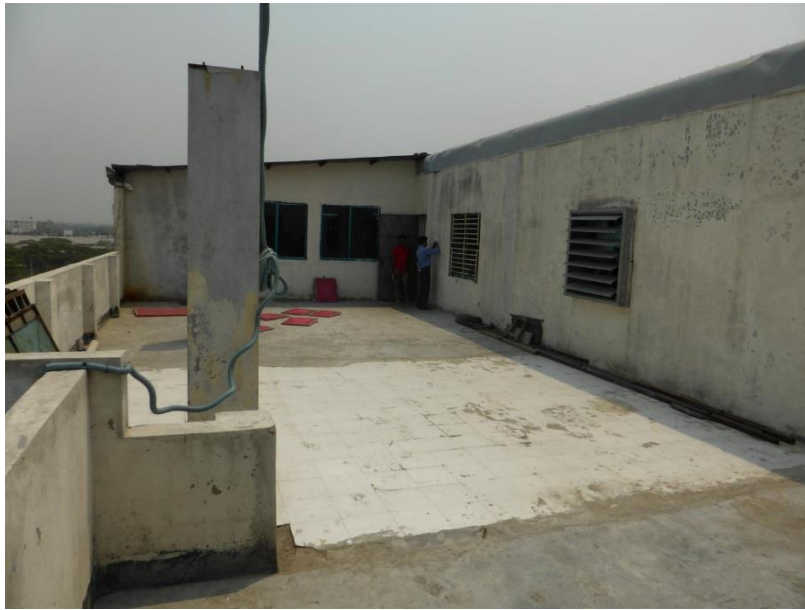
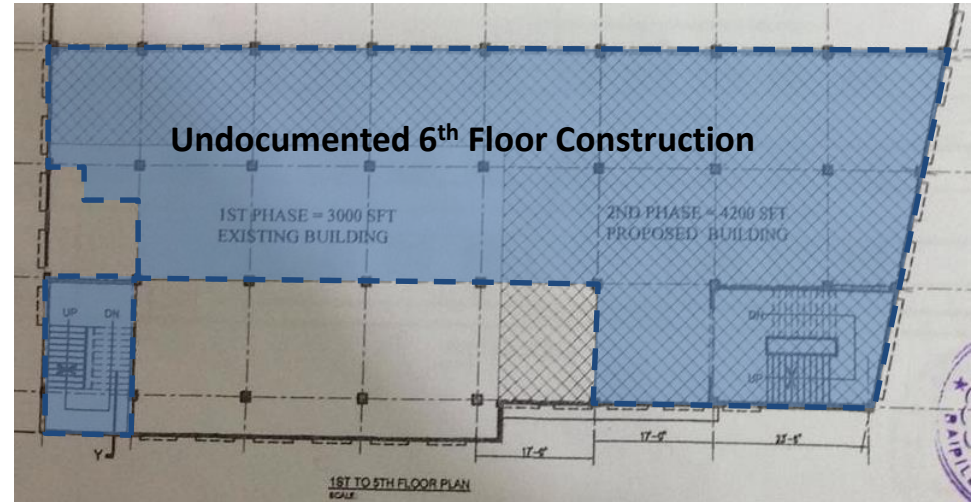
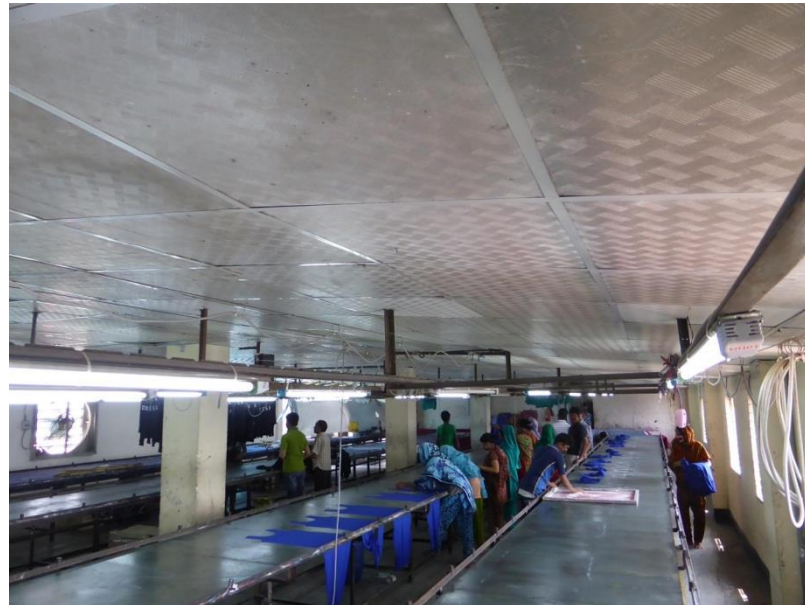
# Undocumented Vertical Extension

**Vertical extension on roof comprising lightweight steel trussed roof on concrete columns with brick masonry infill. Typical Slab used to transfer masonry perimeter wall loads to columns. No structural or design documentation provided for extension.**

| Item No.3 | Observation | Recommended Action Plan | Recommended Timeline |
|---|---|---|---|
| 1 | Undocumented vertical extension | Building engineer to verify structural design of additional structures, with particular attention to structural stability and roof tie-down | 6-weeks |
| 2 | Undocumented vertical extension | The building engineer should check the level 6 structural arrangement and confirm that the main building structure is capable of safely supporting the additional structures. | 6-weeks |
| 3 | Undocumented vertical extension | Implement any actions arising from the Engineering assessments of the additional construction and supporting slab structure. | 6-months |

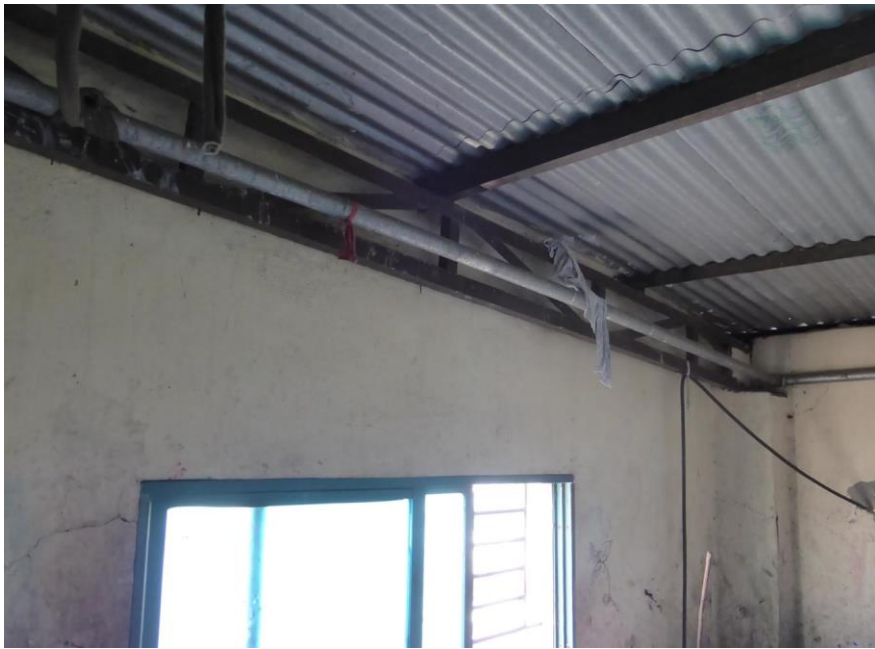
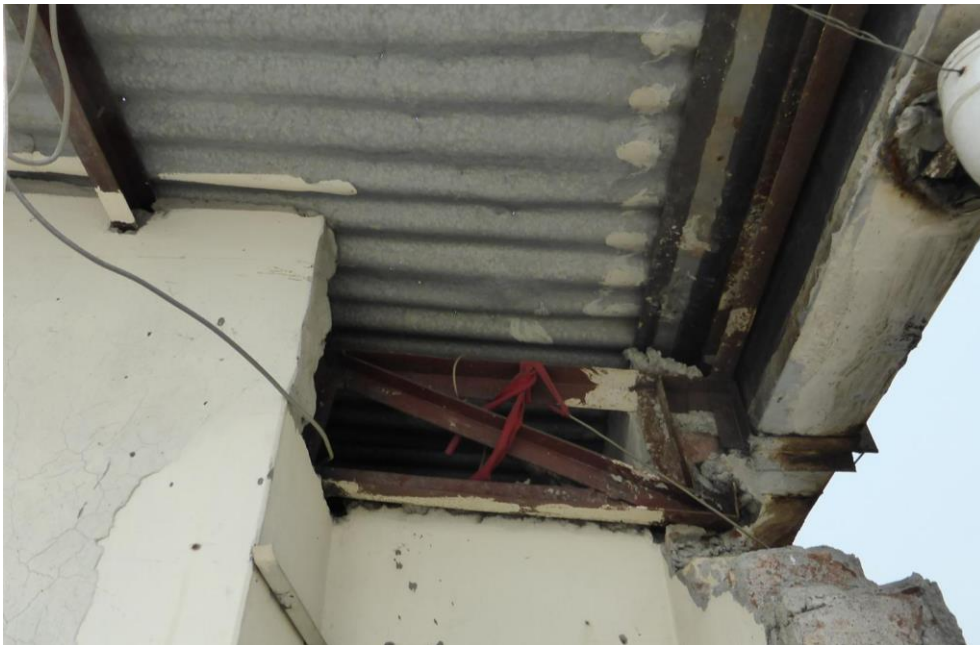
**Lateral Stability system for 6<sup>th</sup> floor structure not clear.**

**Tie-downs for wind uplift on roof not detailed or apparent during inspection.**

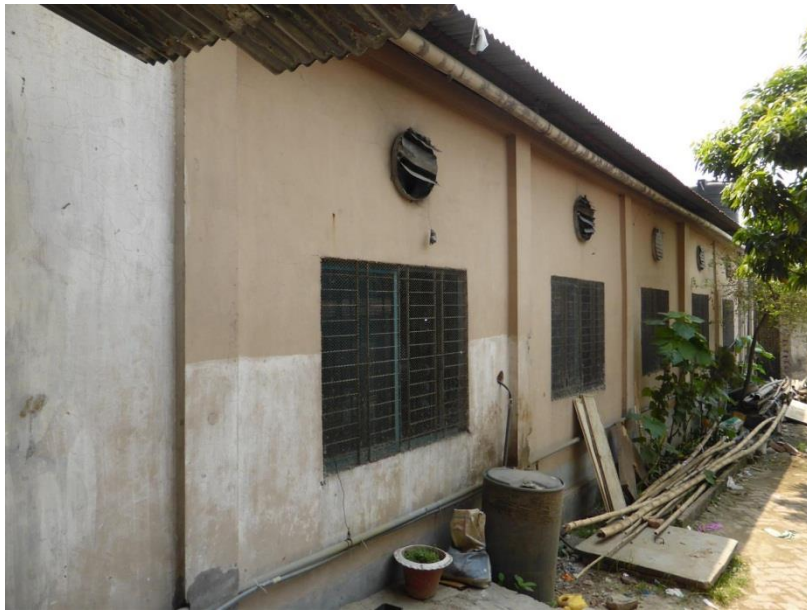
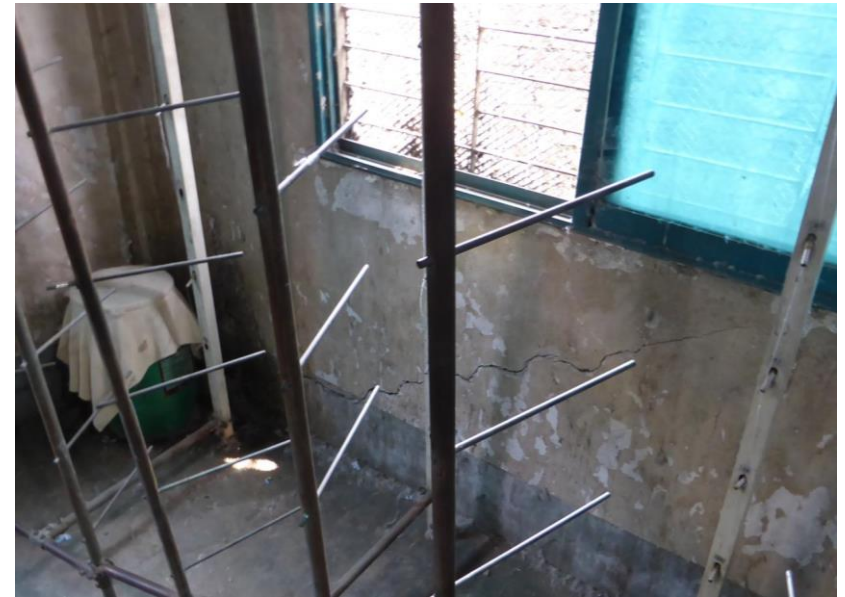
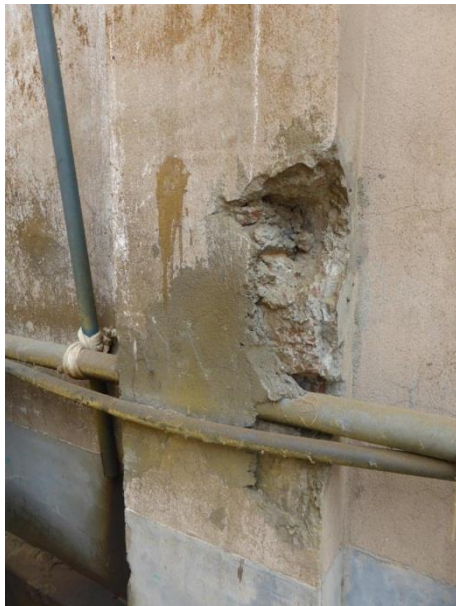
# Non-Engineered Adjoining Shed Structures

**Non Engineered shed,  
connected to main  
building façade.**

**Damage and distress to  
reinforced concrete and  
masonry cantilevered  
walls**

**Threading Area  
& toilet in Non  
Engineered  
Shed**

| Item No.3 | Observation | Recommended Action Plan | Recommended Timeline |
|---|---|---|---|
| 4 | Non-Engineered adjoining shed structures | Building engineer to review the structures and structural design of the adjoining sheds in detail, with particular attention to the larger shed used for production operations. Structural stability, vertical load paths, steelwork connection details, to be specifically addressed | 6-weeks |
| 5 | Non-Engineered adjoining shed structures | Carry out all recommendations from building engineer's assessment | 6-months |
| 6 | Non-Engineered adjoining shed structures | Prepare appropriate structural as built drawings incorporating the completed structural frame once strengthening works are incorporated. | 6-months |

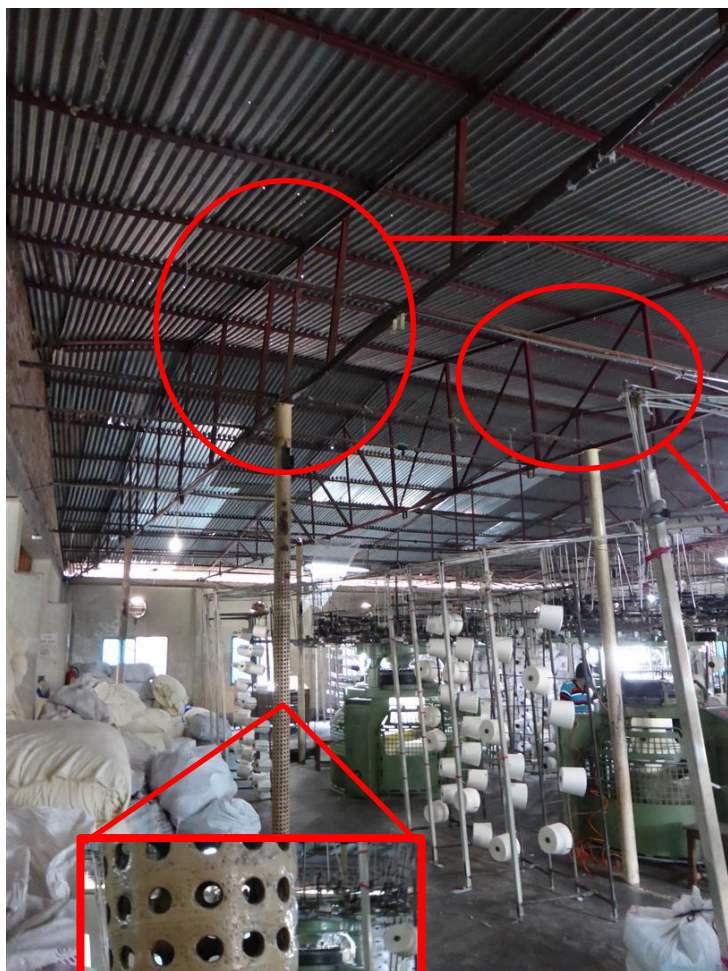
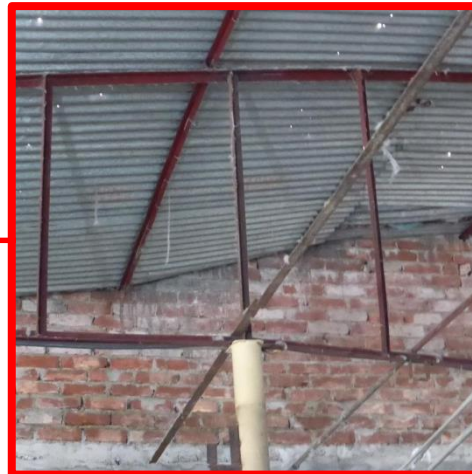
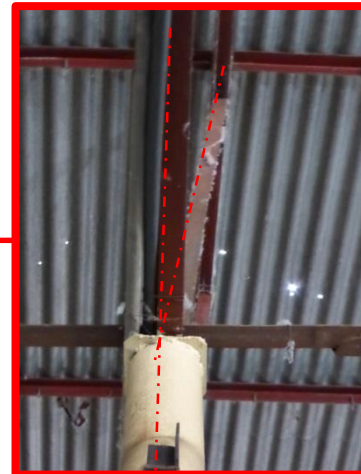
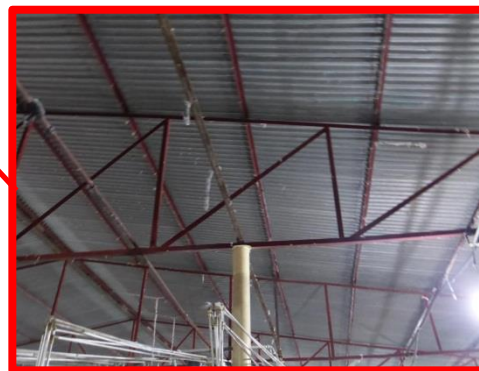
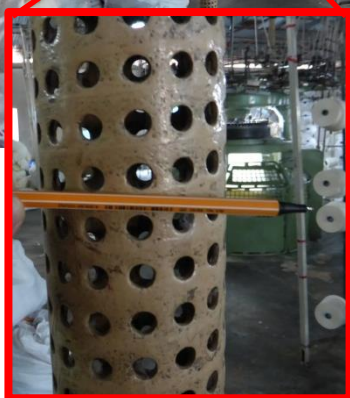
**Non Engineered trusses and internal posts.  
No roof bracing system evident.  
Distress and distortion of structural steelwork  
evident  
Purlins appear to be undersized for cantilever spans.**

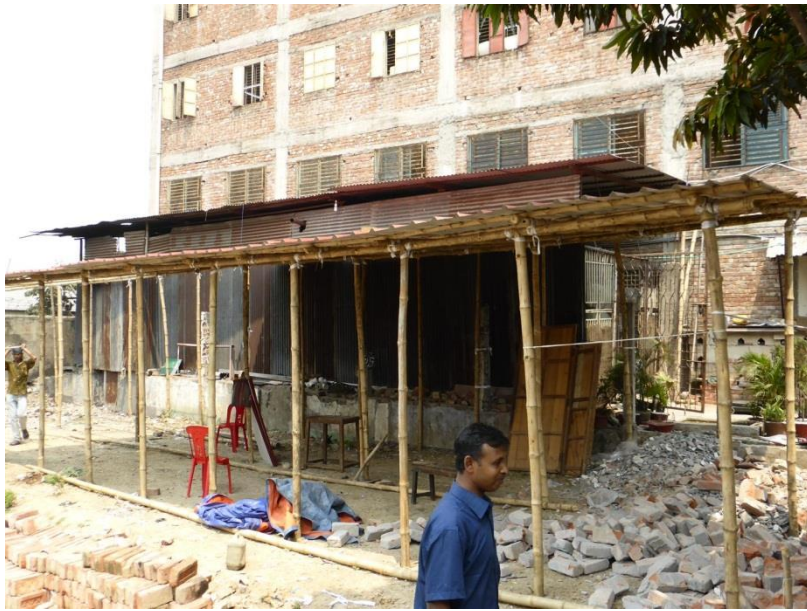
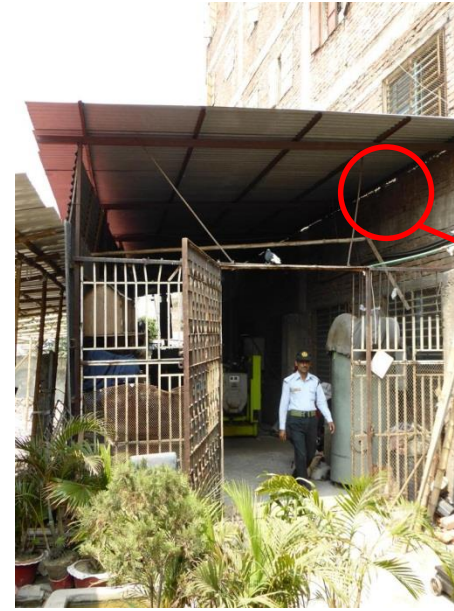
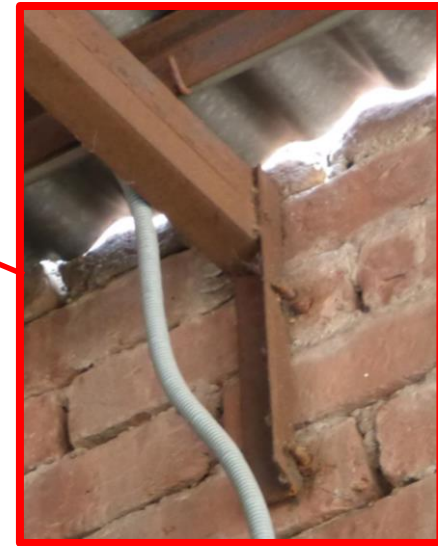
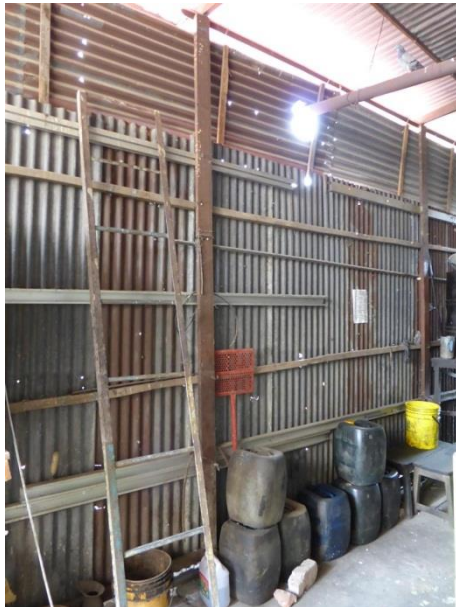
Non Engineered shed,  
connected to main  
building façade.

Building Generator  
located in shed.

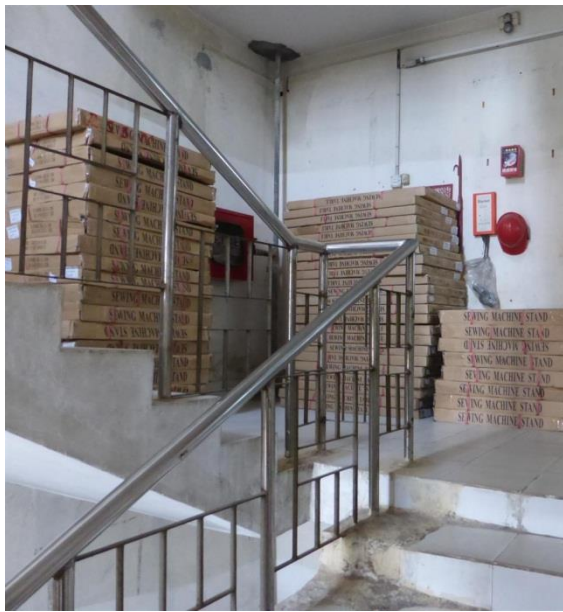
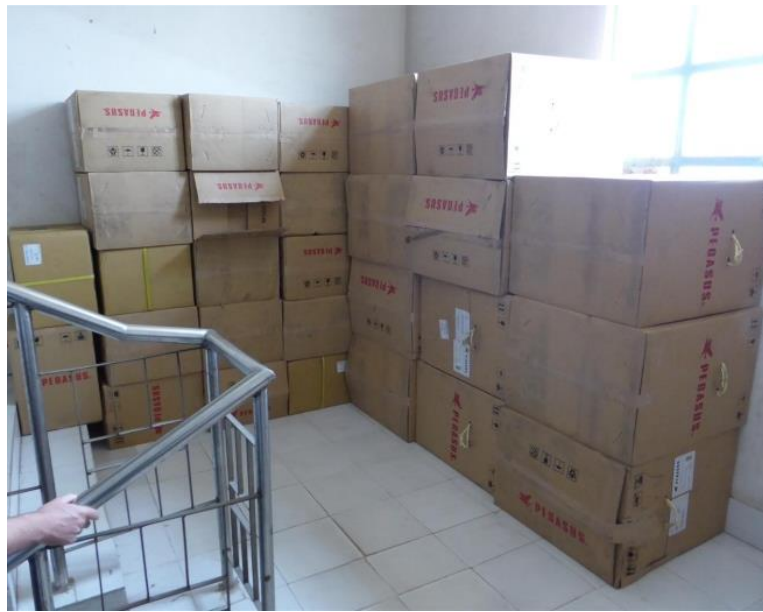
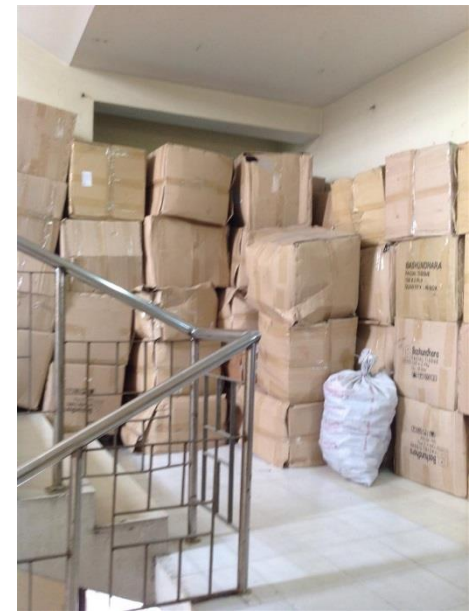
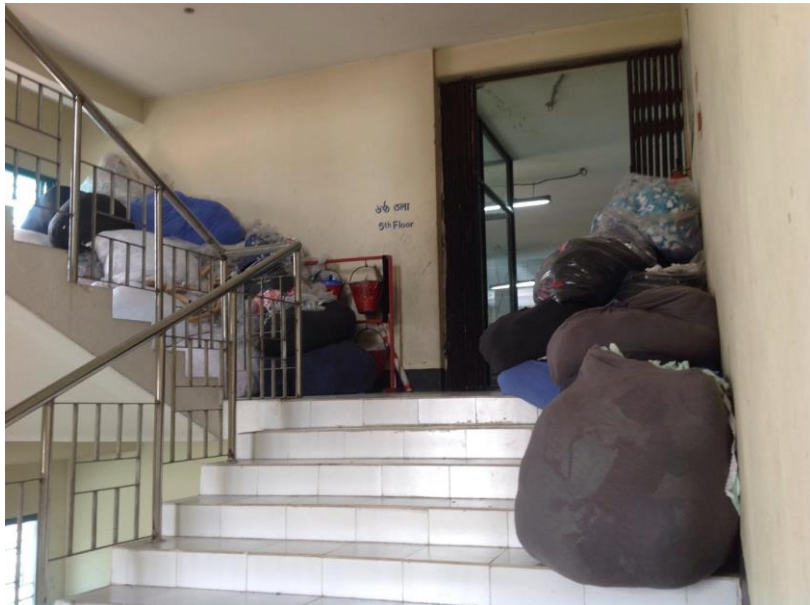
**Numerous areas where load is stored on landings and half landings in both staircores.**

**Issue is raised insofar as it relates to loading. Building manager to review with their fire safety engineer soonest in relation to fire safety issues.**

| Item No. | Observation | Recommended Action Plan | Recommended Timeline |
|---|---|---|---|
| 7 | Localised areas of high loading | Maintain current use of the floors and do not change use or increase occupation or loading prior to completion of safe loading plans by the building engineer | <b>Immediate - Now</b> |
| 8 | Localised areas of high loading | Building Engineer to create controlled loading plans for all floors, which account for existing solid partition loads, extra finishes, heavy fixed items etc. and are based on the structural capacity of supporting slabs, beams and columns in the as built arrangement | <b>6-weeks</b> |

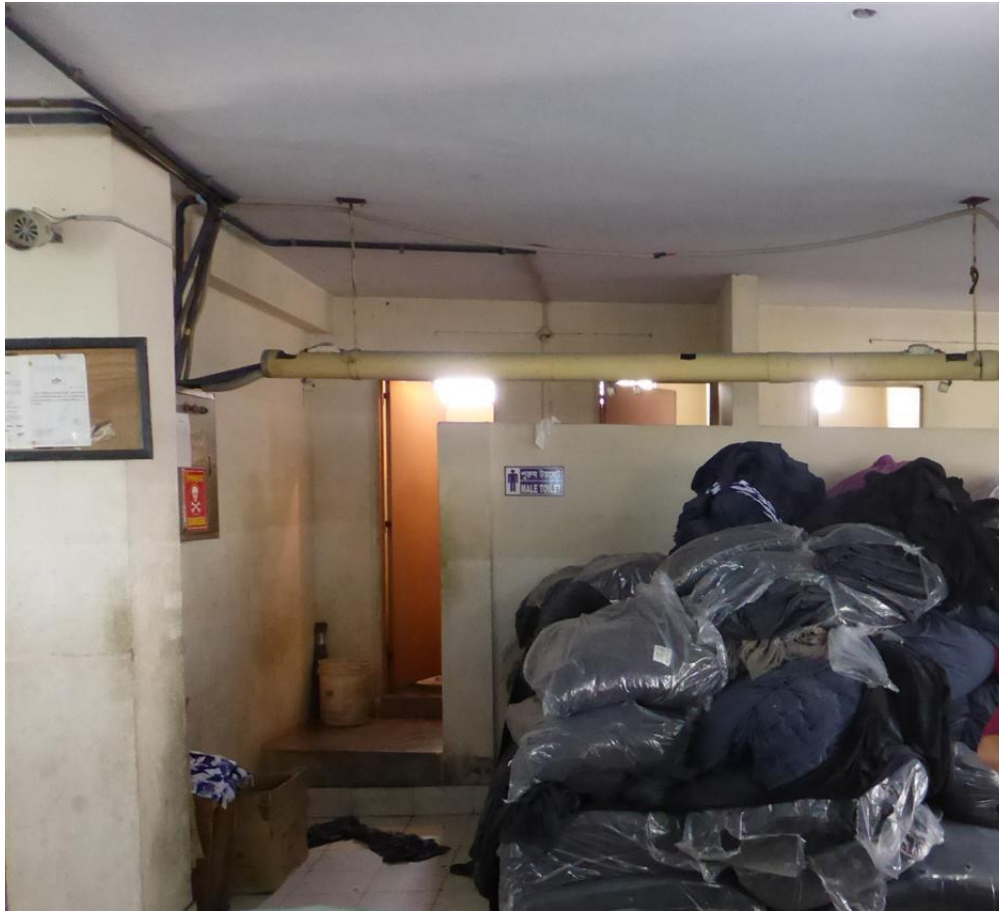
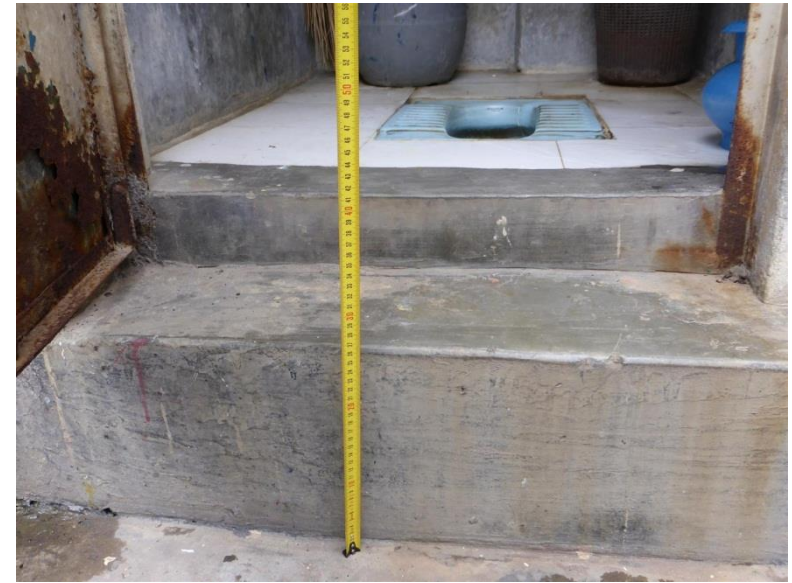
**Toilet drainage infrastructure contained above structural slab level using multiple solid buildups. Additional loading from solid buildups (210mm on 255mm screed recorded) and solid partition walls recorded on bay containing toilet block.**

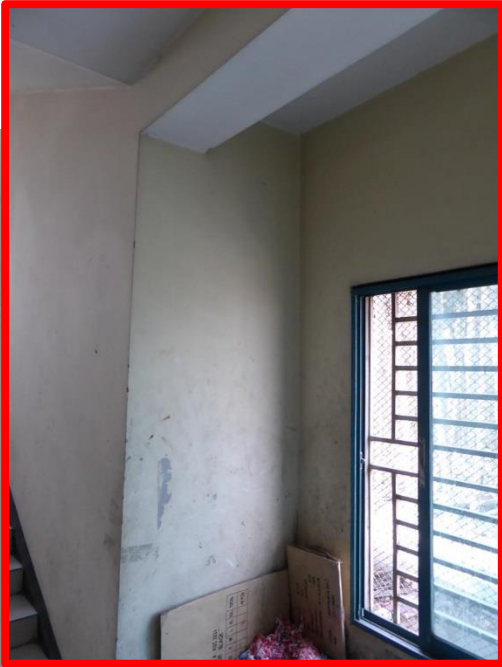
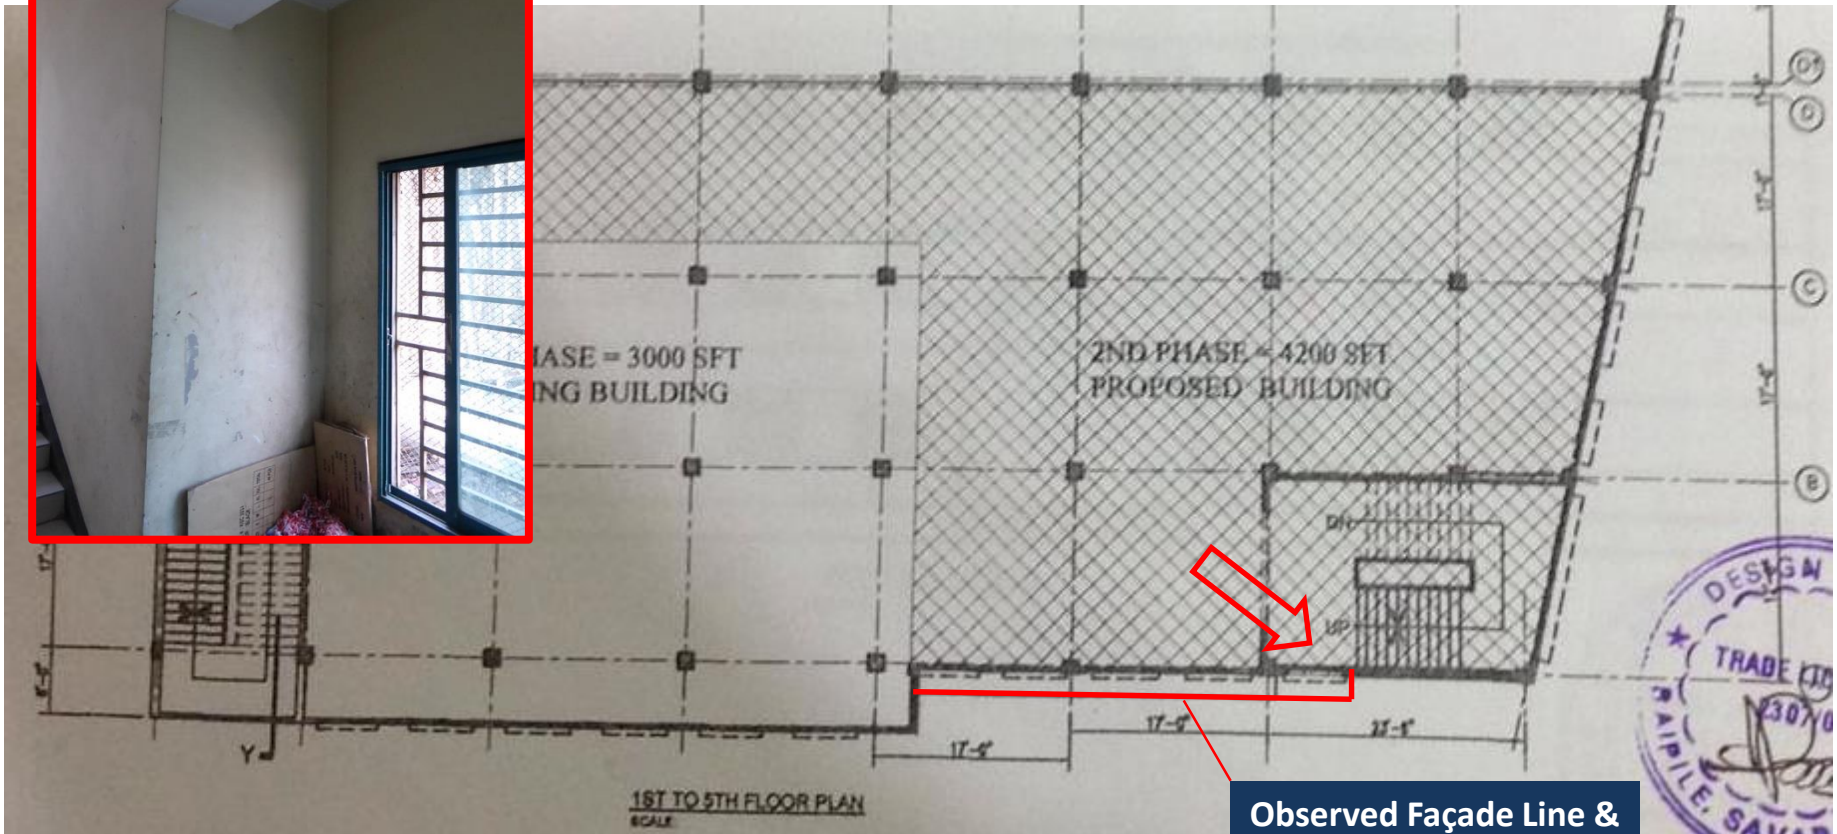
# Undocumented Horizontal Extension

Observed Façade Line & additional Cantilever

| Item No. | Observation | Recommended Action Plan | Recommended Timeline |
|---|---|---|---|
| 11 | Undocumented horizontal extension | Building engineer to verify structural design of additional cantilever and façade load position | <b>6-weeks</b> |
| 12 | Undocumented horizontal extension | Building Engineer to check loading on adjacent columns on basis of as built structural arrangement | <b>6-weeks</b> |
| 13 | Undocumented horizontal extension | Implement any actions arising from the engineering assessment of the additional as built structure | <b>6-months</b> |

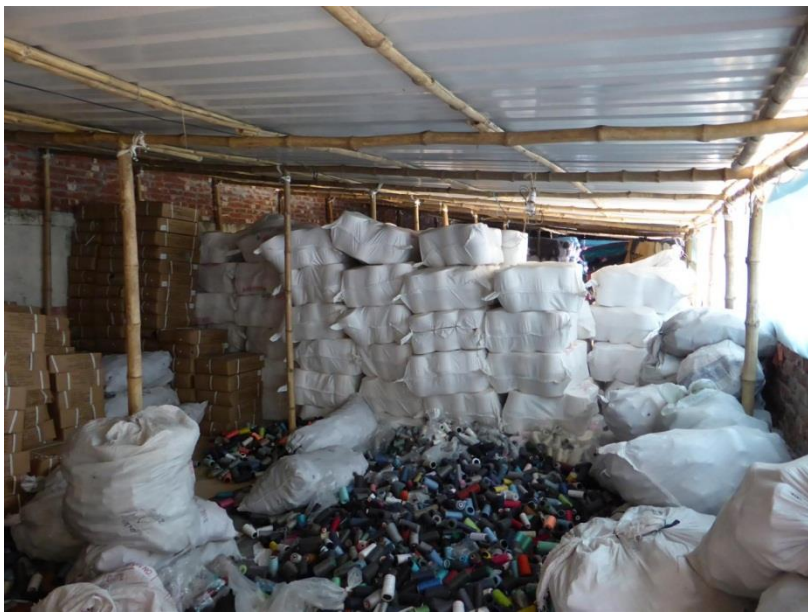
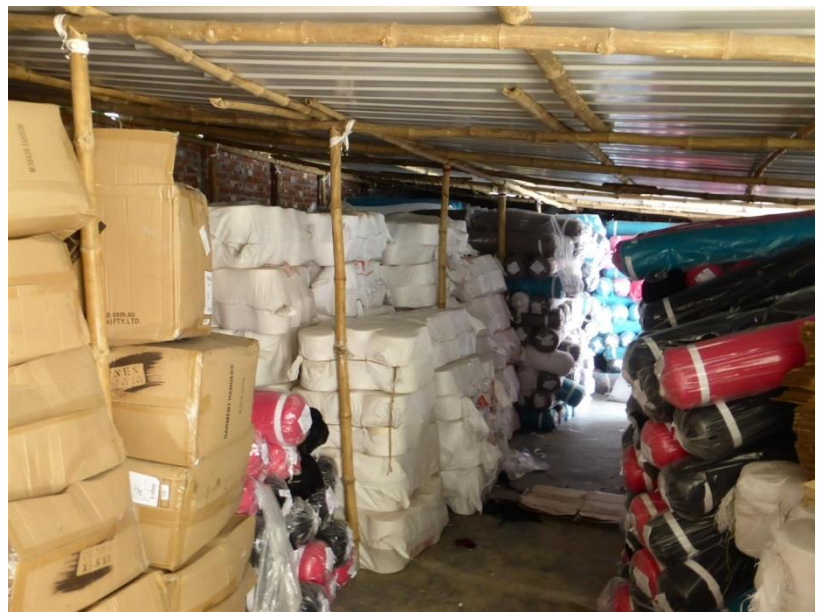
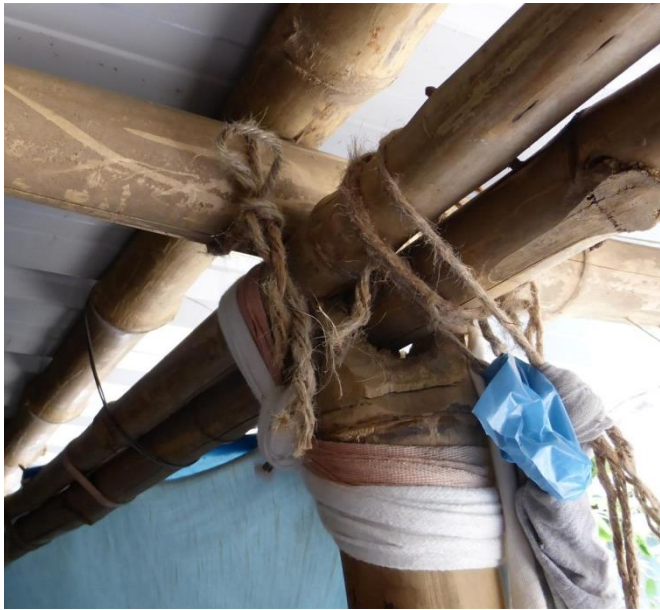
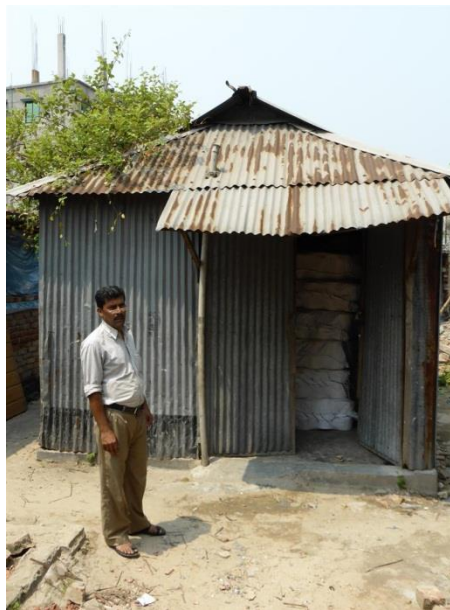
# Non-engineered External Storage Sheds

**Non Engineered bamboo framed storage sheds.**

**Local construction techniques, not normally occupied by factory workers. Not considered assessed as part of this report.**

| Item No. | Observation | Recommended Action Plan | Recommended Timeline |
|---|---|---|---|
| 14 | Non-engineered external storage sheds | Building engineer to review all temporary structures on site and certify that building are fit for purpose and safe for occasional staff access | 6-weeks |
| 15 | Non-engineered external storage sheds | Carry out strengthening or demolitions as advised by the building engineer | 6-weeks |
| 16 | Non-engineered external storage sheds | Implement building manager's plans for appropriate permanent structures required to meet factory storage requirements | 6-months |

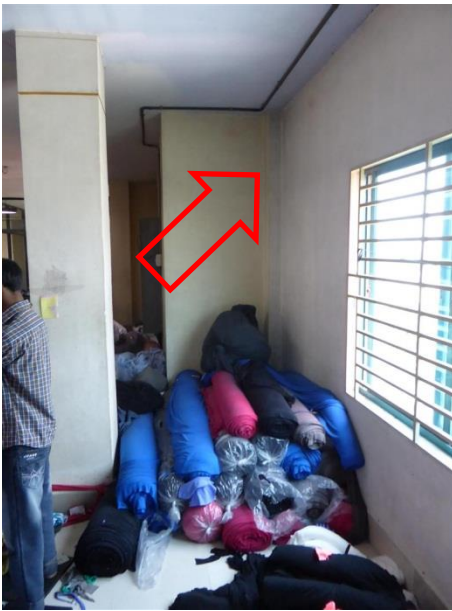
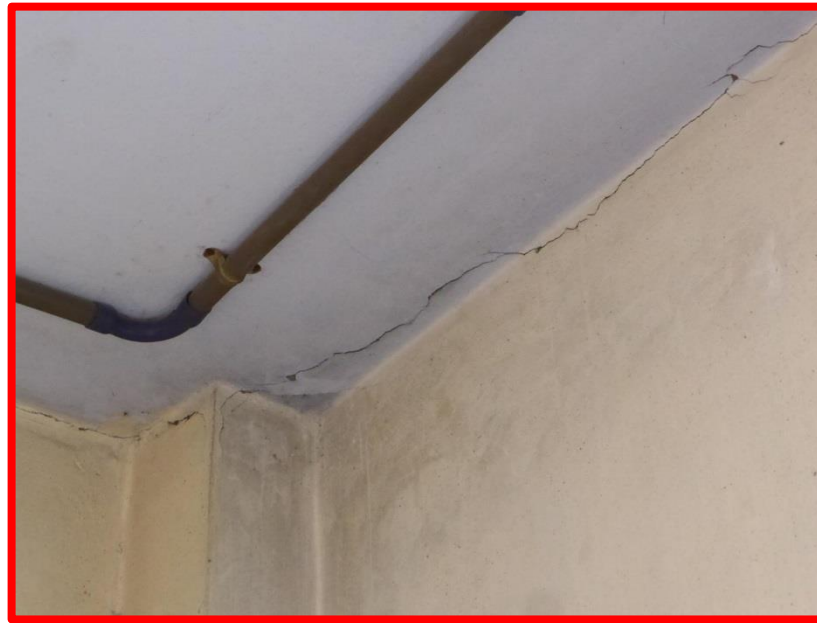
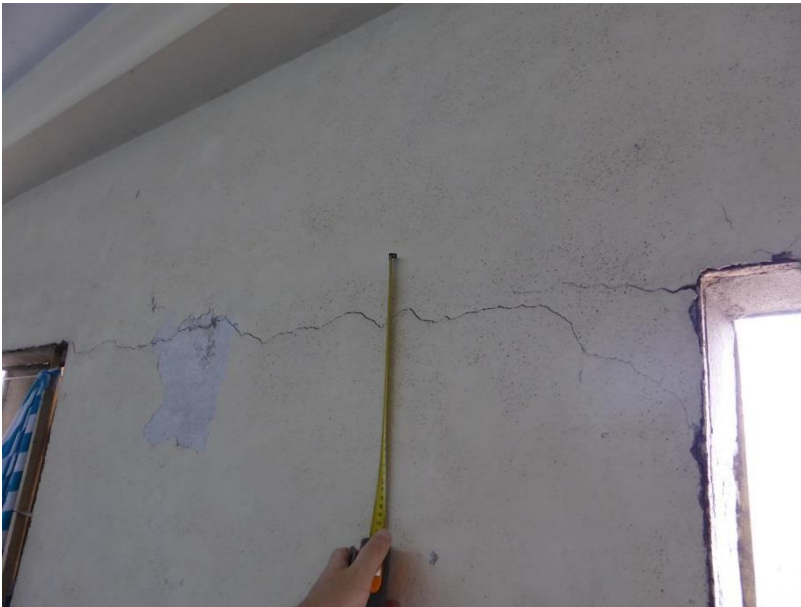
# **Evidence of Distress in Façades and Solid Internal Partitions**

**Evidence of distress on the rendered masonry façade where it is supported on both perimeter beams and flat slab cantilevers.**

**Cracking likely related to deflection of façade support structural elements, lateral load capacity of façade panel and differential thermal movement of façade and structure.**

| Item No. | Observation | Recommended Action Plan | Recommended Timeline |
|---|---|---|---|
| 17 | Evidence of distress in Facades and solid internal partitions | Building engineer to review façade panel design and ensure adequate capacity for applied lateral loads | 6-weeks |
| 18 | Evidence of distress in Facades and solid internal partitions | Building management to continually monitor condition of façade and advise building engineer should any significant of cracking facades or solid partitions take place | 6-months |

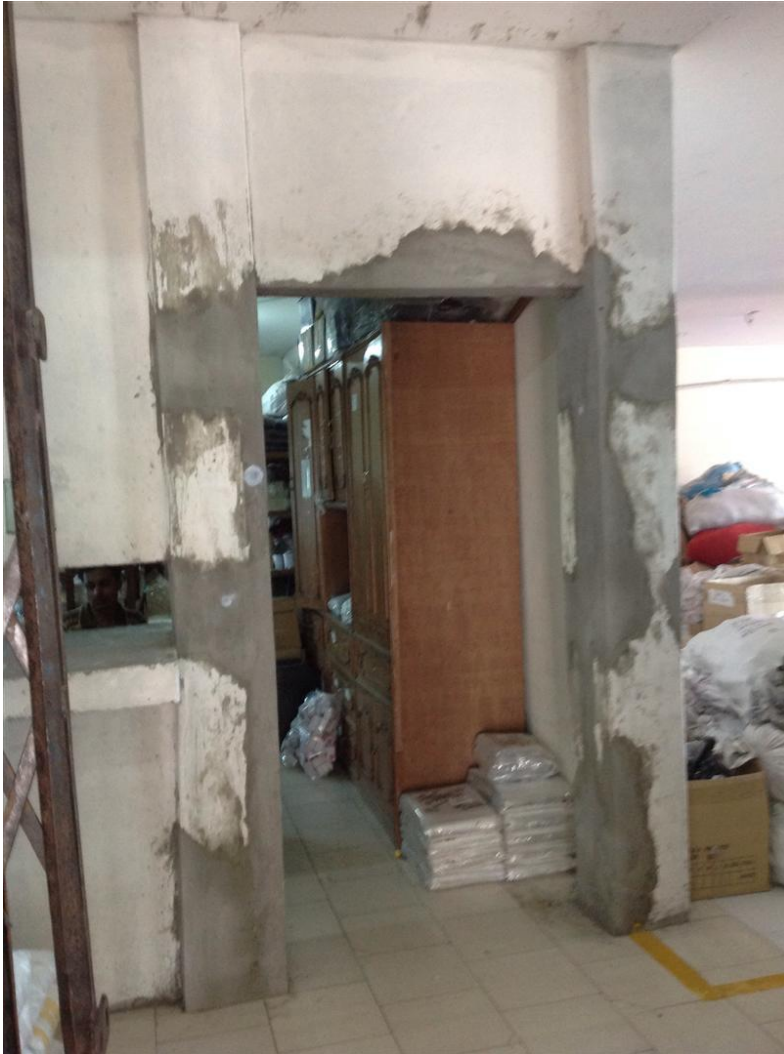
**Evidence of significant prior distress and repair to internal partitions constructed without deflection heads to structural slabs.**

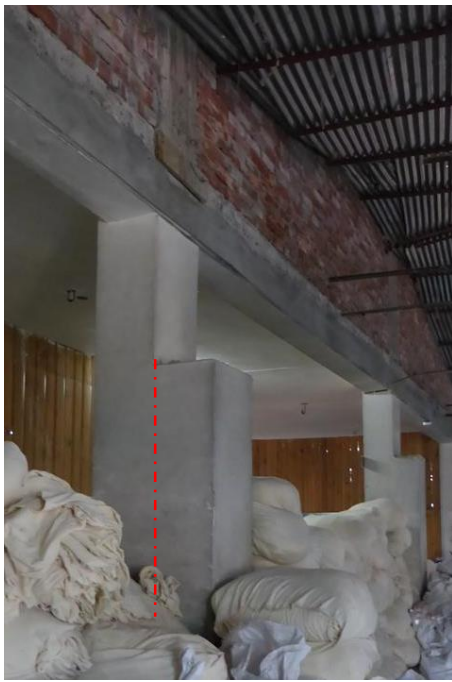
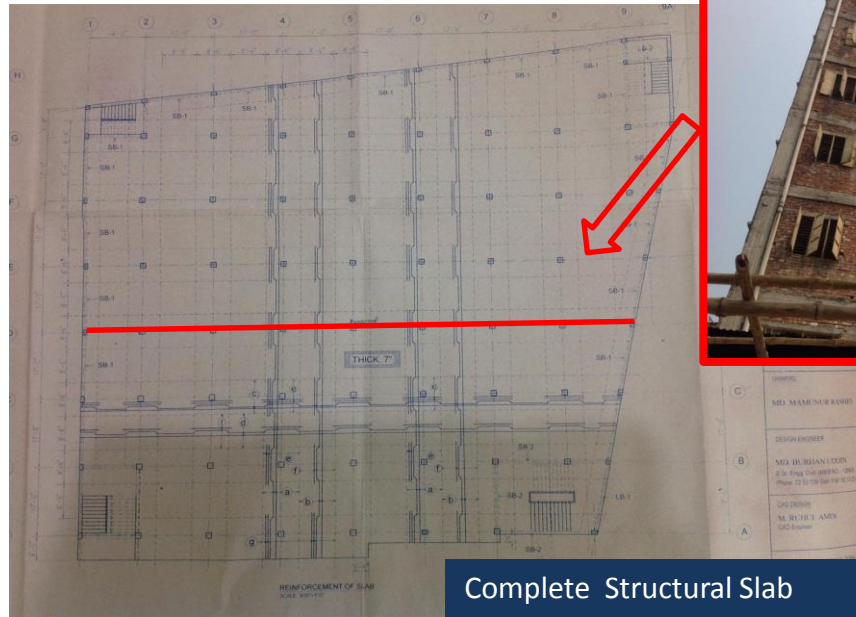
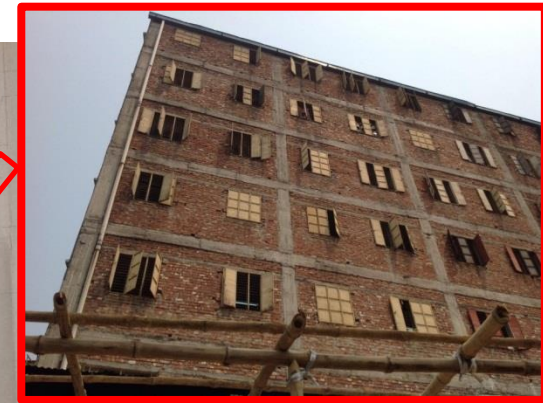
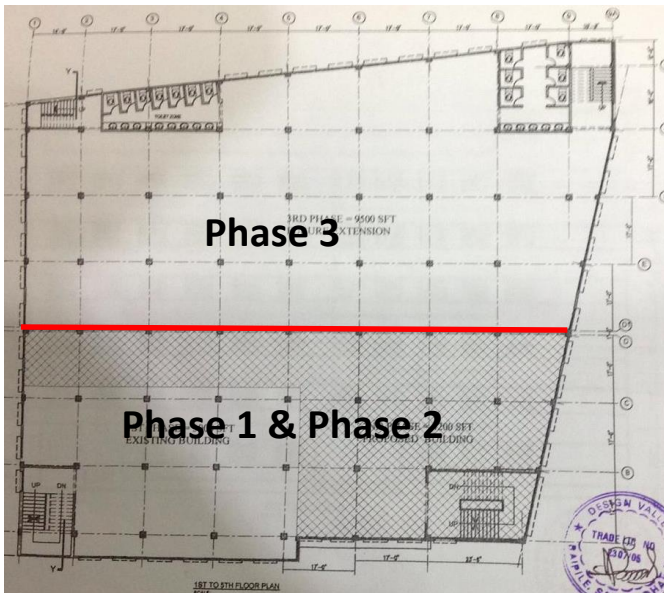
# **Discrepancies between Construction and Design Drawings**

Structural slab design based on multiple spans in 2 directions.

Phase 2 completed without continuity reinforcement for Phase 3.

Reinforcement modifications to phase 2 slab (e.g. additional first internal span requirements) not recorded.

Details for perimeter beam on façade not noted.

Existing perimeter column not sized as an internal column.

Reinforcement included for new phase 3 column on shared pad (currently encased in brick chip concrete and used to support shed structures).

| Item No. | Observation | Recommended Action Plan | Recommended Timeline |
|---|---|---|---|
| 19 | Discrepancies between construction and design drawings | Building engineer to review the structures and structural design for the beam, column and slab arrangement where the original structural design was modified for the construction of Phase 2 | 6-weeks |
| 20 | Discrepancies between construction and design drawings | Carry out any actions arising from the building engineer's assessment of the as constructed bay adjacent to Phase 3. | 6-months |
| 21 | Discrepancies between construction and design drawings | Prepare structural as built drawing for the structure completed to date incorporating changes for original design highlighted in this report | 6-months |
| 22 | Discrepancies between construction and design drawings | Prior to any phase 3 construction commencing, modify design to reflect the new structural arrangements on the Phase 2 to Phase 3 interface. Prepare new designs for double column, new slab span arrangement and check capacity of pad foundation for double column arrangement | 6-months |
