**APS Group Ltd**  
**APS Apparels Ltd**  
**APS Design Works Ltd**  
**APS Clothing Ltd**  
**APS Holding Ltd**

East Faidabad, Dakshinkhan, Uttara, Dhaka

19<sup>th</sup> March 2014

# Observations

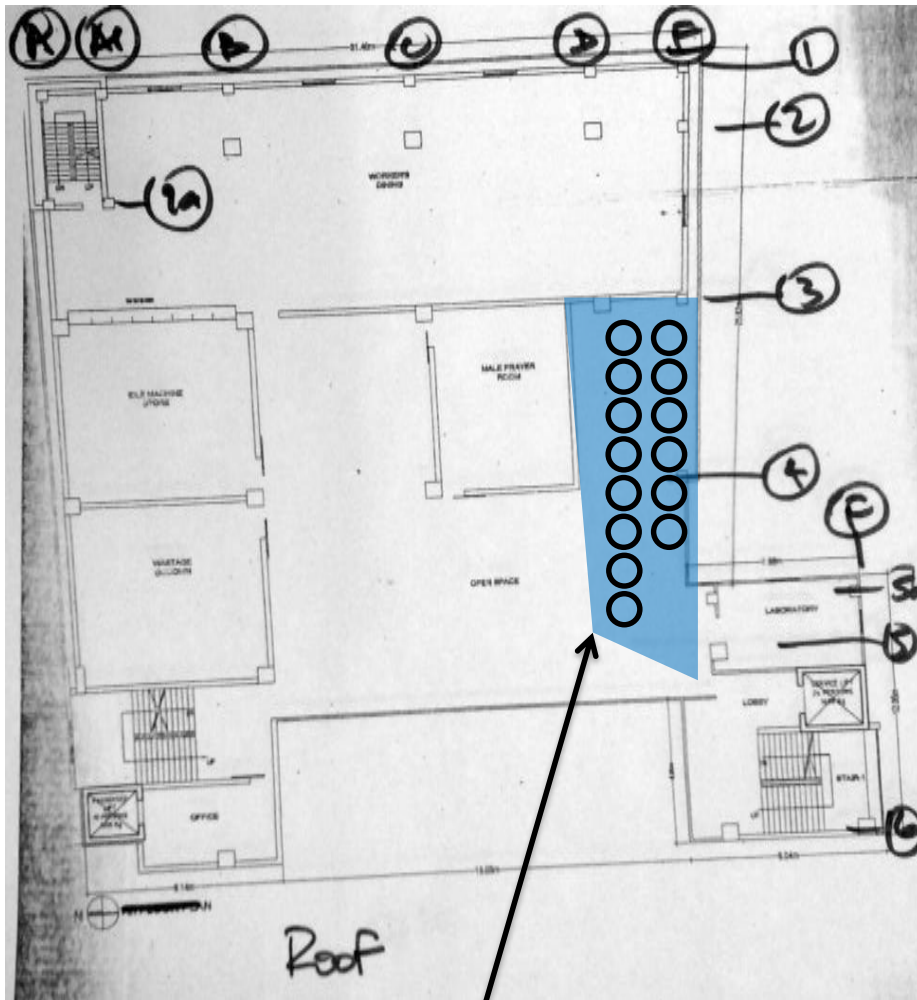
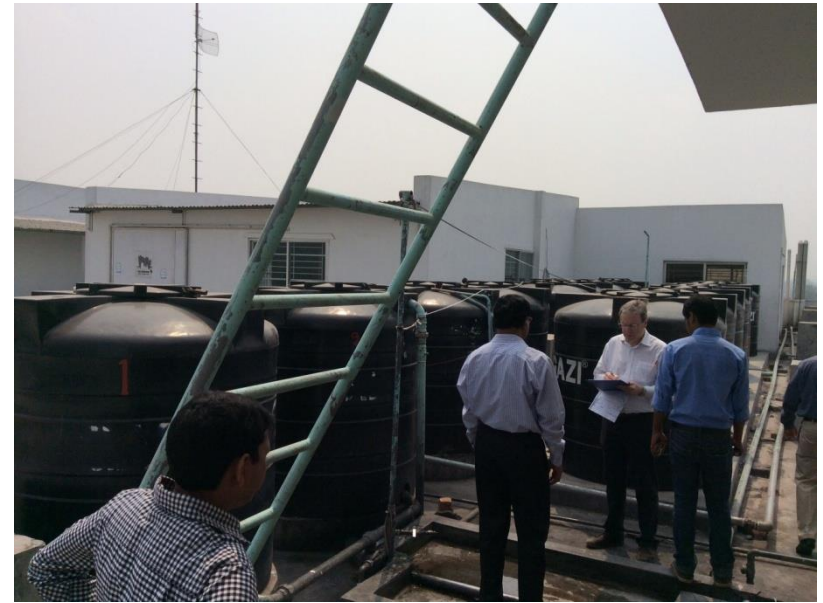
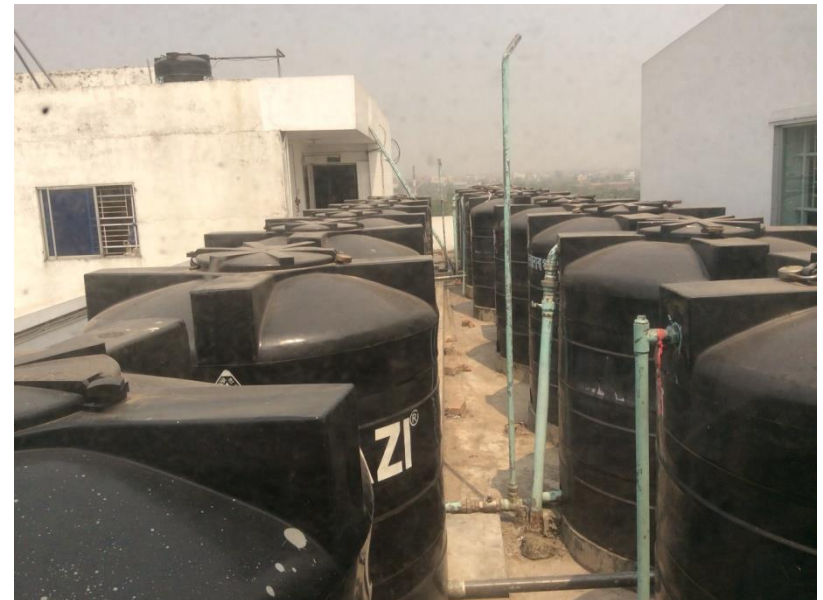
## Loading – water tanks

# High loading due to water tanks

14no. 2000l water tanks in 2 bays of building roof adds significant load to supporting structure in particular the slabs

**ITEM 1:** High Loading due to Water Tanks at Roof Level.

| Item No. | Observation | Recommended Action Plan | Recommended Timeline |
|---|---|---|---|
| 1 | High Loading due to Water Tanks at Roof Level | Building engineer to check the capacity of the slab to carry the concentrated loading and remove/reduce the number of tanks as required | 6-months |

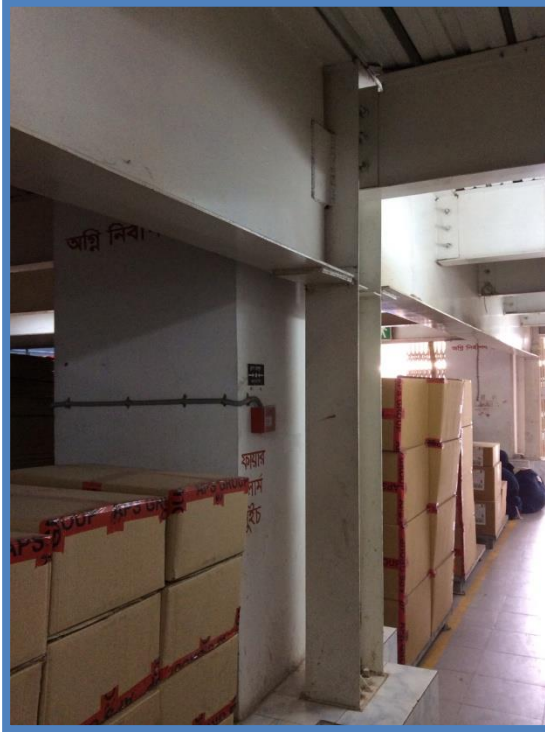
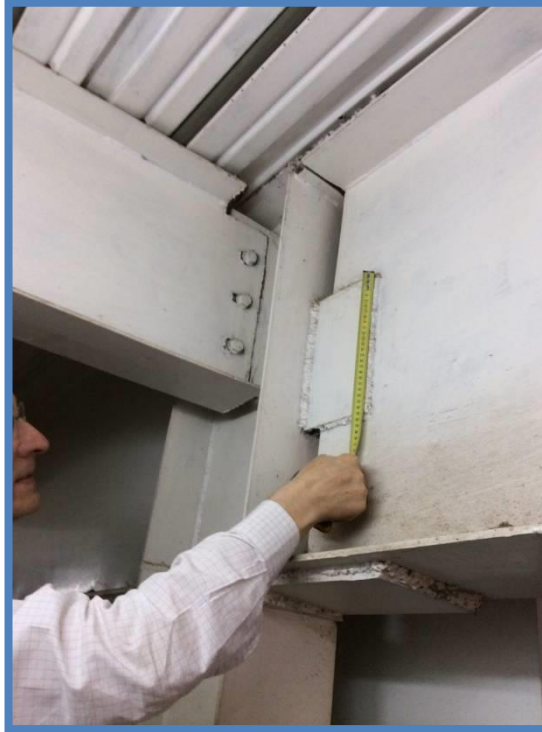
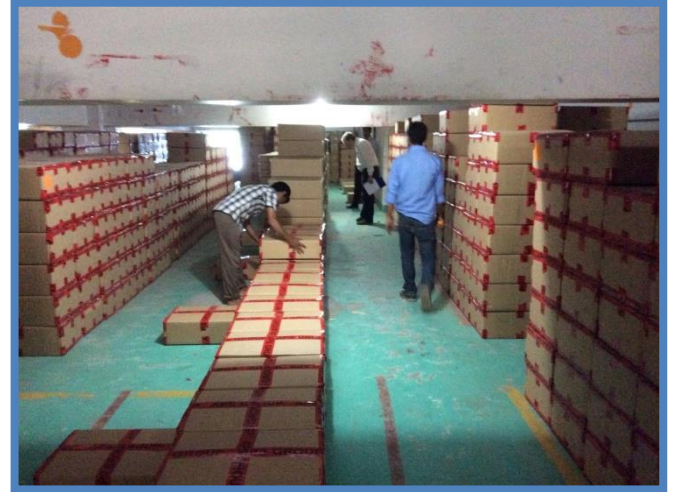
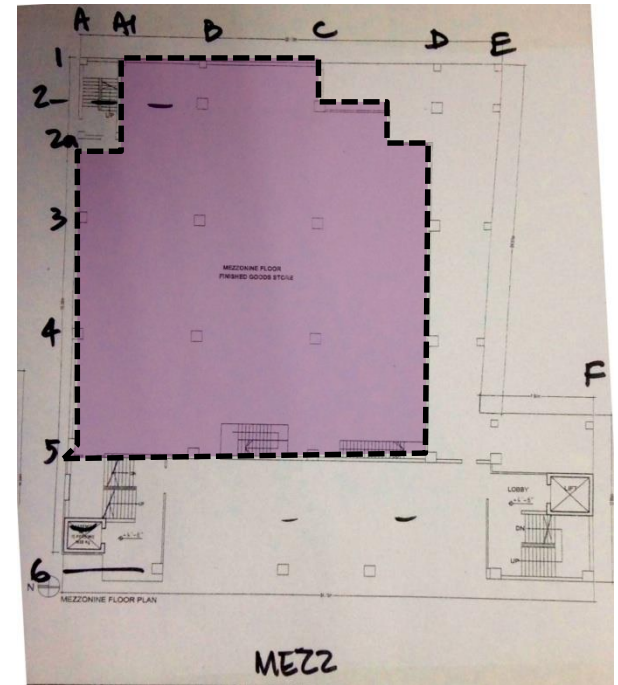
# **Lack of structural drawings for mezzanine**

Extensive mezzanine structure (independent of main reinforced concrete frame) was present, but no structural drawings/calculations/approvals were available. Steel structure with concrete slabs on profiled metal deck. Some connections appeared non-standard and all beams were fabricated. Mezzanine used almost exclusively for storage, with levels limited by low head height

**ITEM 2:** Lack of Structural drawings for Mezzanine Floor and Supports.

| Item No. | Observation | Recommended Action Plan | Recommended Timeline |
|---|---|---|---|
| 2 | Lack of Structural drawings for Mezzanine Floor and Supports | Building engineer to check the structures and provide structural drawings and loading plan for the Mezzanine Floor | 6-months |

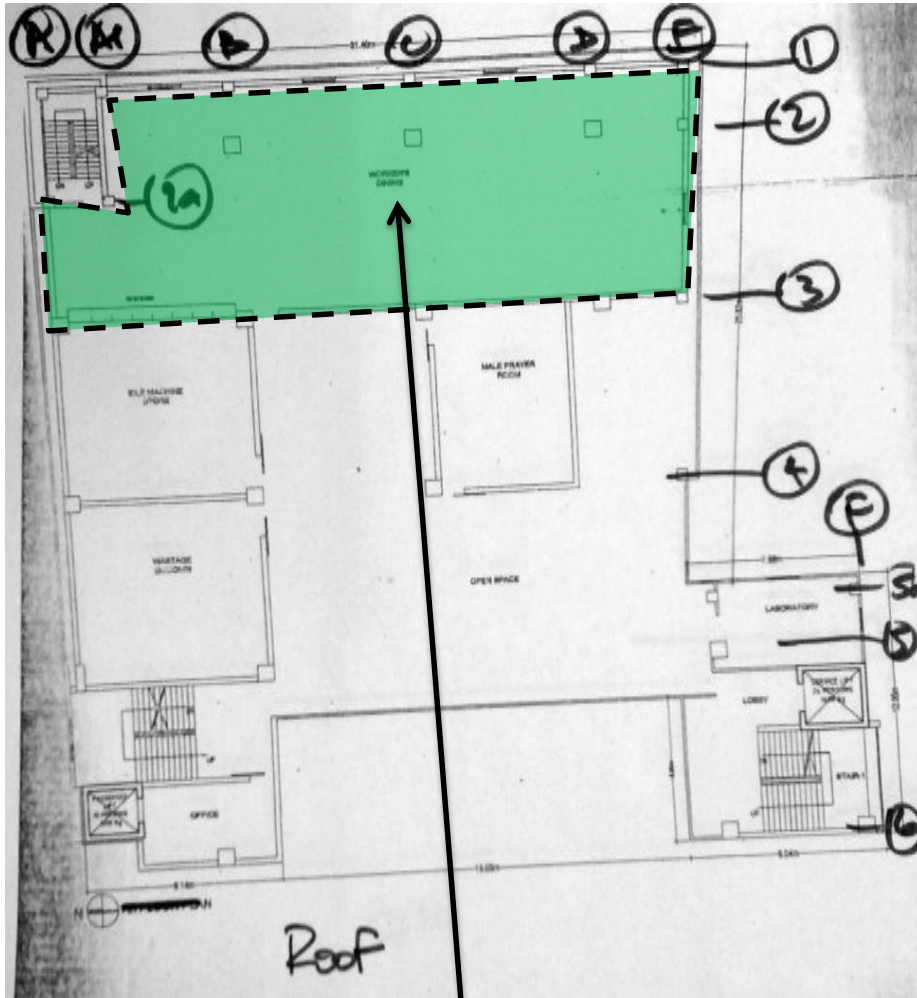
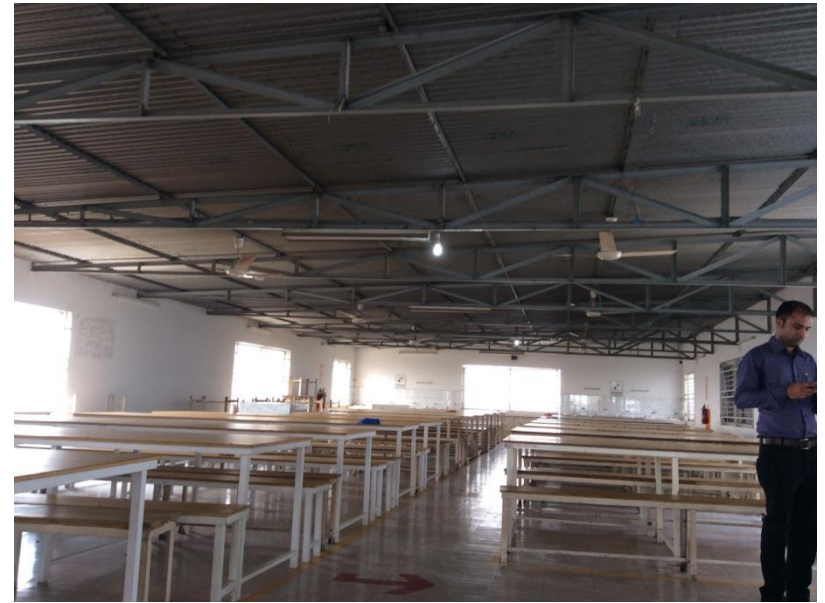
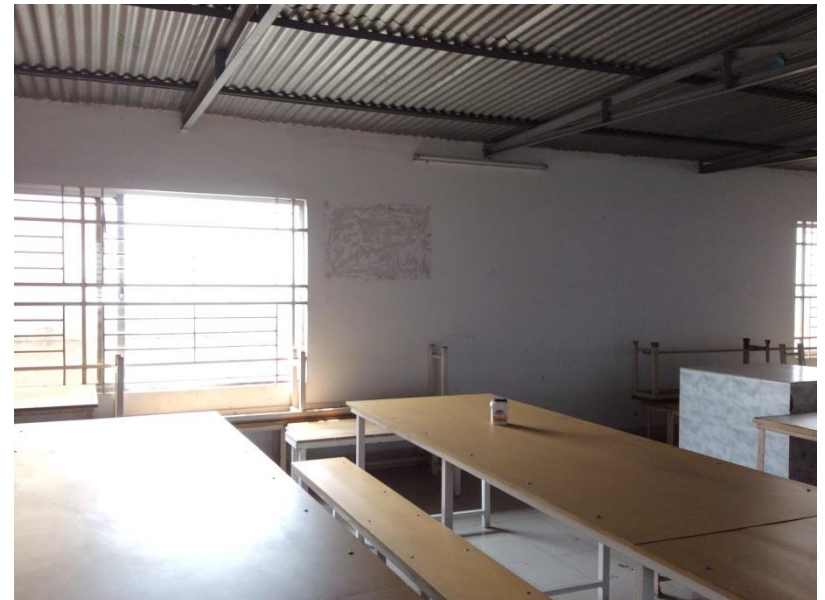
## Canteen roof support

# **Apparently non-engineered structures: Canteen at roof level**

Lightweight steel roof appears to be supported by masonry walls only that may not provide adequate horizontal resistance in a storm event.

**ITEM 3:** Apparently non-engineered roof structures (Canteen at Roof Level).

| Item No. | Observation | Recommended Action Plan | Recommended Timeline |
|---|---|---|---|
| 3 | Apparently non-engineered roof structures (Canteen at roof Level) | Building engineer to check the structures for stability under horizontal loading | 6-months |

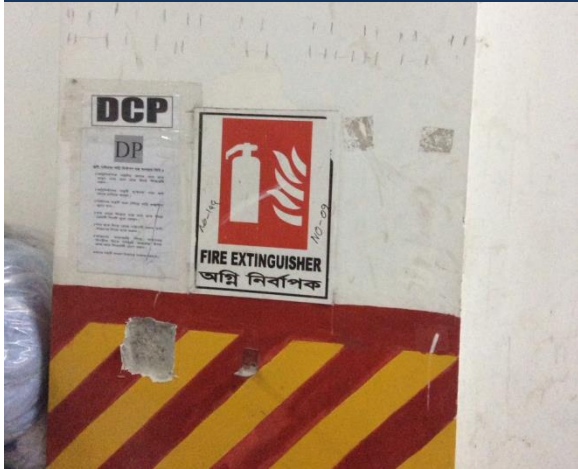
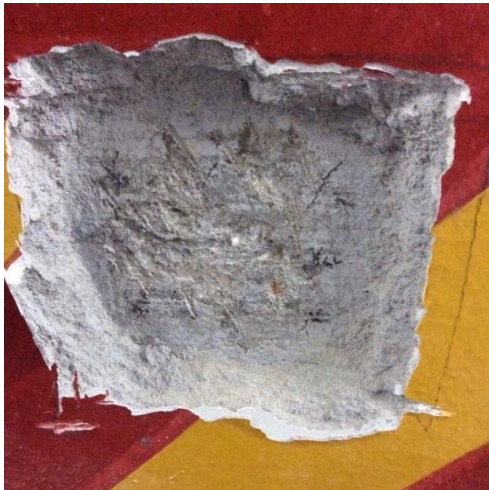
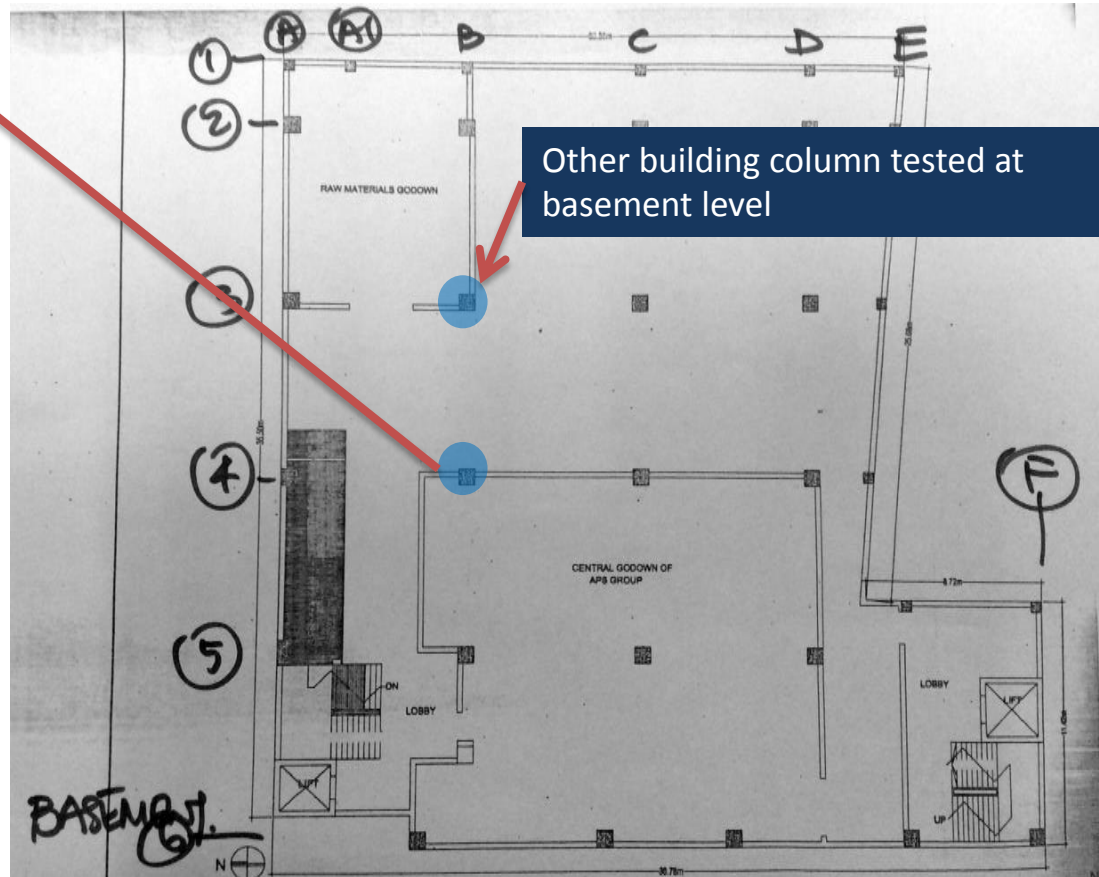
Concrete testing

Building column tested at  
basement level

Stone aggregate

Excepting the mezzanine structure, design drawings are generally in good agreement with as-built structure. Opening up confirms aggregate type is stone throughout, and scanning on several columns indicates levels of reinforcement in agreement with drawings.
