# **FIRE SAFETY INSPECTION REPORT**

**Quazi Abedin Tex Ltd**

**ACCORD ID: 12690**

**Date: 08 February, 2017**

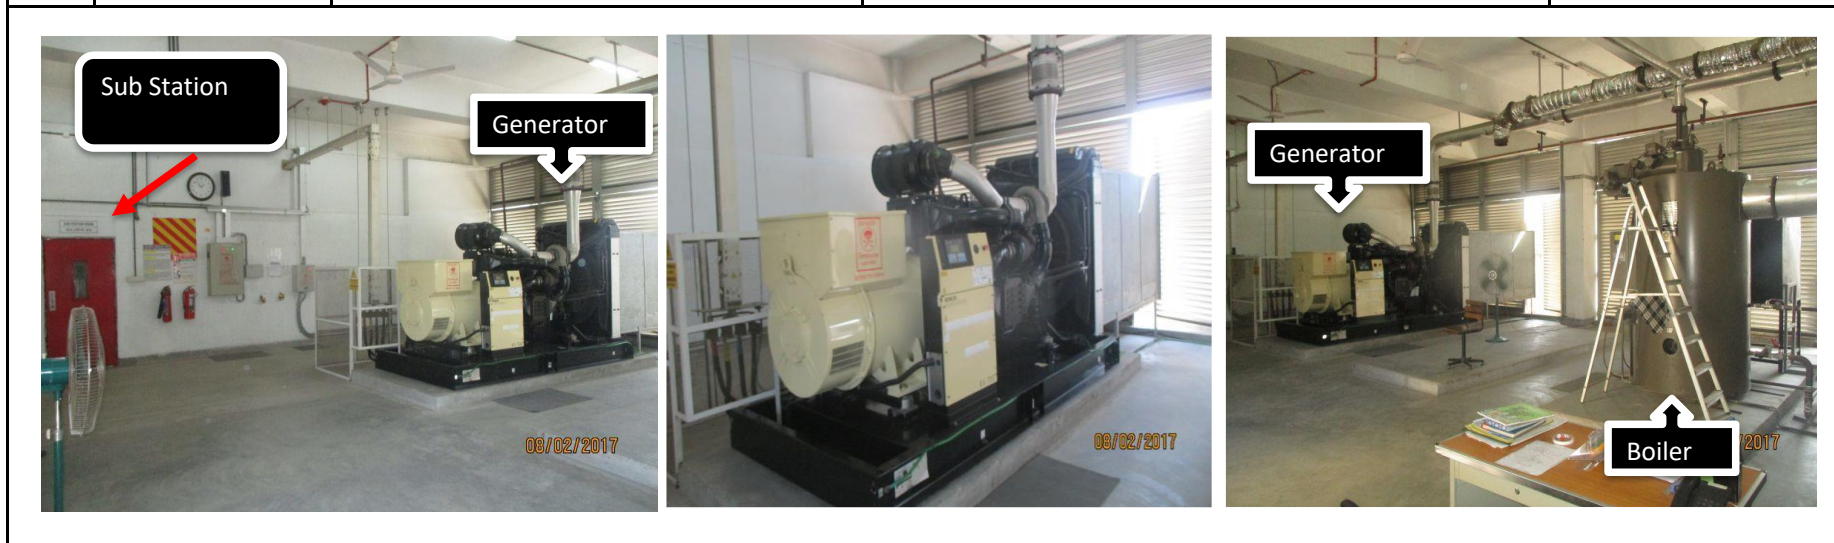
| Sl No. | Category | Findings | Required Action | Remediation Time Frame |
|---|---|---|---|---|
| F-1 | Fire Rated Construction | The boiler/generator/transformer room is not separated by fire rated construction (openings, non-rated doors, penetrations).<br><b>Location: Utility Building.</b> | Separate the generator/transformer/boiler room by a minimum 2-hr fire rated construction. Seal and/or protected all openings to maintain fire separations. | Within 3 months |

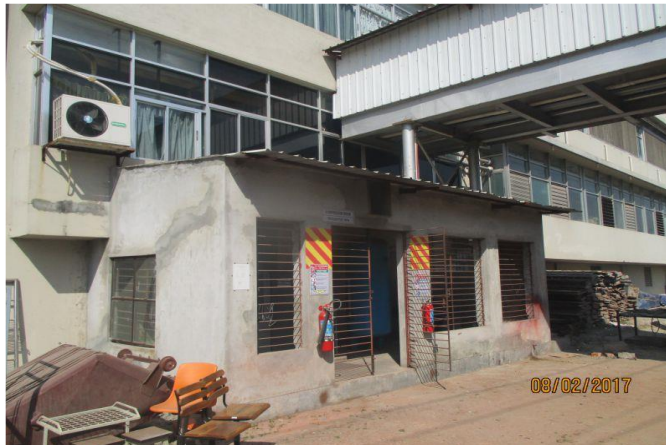
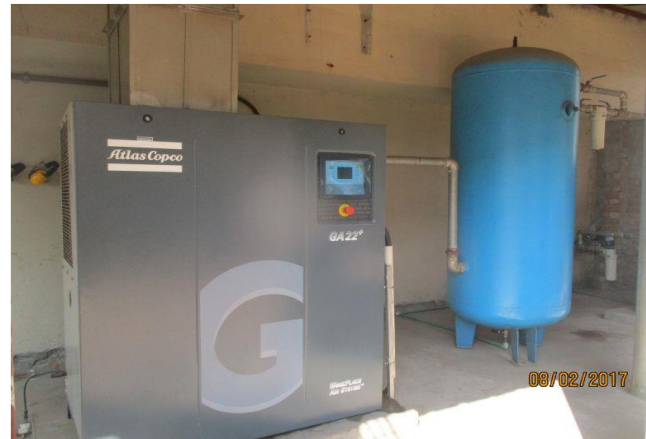
| F-2 | Fire Rated Construction | Compressor room is not separated by fire rated construction (openings, non-rated doors, penetrations). <b>Location: South side of the building adjacent to the ground floor.</b> | Separate the compressor room by a minimum 2-hr fire rated construction. Seal and/or protected all openings to maintain fire separations. | Within 3 months |

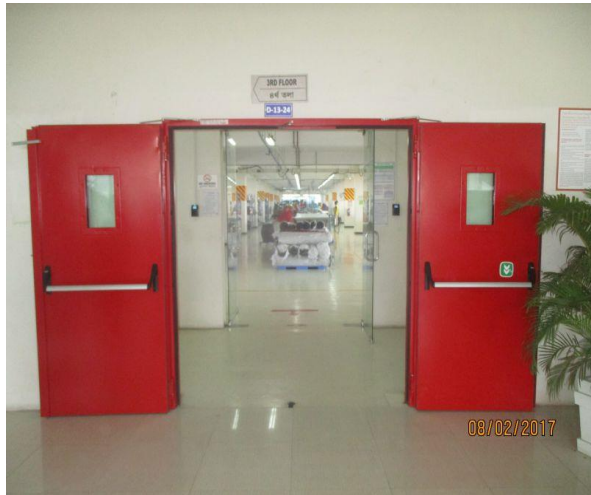
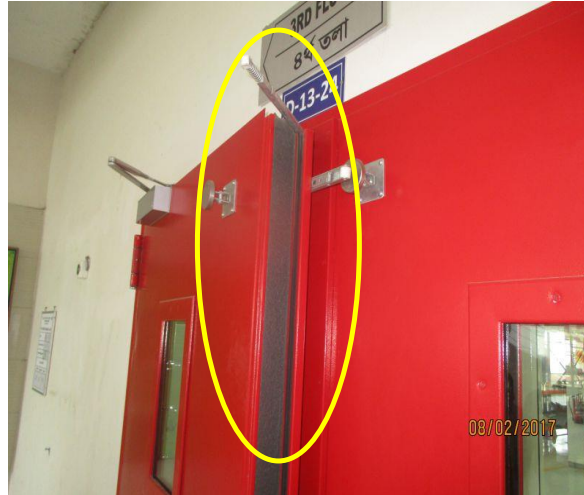
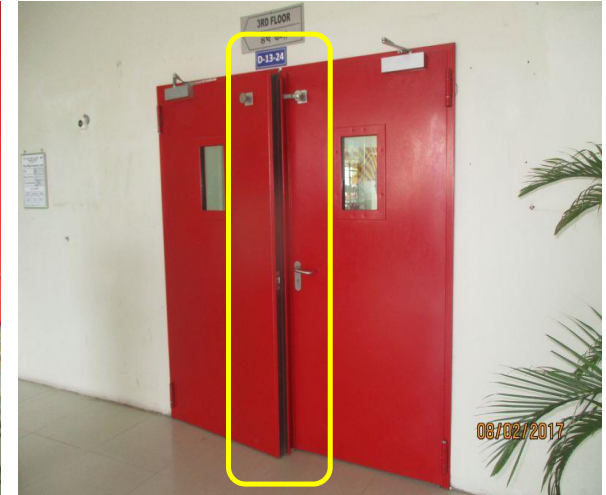
| F-3 | Fire Rated Construction | The exit stairs are not separated from [work areas, other spaces] on each floor by fire rated construction. Door coordinators were not working properly. | <p>Provide minimum 1.5-hr fire rated doors and seal all unprotected openings to separate the exit stairs from work areas and other building spaces on all floor levels. Ensure that the fire rated doors are self-closing and positive latching and that they are provided with fire exit (panic) hardware where serving production floors.</p> <p>If fire rated doors are required to be held open for functional reasons, provide automatic closing devices tied to the fire alarm system.</p> <p>Once fire doors are installed, every door in a stair enclosure serving more than 5 stories shall be provided with re-entry unless it meets ACCORD standard 6.8.3.1.</p> <p>Ensure all the parts are properly installed.</p> | Within 3 months |

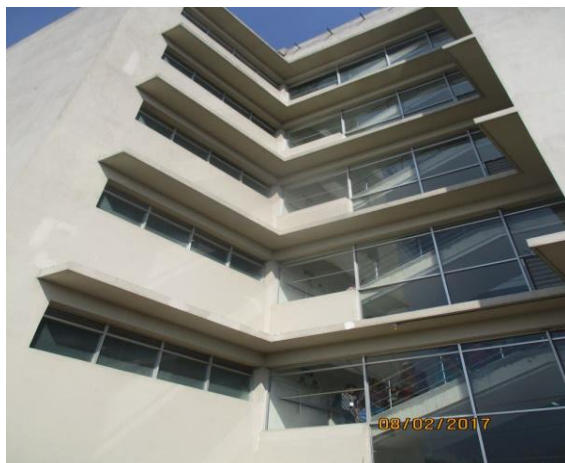
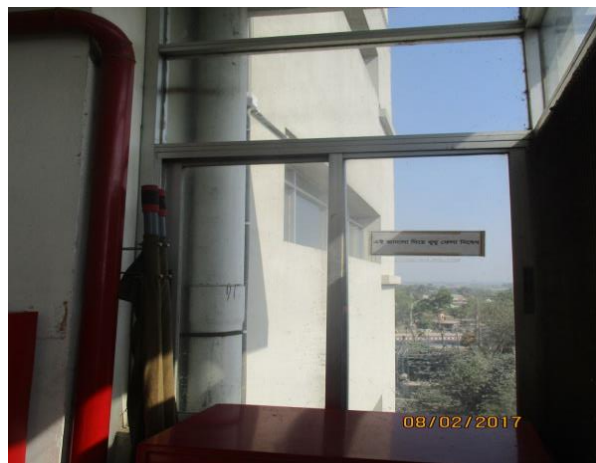
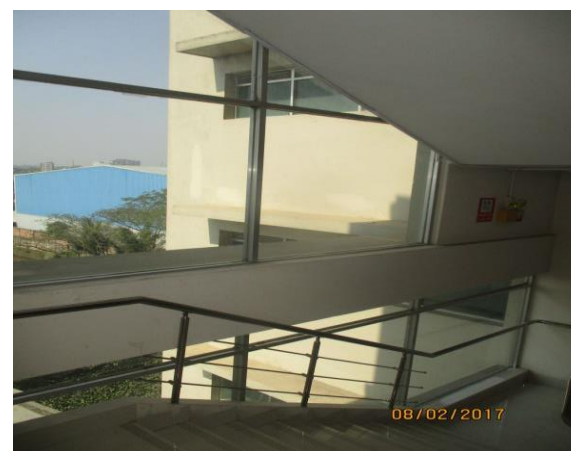
| F-4 | Fire Rated Construction | Unsealed penetrations and openings are located in the exit stair enclosures. <b>Location: all the exit stairs.</b> | Seal all penetrations and openings in exit stair enclosure walls to maintain the fire separations as per Accord standard 6.3.1.3. | Within 3 months |

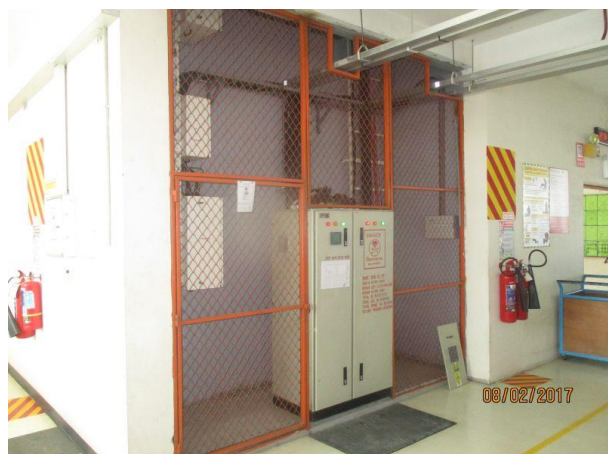
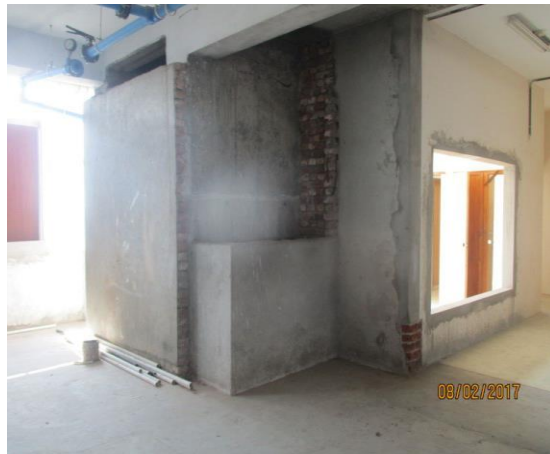
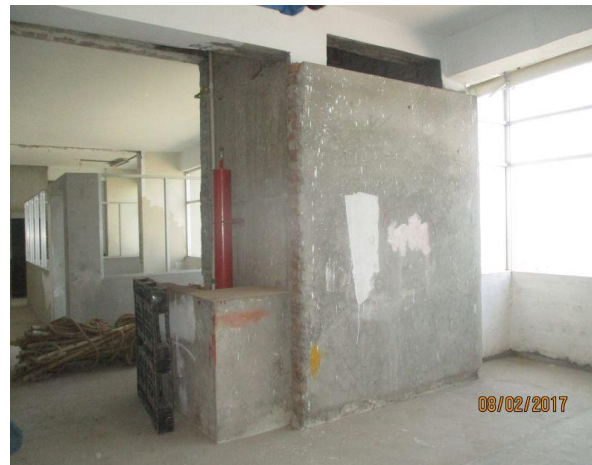
| F-5 | Fire Rated Construction | Unsealed penetrations and openings are located in the fire rated floor/ceiling assemblies. <b>Location: Electrical riser and standpipe riser at south east, north east west middle side of the building.</b> | Provide a minimum 2-hr fire rated shaft to separate the utility risers from each floor level.<br>Seal all penetrations and openings in floors/ceiling assemblies to maintain the fire separation. | Within 3 months |

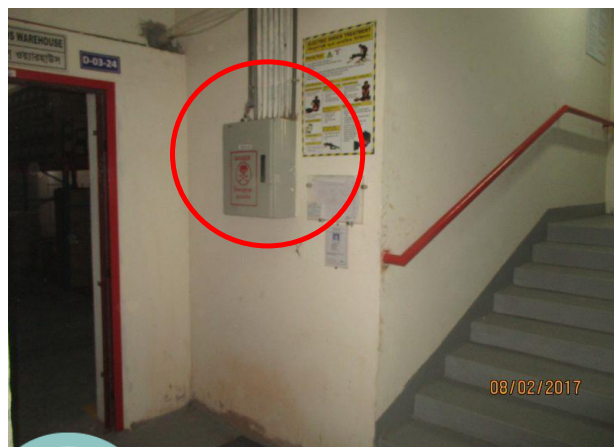
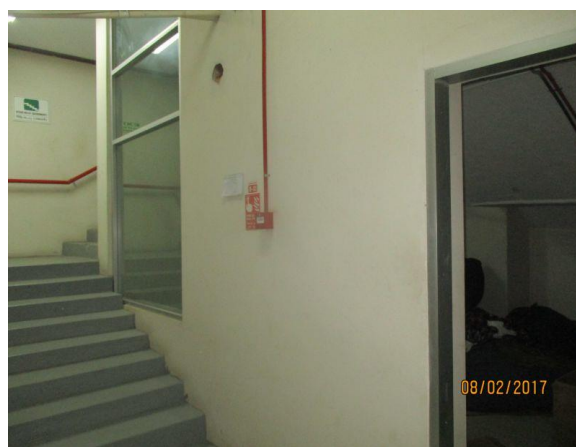
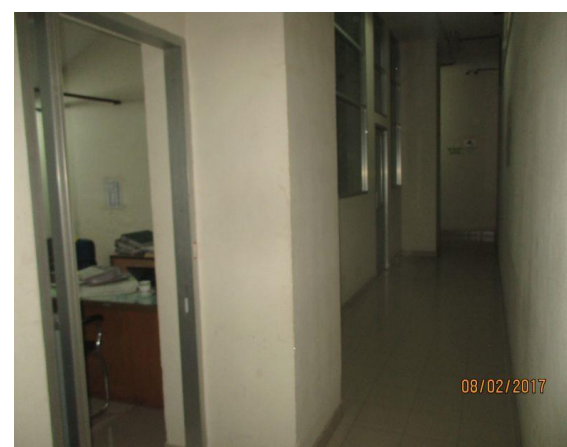
| F-6 | Egress | Combustible storages and electrical panel was located in exit stair encloser on basement area at north east and south east stair. | Remove storage from the exit stairs and egress path. | Immediately |

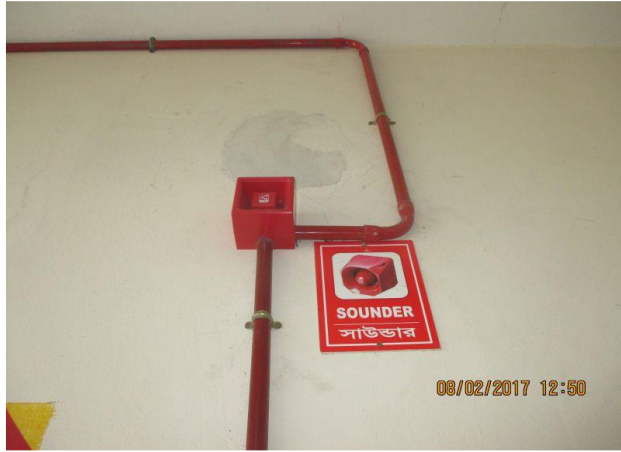
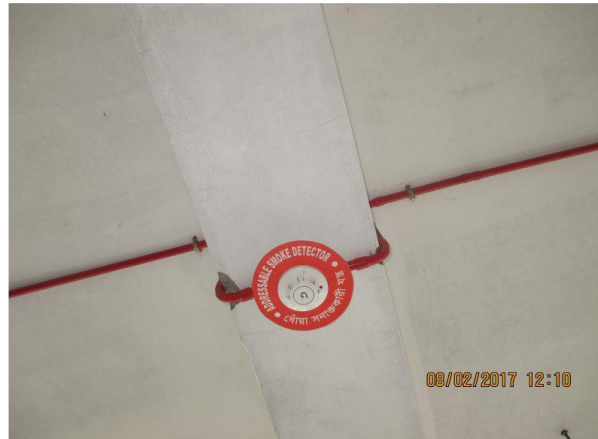
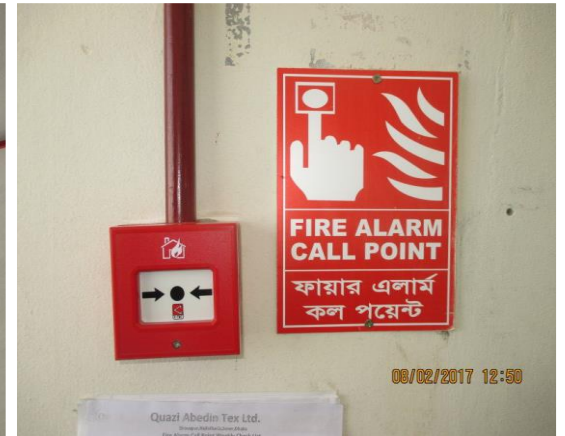
| F-8 | Fire Protection | Fire detection system installation requires detailed review to confirm compliance with NFPA 72 and ACCORD standards. | Submit as-built drawings, testing records, equipment certification and other relevant documentation to the ACCORD for review and approval | Design within 2 months and Modification within 6 months. |

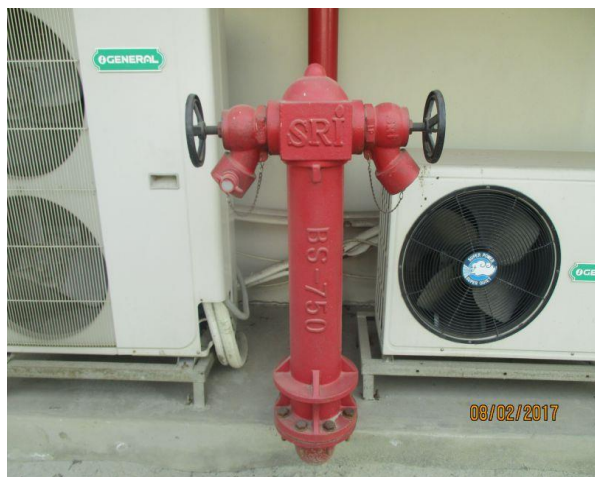
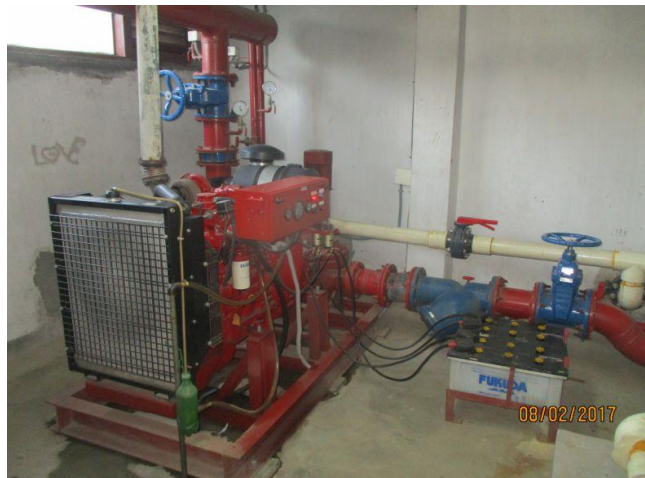
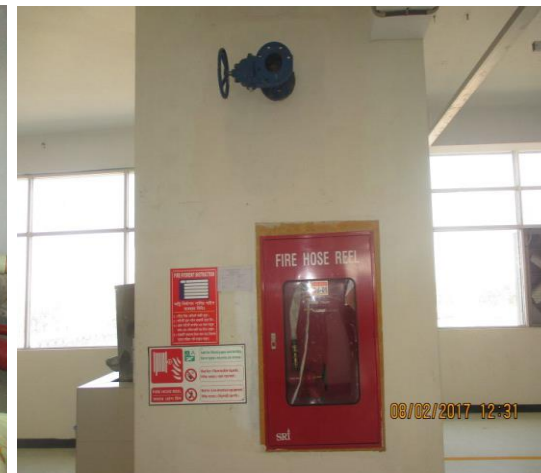
| F-10 | Fire Protection | Standpipe system installation requires detailed review to confirm compliance with NFPA 14 and ACCORD standards | Submit as-built drawings, testing records, equipment certification and other relevant documentation to the ACCORD for review and approval | Design within 2 months<br>Modification within 6 month. |

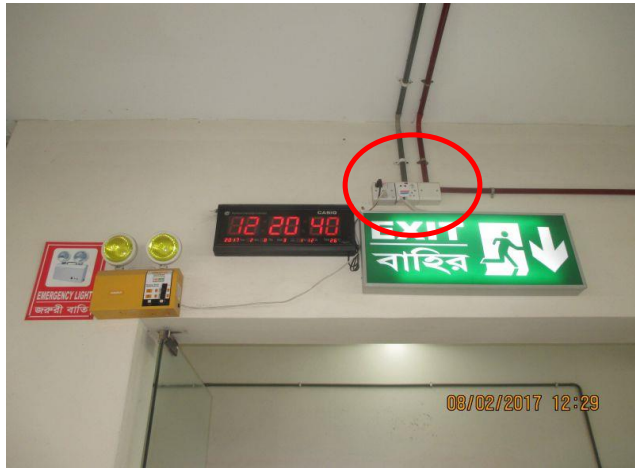
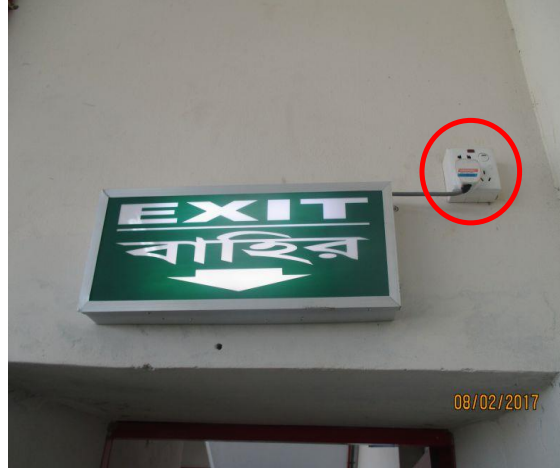
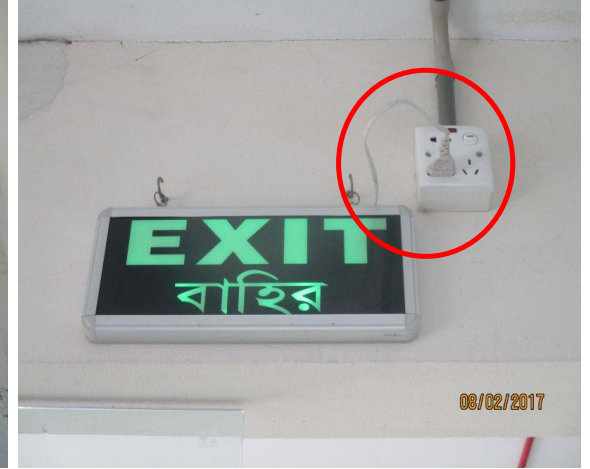
| F-12 | Egress Lighting | Manual on-off switch is provided for [emergency lighting / exit signage] units. | Remove manual on/off switches from [emergency lighting /exit signage] units to prevent them from being switched off. | Within 1 month |

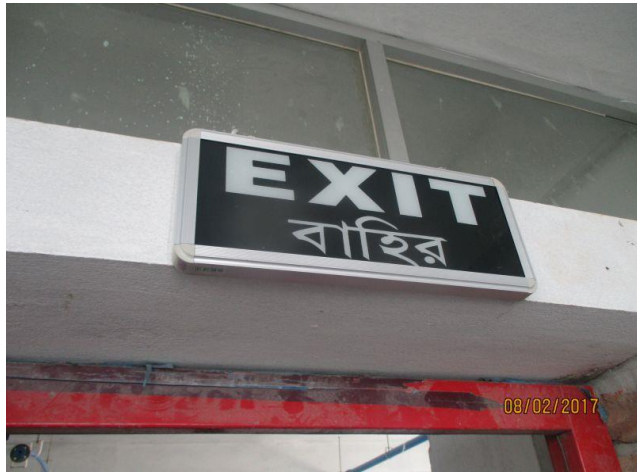
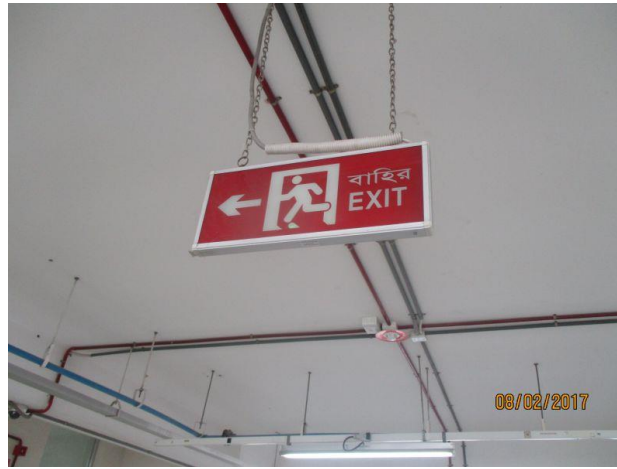
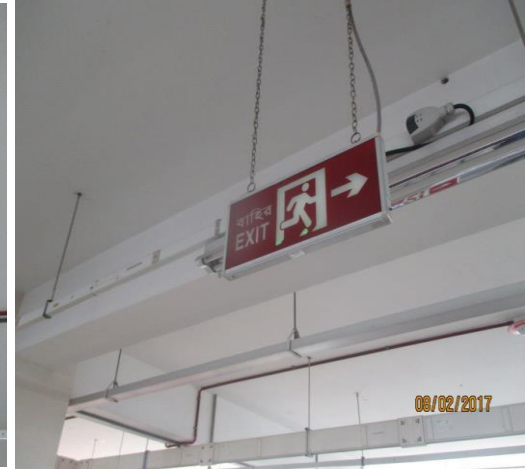
| F-13 | Egress Lighting | Exit signage not illuminated (burned out, broken, etc.). | Regularly inspect all exit signage and replace/install lights as needed to illuminate signs | Within 1 month |

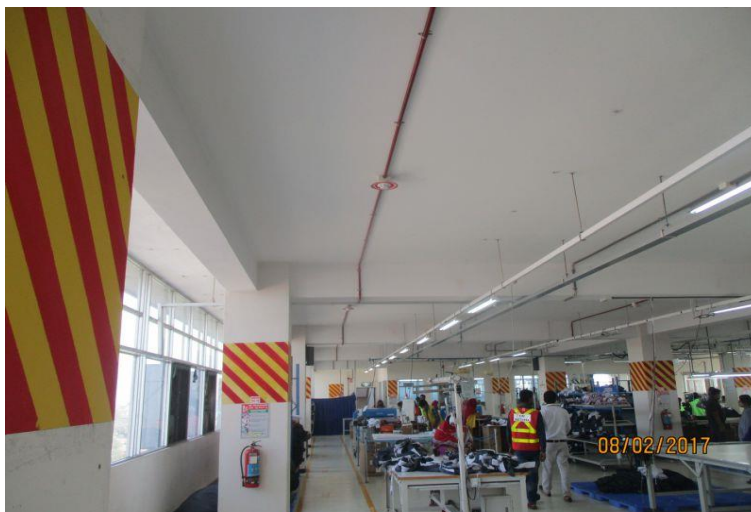
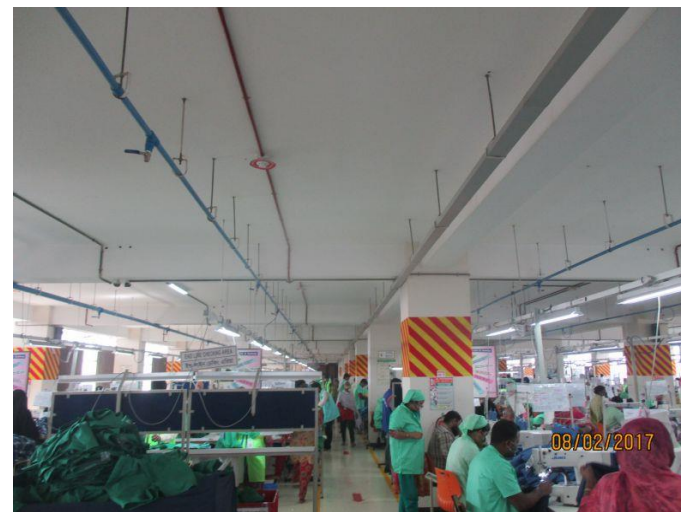
| F-14 | Egress Lighting | Based on the number and location of emergency lights observed, adequate illumination levels are not anticipated along egress routes. | Test the emergency lighting system on each floor and provide additional emergency fixtures to provide adequate illumination along the means of egress. Provide a minimum illumination of 10 lux at the floor level within exit stairs and exit discharge paths and minimum 2.5 lux along exit access aisles. | Within 3 months |

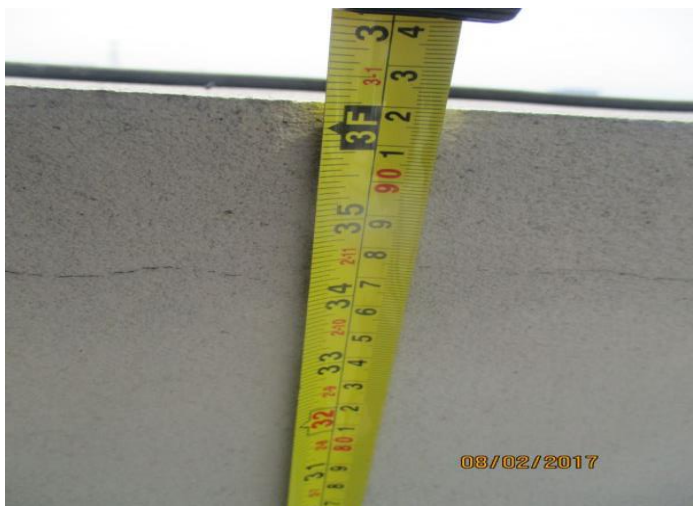
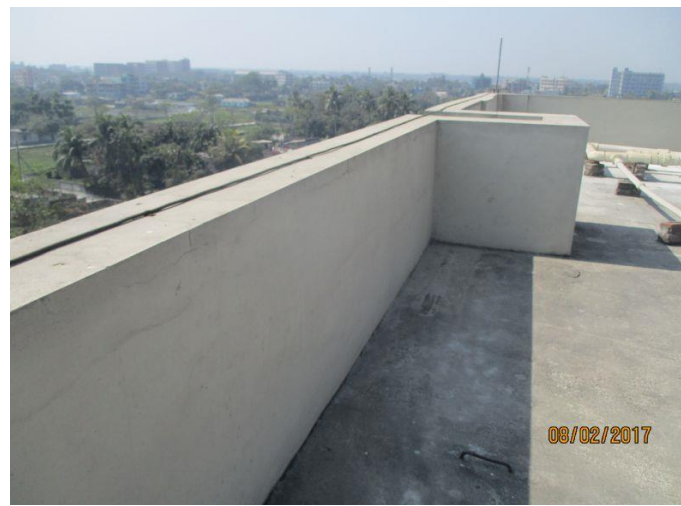
| F-16 | Egress | Parapets or guards are provided in occupied roof which is less than 1067mm (42 inch.). | Provide parapets or guards with a minimum height of 1067mm (42 inch.). | Within 3 months |
