# **FIRE SAFETY INSPECTION REPORT**

## **J.F.K FASHION LTD**

**ACCORD ID: 12673**

**Date: 13 March, 2017**

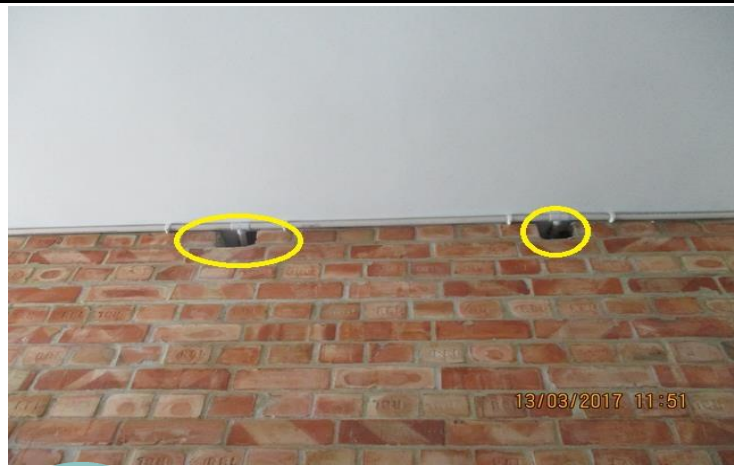
| SI No. | Category | Findings | Required Action | Remediation Time Frame |
|---|---|---|---|---|
| F-1 | Fire Rated Construction | Unsealed penetrations are located in the finished goods warehouse on 2nd floor. | Seal all penetrations and openings in exit stair enclosure walls to maintain the fire separation. | Within 3 months |

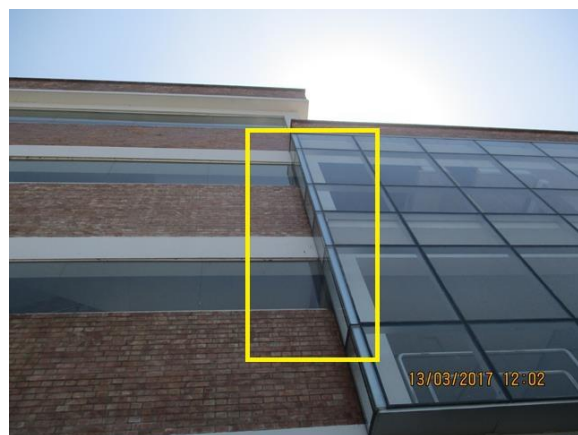
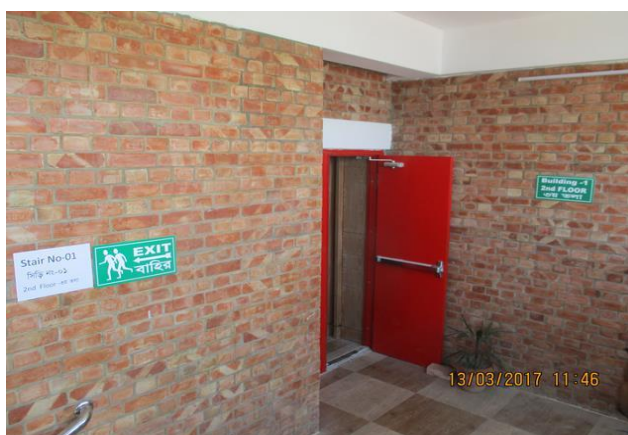
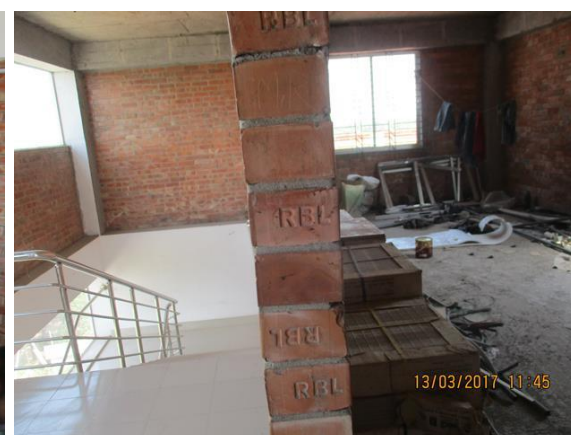
| F-2 | Fire Rated Construction | The exit stairs are not separated from work areas and other spaces on each floor due to unprotected opening and penetration. | Provide minimum 1-hr rated doors for buildings with 3 or fewer stories and 1.5-hr fire rated doors for buildings that are 4 or more stories. Seal all unprotected openings to separate the exit stairs from work areas and other building spaces on all floor levels. Ensure that the fire doors are self-closing and positive latching and that they are provided with fire exit (panic) hardware where serving production floors. If fire doors are required to be held open for functional reasons, provide automatic closing devices tied to the fire alarm system. Once fire doors are installed, every door in a stair enclosure serving more than 5 stories shall be provided with re-entry unless it meets. | Within 3 months |

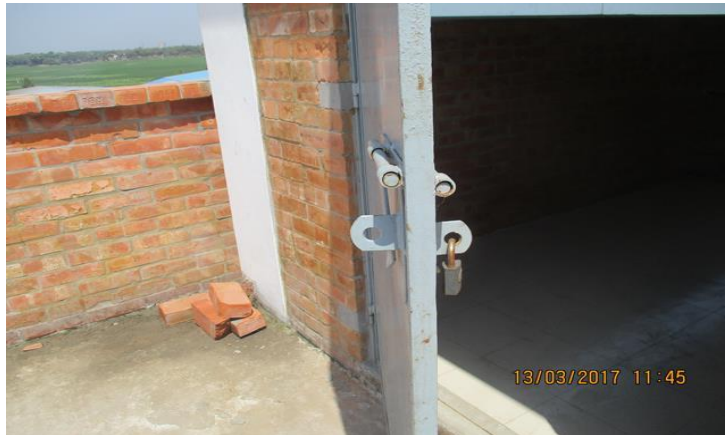
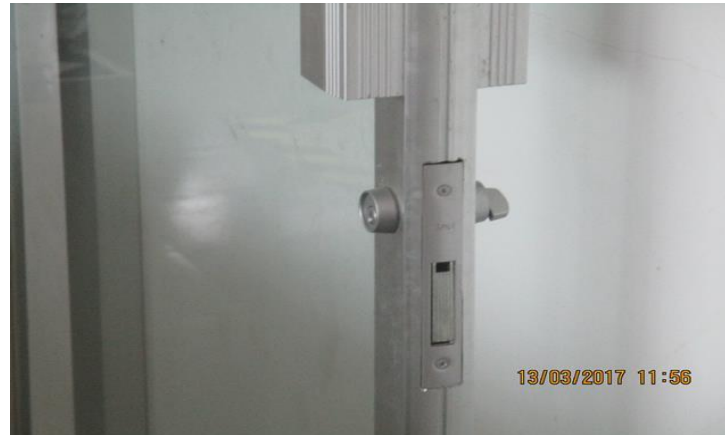
| F-3 | Egress | Non-compliant locking features available in two exits doors on top floor and secondary exits for ground floor. | Remove locking features from all egress doors and gates. If locks are required for security reasons, utilize special door locking features complying with NFPA-101 and ACCORD standard 6.8.2. | Immediate |

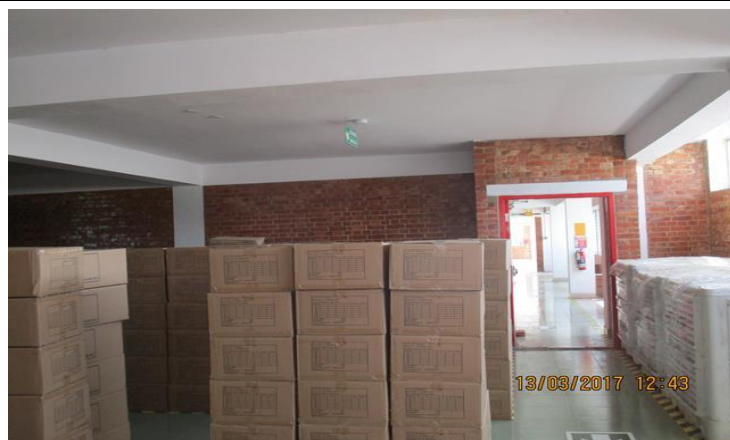
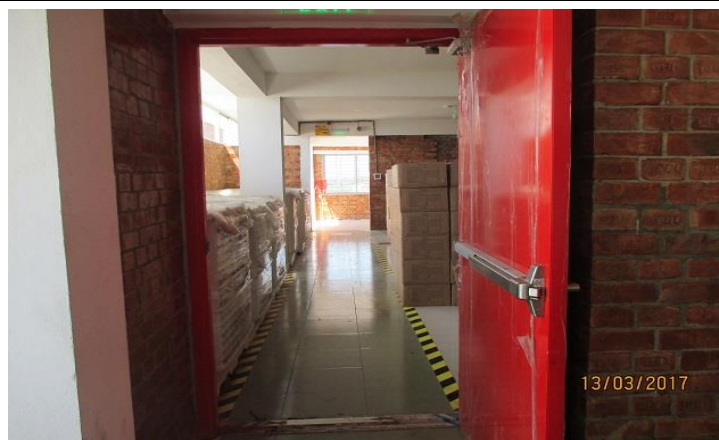
| F-3 | Fire Rated Construction | The dining area is not separated from adjacent storage area by fire rated construction on 2nd floor. | Separate the dining area by minimum 2-hr fire-rated construction having a direct access to exit stair or safe location. Seal and/or protected all openings to maintain the required fire separations. | Within 3 months |

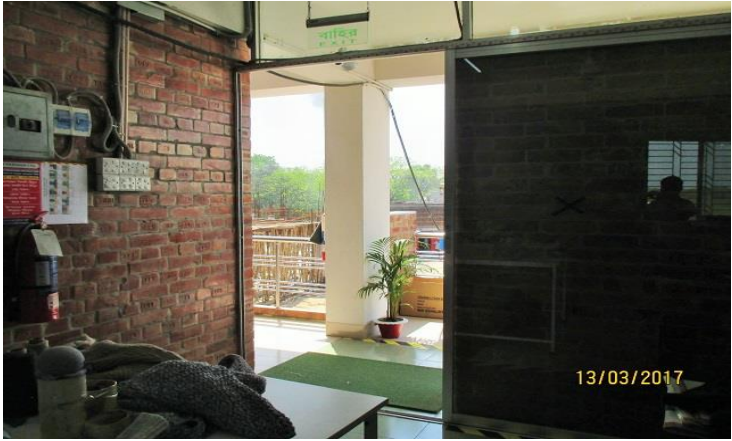
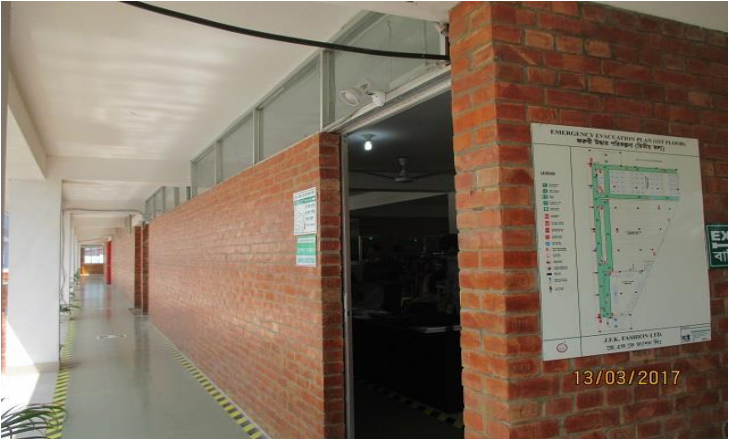
| F-4 | Means of Egress | Sliding gates are provided at building exits on 1st floor sample section. | Replace all non-compliant doors along the means of egress with side-hinged, swinging egress doors in accordance with ACCORD standard 6.8.1. | Immediately |

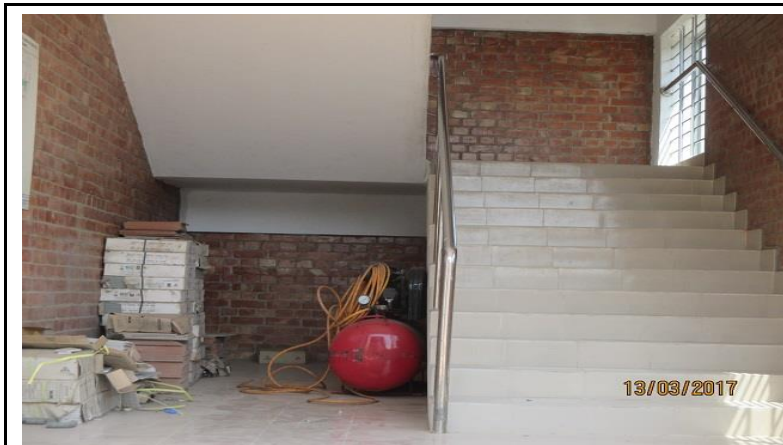
| F-5 | Means of Egress | Storage was located in the south exit stair on ground. | Remove all storage from exit stairs and egress paths. | Immediately |

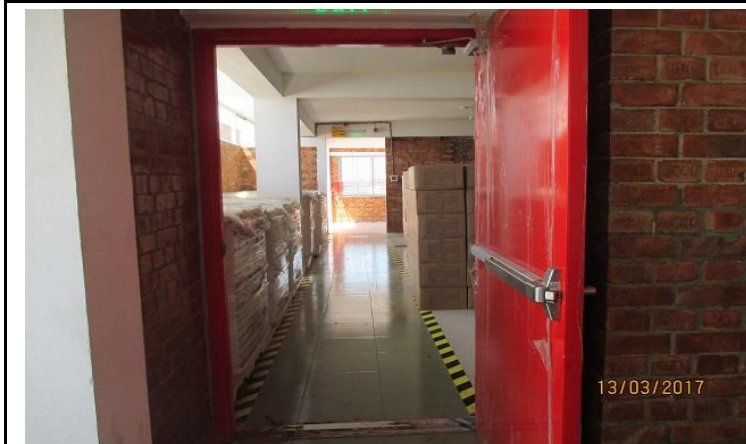
| F-6 | Means of Egress | The occupant load more than 50 but the north side exit door swing inward direction on 2nd floor. | Modify swing direction of egress doors to the direction of egress travel. Doors serving an occupant load of more than 50 shall swing in the direction (out-ward) of egress travel . | Within 1 month |

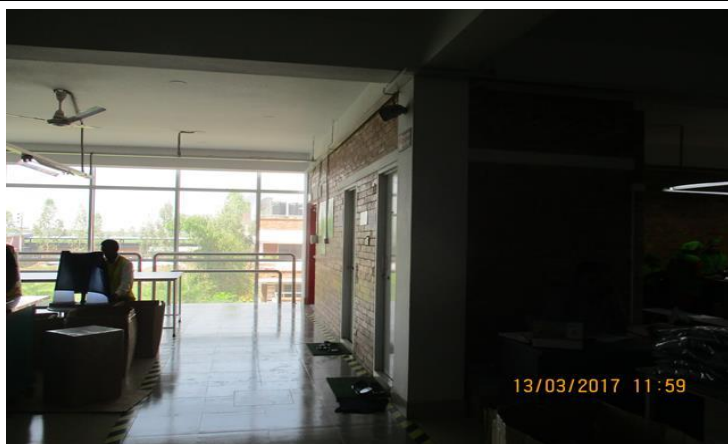
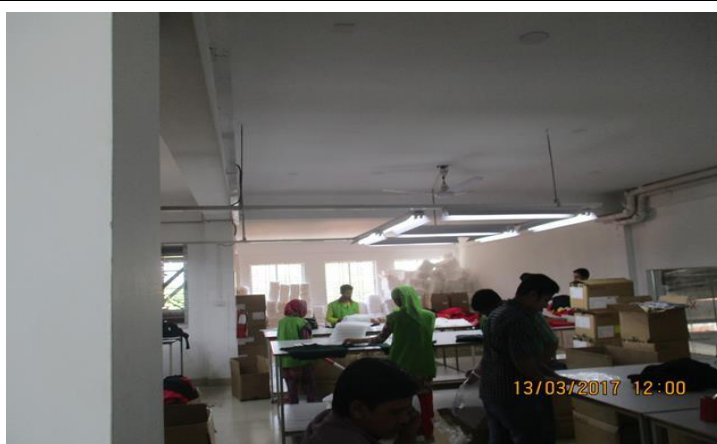
| F-2 | Egress Lighting | Based on the number and location of emergency lights observed, adequate illumination levels are not anticipated along egress routes on all floors. | Test the emergency lighting system on each floor and provide additional emergency fixtures to supply adequate illumination along the means of egress. Provide a minimum illumination of 10 lux at the floor level within exit stairs and along exit discharge paths and a minimum 2.5 lux along exit access aisles. | Within 3 months |

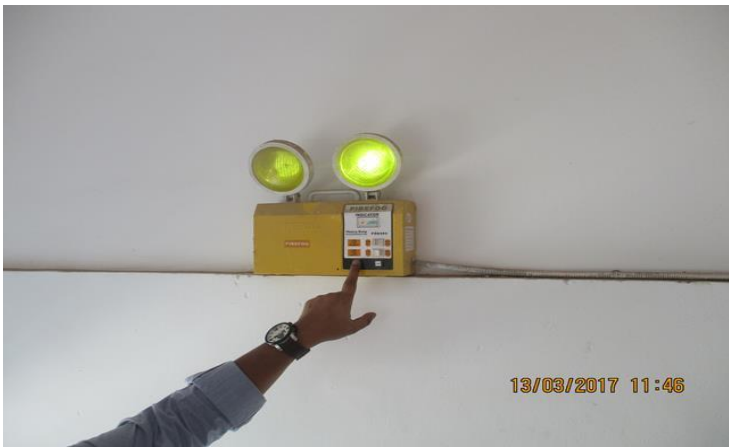
| F-3 | Egress Lighting | Manual on-off switch is provided for emergency lighting units. | Remove manual on/off switches from emergency lighting / exit signage units to prevent them from being switched off. | Within 1 month |

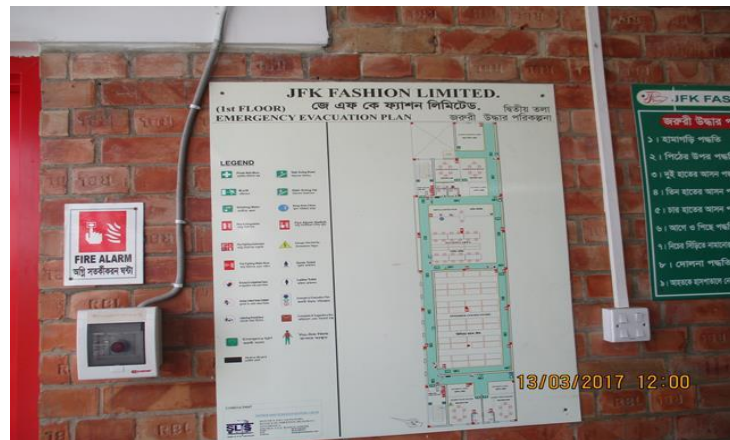
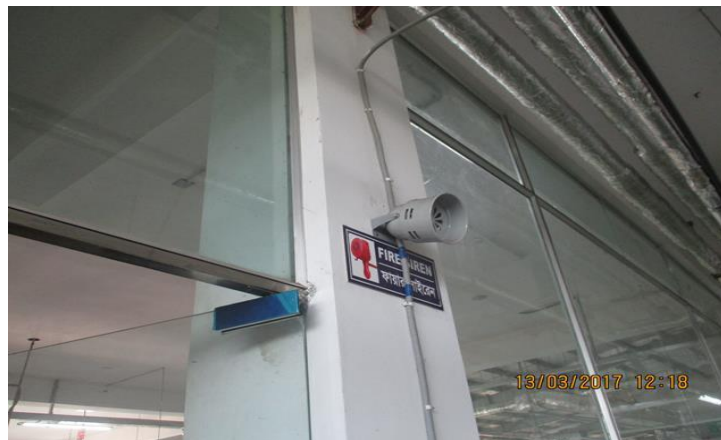
| F-5 | Fire Detection and Alarm System | The fire detection and alarm system is antiquated, not a listed system and does not provide alarm and notification features consistent with acceptable standards. | <p>Replace the fire detection and alarm system with a new, listed addressable fire alarm system in accordance with NFPA 72.</p> <p>Design shall be submitted to ACCORD Chief Safety Inspector for review prior to installation of the system.</p> | Design within 4 months and installation within 9 months. |
