FIRE SAFETY INSPECTION REPORT

SHARMIN APPARELS LIMITED
EAST NARASHINGHAPUR, ZIRABO, ASHULIA, SAVAR

ACC   **RD**
on Fire and Building Safety in Bangladesh

April 23, 2014

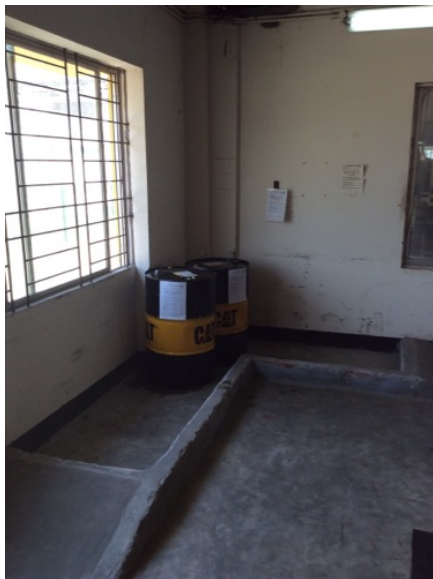
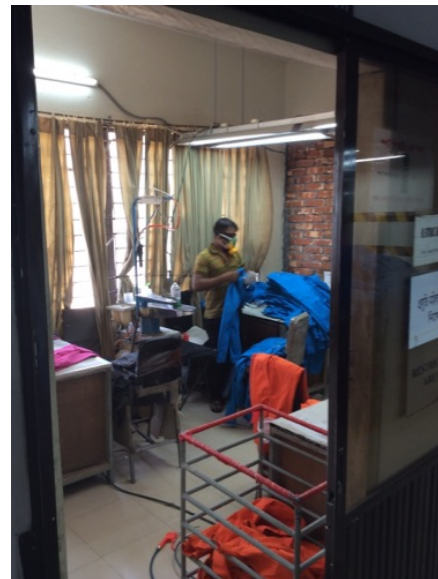
No.	Category	Finding	Recommendation	Remediation Timeframe
F-1	Fire Rated Construction	Hazardous materials / flammable liquid storage areas are not separated by fire-rated construction (openings, non-rated doors, penetrations). Locations: -55 gallon drums of diesel fuel located adjacent to generators. -Possible hazardous area on First floor where masked personnel was spraying unknown substance in an unsealed, non-ventilated area.	Separate the hazardous materials / flammable liquid storage room by a minimum 2-hr fire-rated construction. Seal and/or protected all openings to maintain the required fire separations.	Within 3 months

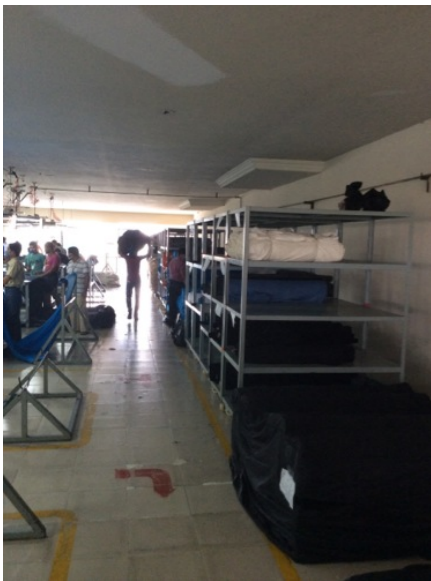
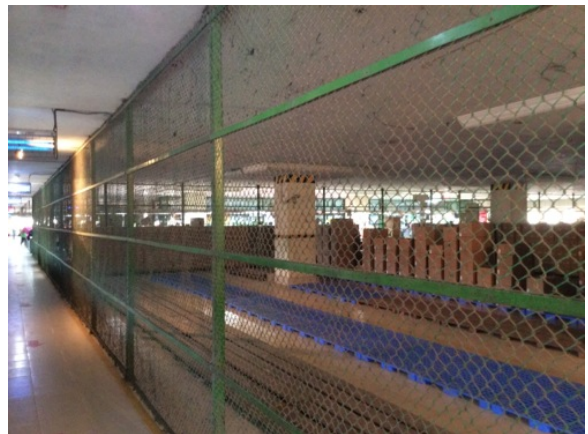
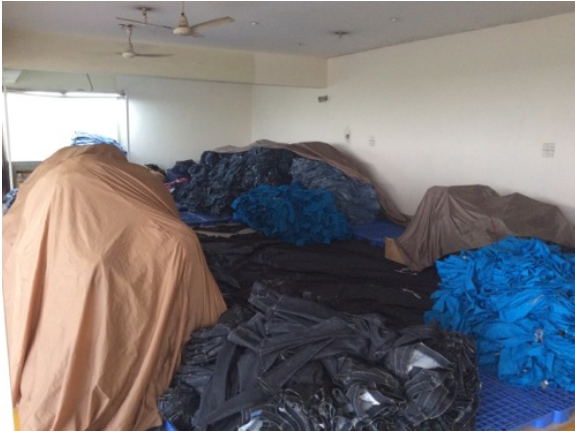
F-2	Fire Rated Construction	Areas used for combustible storage are not separated by fire-rated construction. Locations: -Storage areas on the First floor had gated doors and security mesh for separation which does not create a fire barrier. -General storage on multiple floors was open to production areas.	Provide dedicated storage rooms separated by minimum 1-hr fire-rated construction. Where separate storage rooms are not feasible, provide defined storage areas and limit the storage arrangement as follows: - Maximum height of 2.4m and maximum area of 23m ² - If sprinkler protected: maximum height of 3.66m and maximum area of 93m ² Separate areas of unenclosed combustible storage by a minimum clear distance of 3m.	Within 3 months
-----	-------------------------	---	--	-----------------

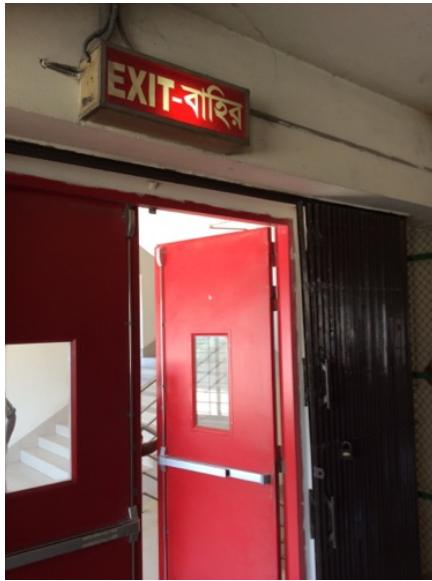
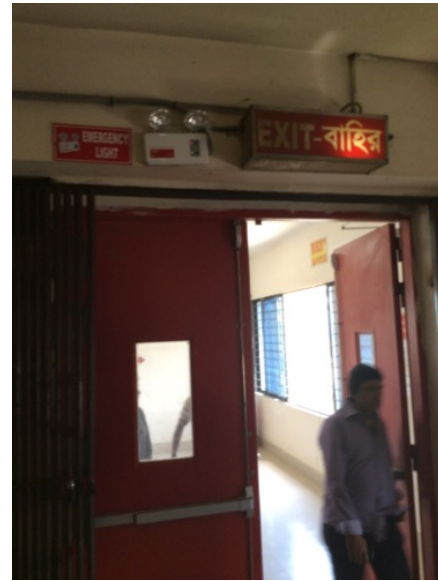
F-3	Fire Rated Construction	<p>The exit stairs are not separated from work areas and other spaces on each floor by fire-rated construction.</p> <p>At the time of the inspection, it appeared that the doors to the exit stairs were possible fire-rated doors; however, it was unclear whether or not these doors were listed assemblies. A test report was provided by factory personnel; however, it is not evident that the tests were conducted by an approved listing agency.</p>	<p>Provide minimum 1.5-hr fire rated doors and seal all unprotected openings to separate the exit stairs from work areas and other building spaces on all floor levels. Ensure that the fire doors are self-closing and positive latching and that they are provided with fire exit (panic) hardware where serving production floors.</p> <p>If fire doors are required to be held open for functional reasons, provide automatic-closing devices tied to the fire alarm system.</p>	Within 3 months

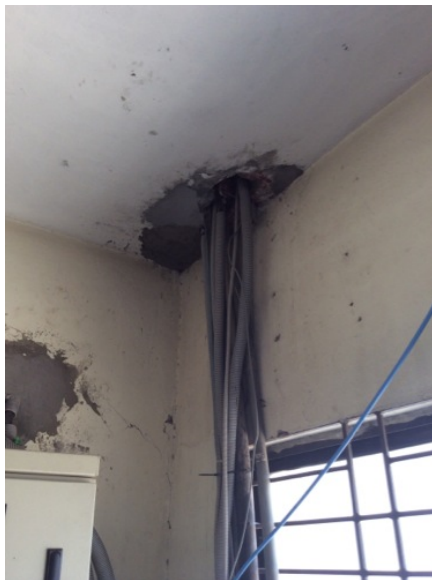
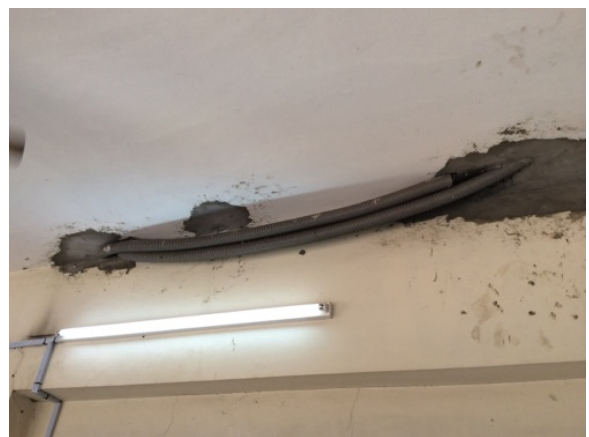
F-4	Fire Rated Construction	Unsealed penetrations and openings are located in the fire-rated wall and ceiling assemblies.	Provide a minimum 2-hr fire-rated shaft to separate the utility risers from each floor level.	Within 3 months
			Seal all penetrations and openings in wall and ceiling assemblies to maintain the fire separation.

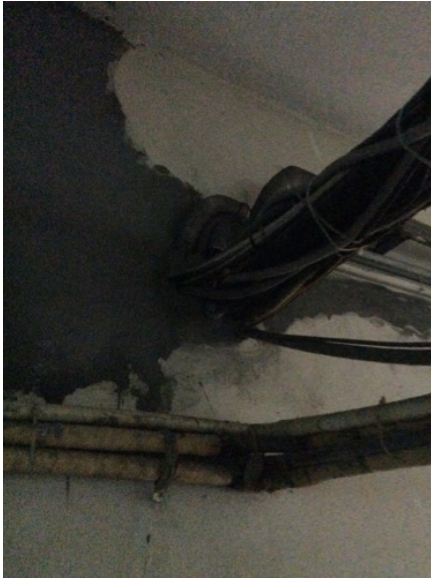
F-5	Fire Rated Construction	Unsealed penetrations and openings are located in exit stair enclosures.	Seal all penetrations and openings in exit stair enclosure walls to maintain the fire separation.	Within 3 months
-----	-------------------------	--	---	-----------------

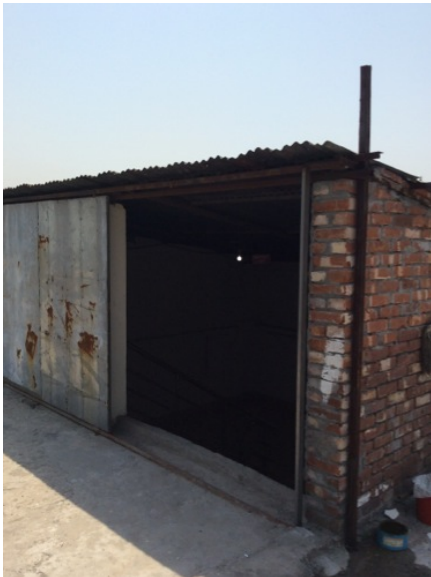
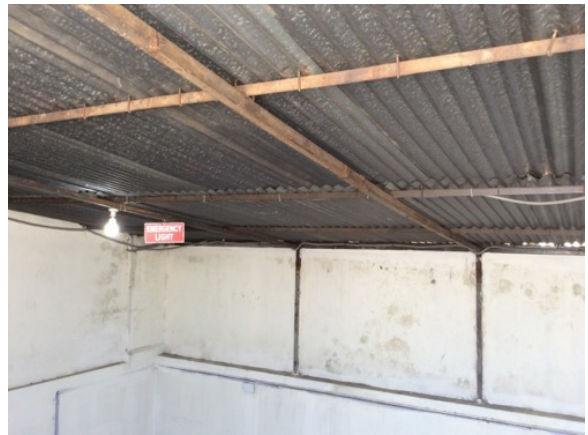
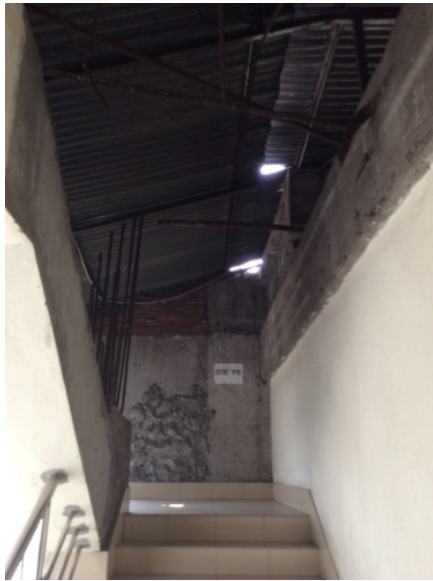
F-6	Fire Rated Construction	Corrugated metal roofing is used to cover the exit stairs at the Roof level, which does not constitute the classification of fire-rated construction for the stairs.	Enclose the stairs with a minimum 2-hr fire-rated construction.	Within 3 months
-----	-------------------------	--	---	-----------------

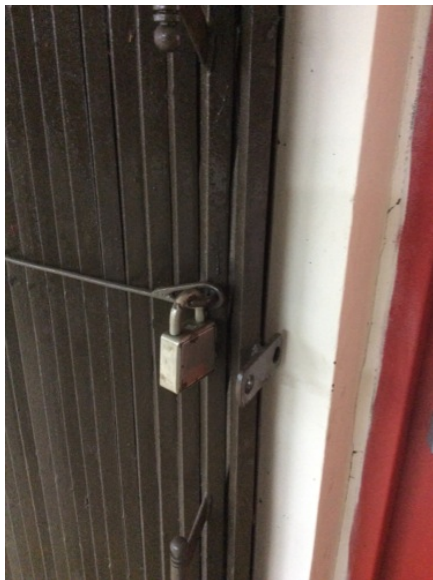
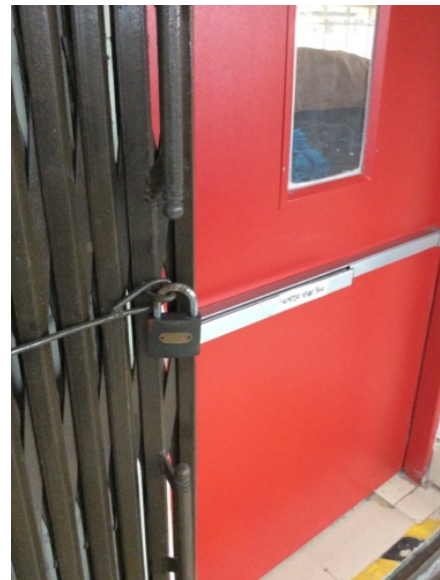
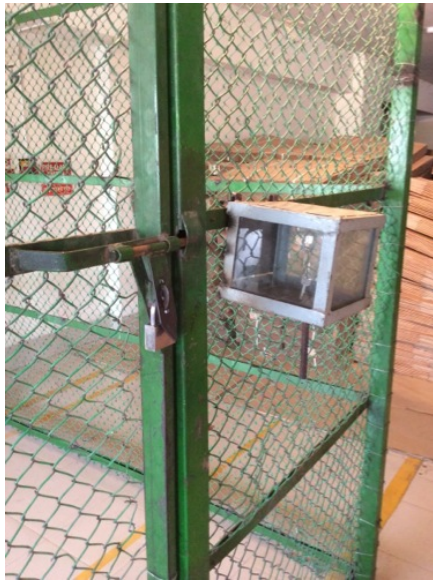
F-7	Egress	Egress doors / gates with locking features are provided at building exits, exit stairs, along egress routes, and exit discharge.	Remove locking features from all egress doors / gates. If locks are required for security reasons, utilize special door locking features complying with NFPA 101.	Immediat
		Locations: All floors.

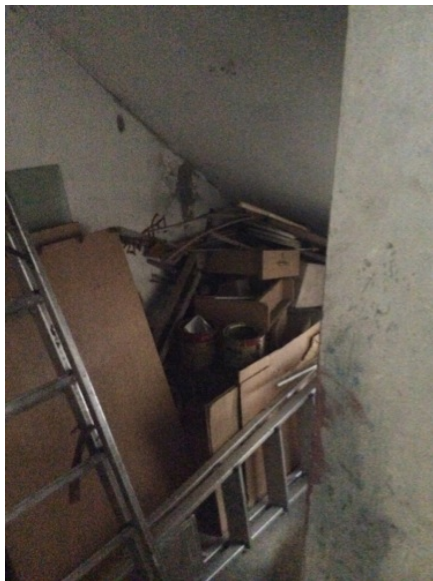
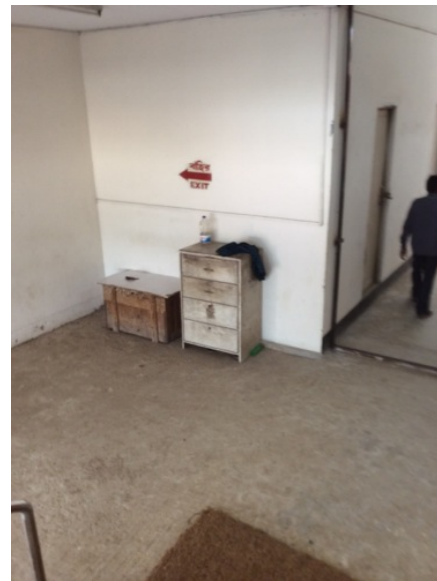
F-8 Egress

Storage was located in the exit stair.

Locations:
Various exit stair landings.

Remove all storage from exit stairs and egress paths.

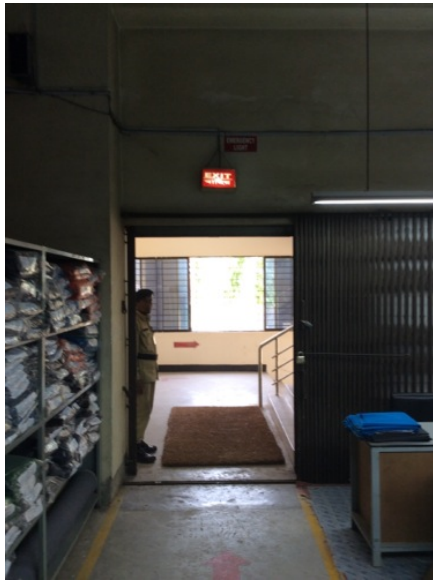
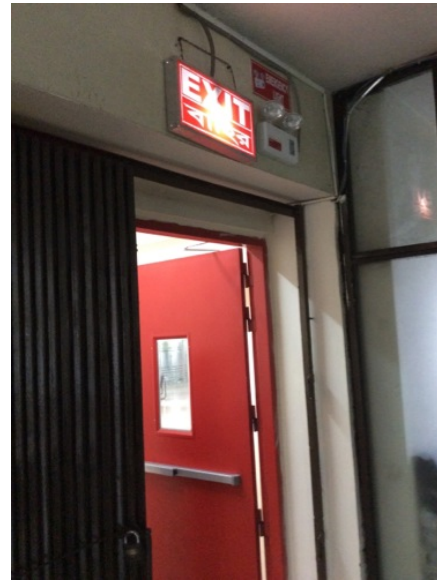
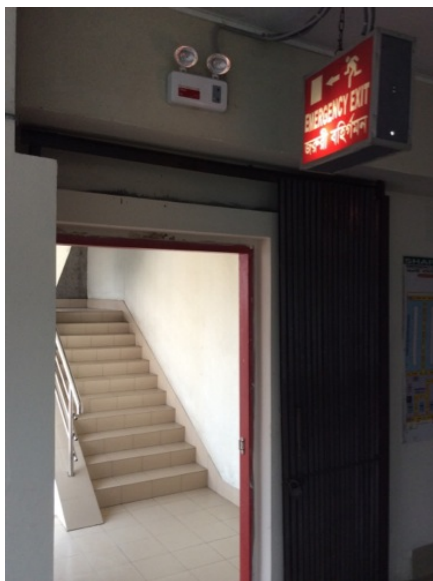
F-9	Egress	<p>Collapsible gates and sliding doors are provided at building exits, exit stairs, along egress routes, and exit discharge.</p> <p>Locations: Collapsible gates and sliding doors on all floors.</p>	<p>Replace all gates / sliding doors along the means of egress with side-hinged, swinging egress doors.</p> <p>If locks are required for security reasons, utilize special door locking features complying with NFPA 101.</p>	Within 1 month
-----	--------	---	---	----------------

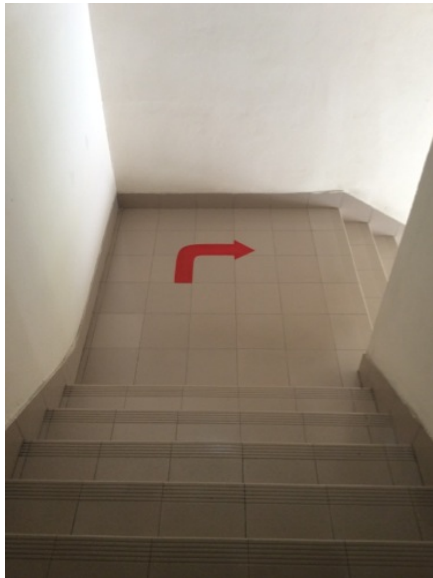
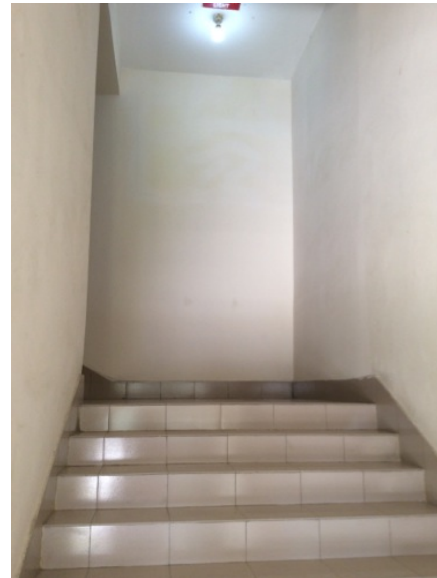
F-10	Egress	Current travel distances are excessive on the Ground floor since what appears to be a horizontal exit does not have adequate separation.	Provide adequate separation and opening protectives for horizontal exits in compliance with the requirements of BNBC Part 4, Section 3.12. In addition, upgrade the fire alarm, detection, and firefighting systems per the applicable findings elsewhere in this report.	Within 3 months
F-11	Egress	Handrails are not provided in the exit stair.	Provide handrails on both sides of exit stair.	Within 3 months
		Location: East exit stair (Stair 07).

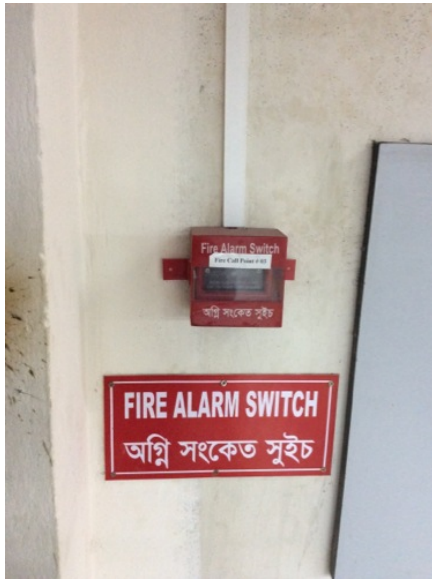
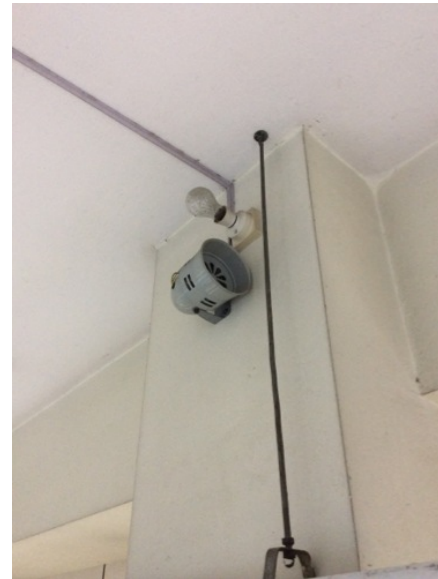
F-12	Fire Protection	The fire alarm system is antiquated, not a listed system, and does not provide alarm and notification features consistent with acceptable standards.	Replace the fire alarm system with a new, listed addressable fire alarm system in accordance with NFPA 72.	Design within 4 months, install within 9 months
------	-----------------	--	--	---

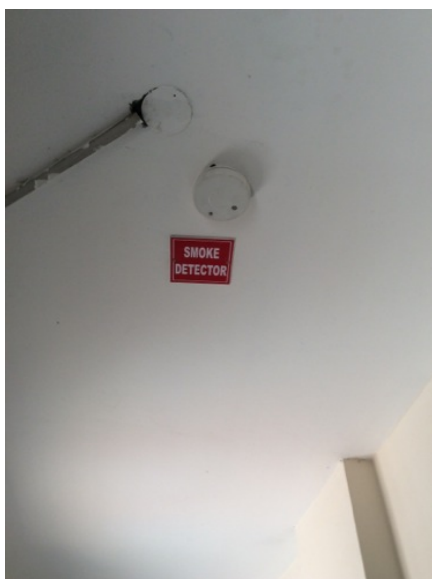
F-13	Fire Protection	Inspection, testing, and maintenance for the fire alarm system was not in accordance with NFPA 72.	Inspect, test and maintain the fire alarm system, and keep written records on-site, in accordance with NFPA 72.	Within 3 months
F-14	Fire Protection	The building is equipped with single-station smoke alarms. Smoke alarm activation sounds only a local alarm and does not provide automatic fire alarm notification of occupants.	Replace the single-station smoke alarms with automatic smoke detectors tied into the fire alarm system. Configure the fire alarm system to initiate occupant notification upon activation of any two smoke detectors in addition to the manual fire alarm stations.	Within 6 months

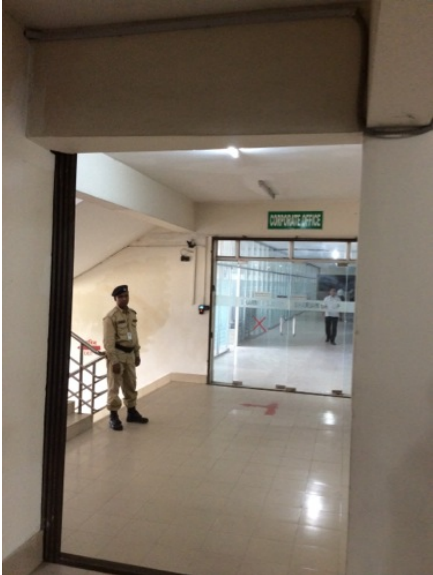
F-15	Egress Lighting	Exit sign not provided at exit. Location: Southeast exit stair (Stair 01) on Fourth floor.	Provide exit signs above all exits to the exterior and all doors to the exit stairs.	Within 1 month

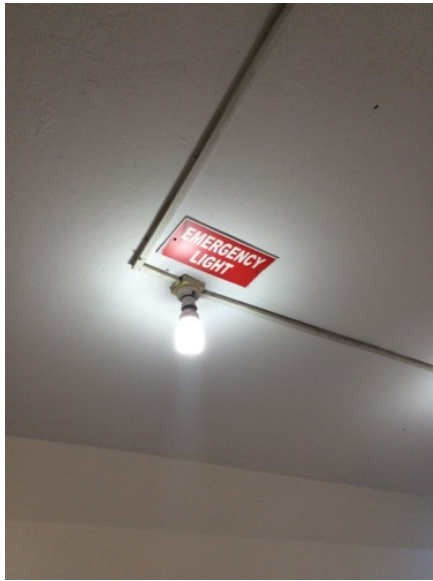
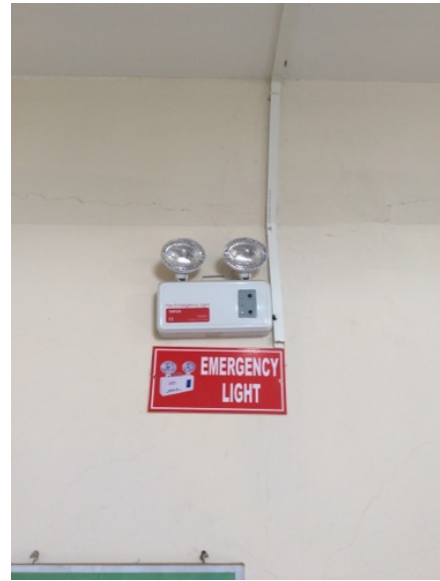
F-16	Egress Lighting	Based on the number and location of emergency lights observed, adequate illumination levels are not anticipated along egress routes. Locations: All areas.	Test the emergency lighting system on each floor and provide additional emergency fixtures to provide adequate illumination along the means of egress. Provide a minimum illumination of 10 lux at the floor level within exit stairs and exit discharge paths and minimum 2.5 lux along exit access aisles.	Within 3 months
------	-----------------	--	--	-----------------

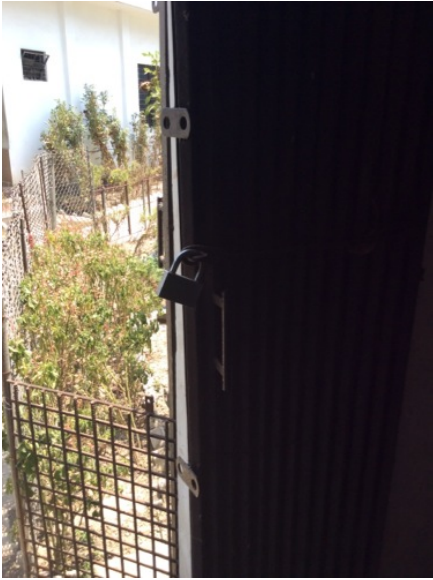
No.	Category	Finding	Recommendation	Remediation Timeframe
F-1	Egress	Egress doors / gates with locking features are provided at building exits and exit discharge.	Remove locking features from all egress doors / gates. If locks are required for security reasons, utilize special door locking features complying with NFPA 101.	Immediate

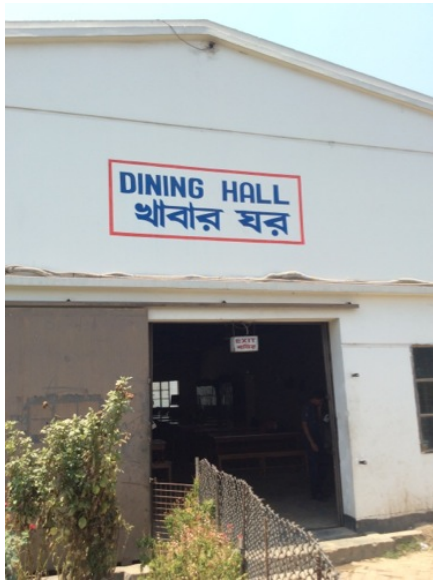
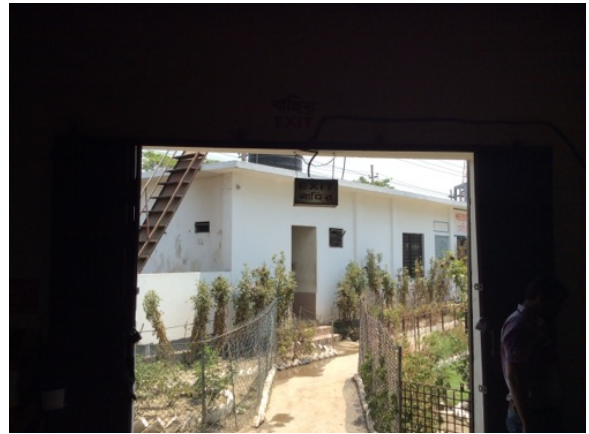
F-2	Egress	Collapsible gates and sliding doors are provided at building exits and exit discharge.	Replace all gates / sliding doors along the means of egress with side-hinged, swinging egress doors. If locks are required for security reasons, utilize special door locking features complying with NFPA 101.	Within 1 month

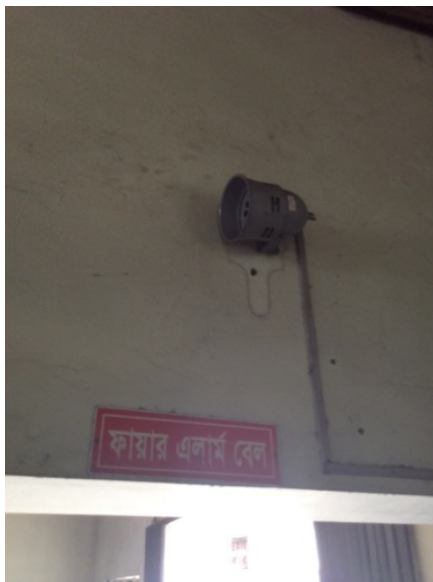
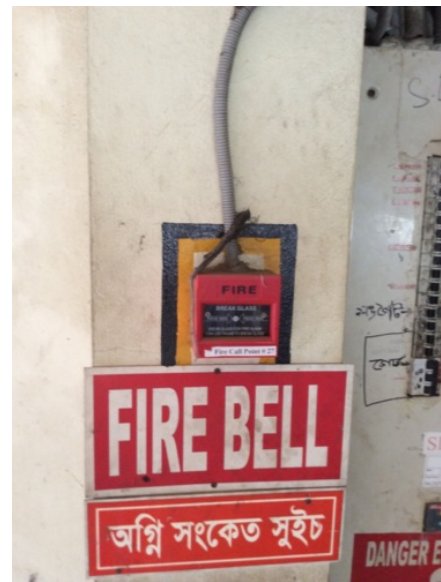
F-3	Fire Protection	The fire alarm system is antiquated, not a listed system, and does not provide alarm and notification features consistent with acceptable standards.	Replace the fire alarm system with a new, listed addressable fire alarm system in accordance with NFPA 72.	Design within 4 months, install within 9 months
-----	-----------------	--	--	---

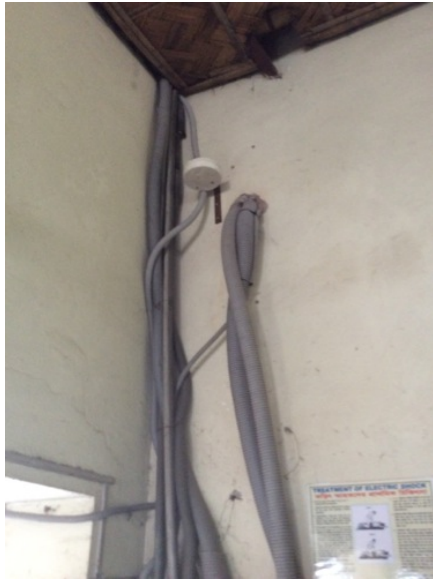
F-5	Fire Protection	The building is equipped with single-station smoke alarms. Smoke alarm activation sounds only a local alarm and does not provide automatic fire alarm notification of occupants.	Replace the single-station smoke alarms with automatic smoke detectors tied into the fire alarm system. Configure the fire alarm system to initiate occupant notification upon activation of any two smoke detectors in addition to the manual fire alarm stations.	Within 6 months
-----	-----------------	--	---	-----------------

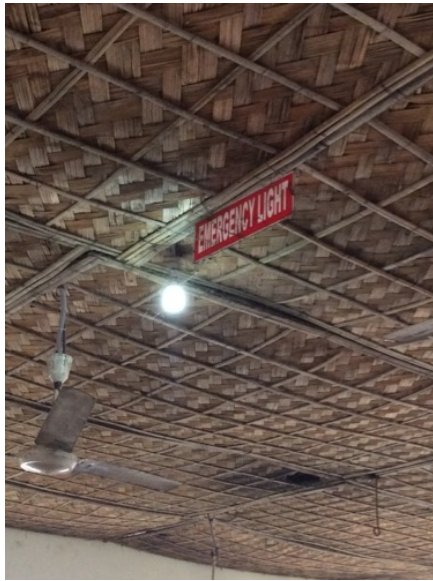
F-6	Egress Lighting	Based on the number and location of emergency lights observed, adequate illumination levels are not anticipated along egress routes. Locations: All areas.	Test the emergency lighting system on each floor and provide additional emergency fixtures to provide adequate illumination along the means of egress. Provide a minimum illumination of 10 lux at the floor level within exit stairs and exit discharge paths and minimum 2.5 lux along exit access aisles.	Within 3 months
-----	-----------------	--	--	-----------------
