# FIRE SAFETY INSPECTION REPORT

**FACTORY: Lintas Bangladesh Co. Ltd**

**ACCORD ID: 12788**

**Date: 27/04/2017**

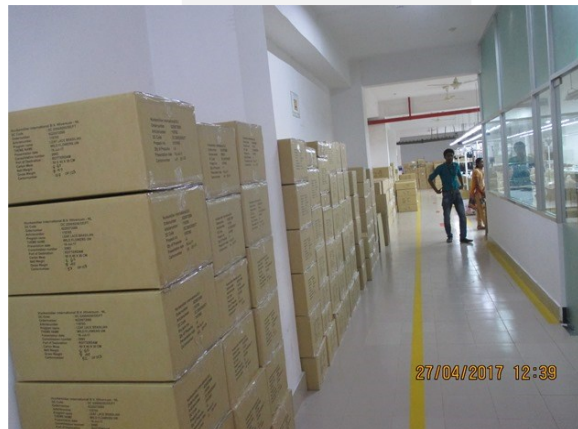
| Sl No. | Category | Findings | Required Action | Remediation Time Frame | Pictorial Evidence |
|---|---|---|---|---|---|
| 1 | Fire Rated Construction | Areas used for combustible storage are not separated by fire-rated. | <p>Provide dedicated storage rooms separated by minimum 1-hr fire-rated construction.</p> <p>Where separate storage rooms are not feasible, provide defined storage areas and limit the storage arrangement as follows:</p> <ul style="list-style-type: none"> <li>- Maximum height of 2.4m and maximum area of 23m<sup>2</sup></li> <li>- If sprinkler protected: maximum height of 3.66m and maximum area of 93m<sup>2</sup></li> </ul> <p>Separate areas of unenclosed combustible storage by a minimum clear distance of 3m</p> | Within 3 Months | |

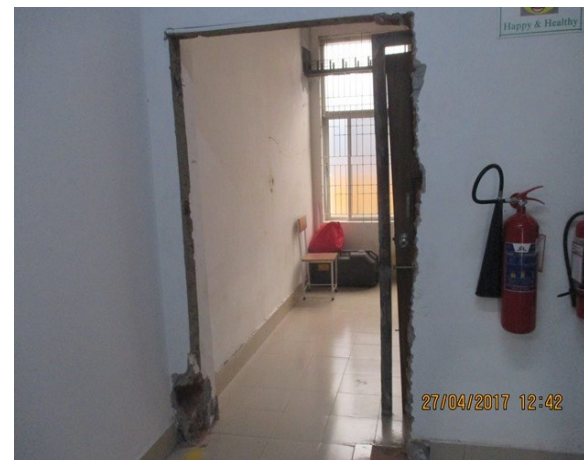
| 2 | Fire Rated Construction | Fire alarm control panel room is not separated by fire rated construction. | Fire alarm control panel room shall be separated by minimum 2 hours construction. | Within 3 Months | |

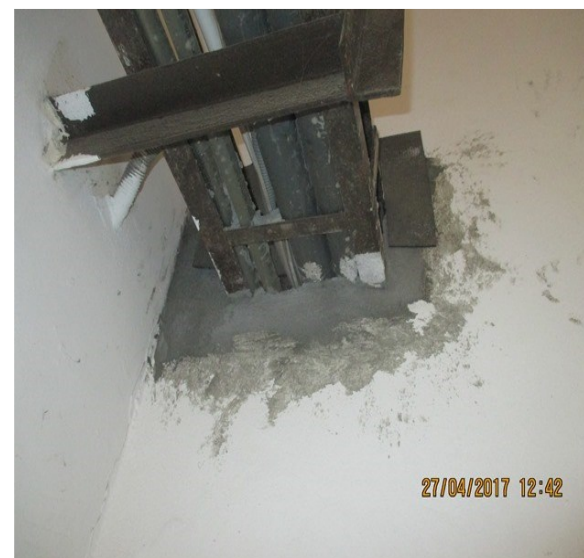
| 3 | Fire Rated Construction | Penetrations through floor/ceiling assemblies are found unsealed. | <p>Seal all penetrations and openings in floor/ceiling (full thickness of the floor/ceiling) assemblies by fire rated materials to maintain the fire resistance rating.</p> <p>Or</p> <p>Provide a minimum 2-hr fire rated shaft to separate the utility risers from each floor if required.</p> | Within 3 Months | |

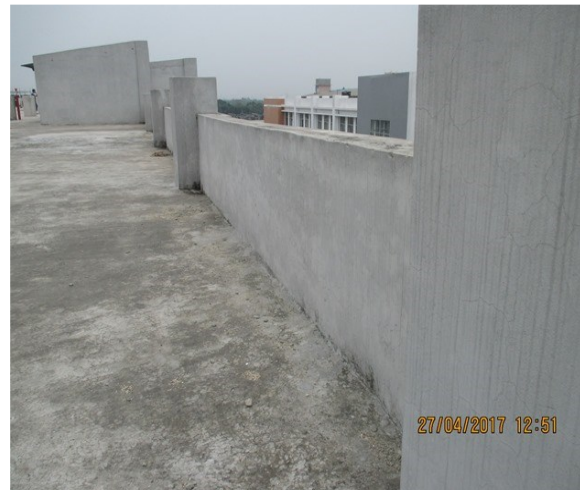
| Sl No. | Category | Findings | Required Action | Remediation Time Frame | Pictorial Evidence |
|---|---|---|---|---|---|
| 4 | No Parapets or Guards | Parapets or guards are not provided in occupied roof.<br>OR<br>Parapets or guards are provided in occupied roof which is less than 1067mm (42 inch.). | Provide parapets or guards with a minimum height of 1067mm (42 inch.). | Within 3 Months | |

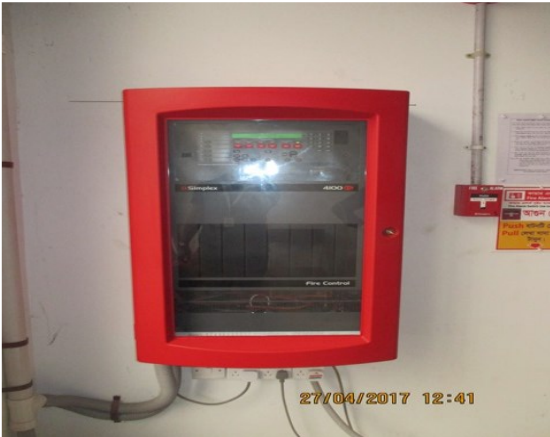
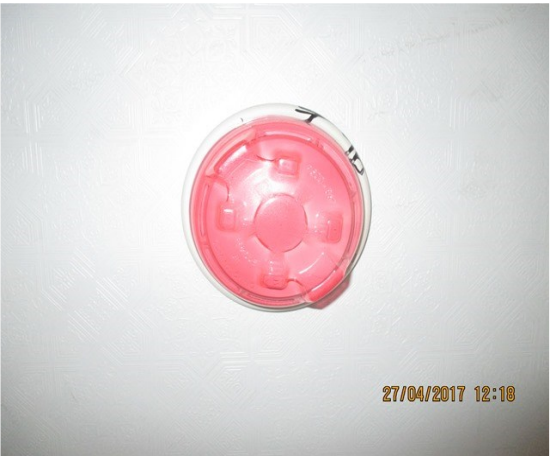
| SI No. | Category | Findings | Required Action | Remediation Time Frame | Pictorial Evidence |
|---|---|---|---|---|---|
| 7 | Fire Alarm & Detection System | The addressable fire alarm system installation is going on without approval from AHJ. | Submit As-Built drawing to AHJ for approval and replace or modify the fire alarm system in accordance with NFPA 72. | Within 2 months (Design submission) & 6 months (Installation) | |

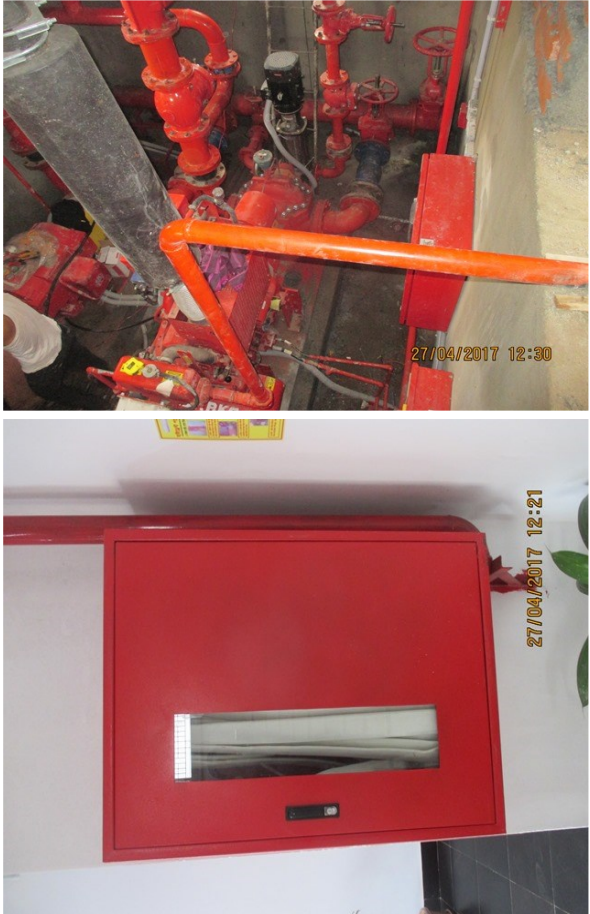
| Sl No. | Category | Findings | Required Action | Remediation Time Frame | Pictorial Evidence |
|---|---|---|---|---|---|
| 9 | Water Based Fire Protection System | The standpipe system installation is going on without approval from AHJ. | Submit As-Built drawing to AHJ for approval and replace or modify the standpipe system in accordance with NFPA 14. | Within 2 months (Design submission) & 6 months (Installation) | |
