# **FIRE SAFETY INSPECTION REPORT**

**Factory Name: Progress Apparels (Bangladesh) Limited**

**ACCORD ID: 12764**

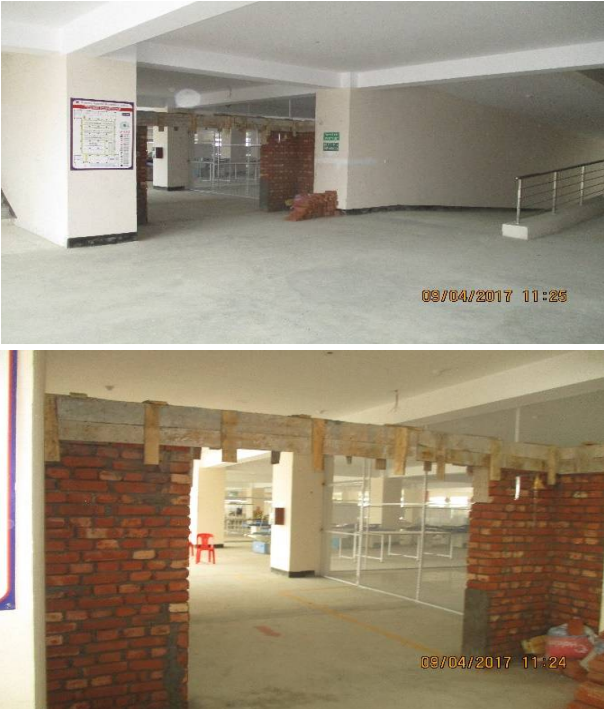
| SI No. | Category | Findings | Required Action | Remediation Time Frame | Pictorial Evidence |
|---|---|---|---|---|---|
| 1 | <b>Building: A (MS-SFB-01) &amp; Building: B (MS-SFB-02)</b><br>Fire Rated Construction | All exit stairs are not separated from work areas and other spaces on each floor by fire rated construction. | Provide minimum 1.5-hr fire rated doors and seal all unprotected openings to separate the exit stairs from work areas and other building spaces on all floor levels. Ensure that the fire doors are self-closing and positive latching and that they are provided with fire exit (panic) hardware where serving production floors. If fire doors are required to be held open for functional reasons, provide automatic closing devices tied to the fire alarm system. | Within 3 months | |

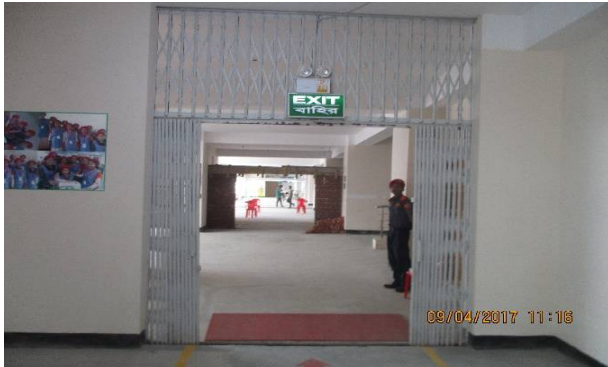
| Sl No. | Category | Findings | Required Action | Remediation Time Frame | Pictorial Evidence |
|---|---|---|---|---|---|
| 2 | Non complaint gates | Sliding doors are provided at overall exit doors & exit stairs | <p>Replace all collapsible/ sliding type doors &amp; gates by the side-hinged swinging type doors.</p> <p>If locks are required for security reasons, utilize special door locking features complying with NFPA 101.</p> | Within 1 month | |

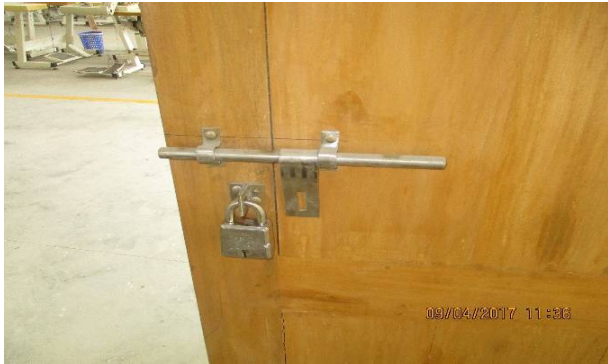
| Sl No. | Category | Findings | Required Action | Remediation Time Frame | Pictorial Evidence |
|---|---|---|---|---|---|
| 3 | Non complaint locking features | Egress doors and gates with locking features are provided at several exit doors & exit stairs. | <p>Remove locking features from all egress doors &amp; gates. If locks are required for security reasons, utilize special door locking features complying with NFPA 101.</p> | Immediate | |

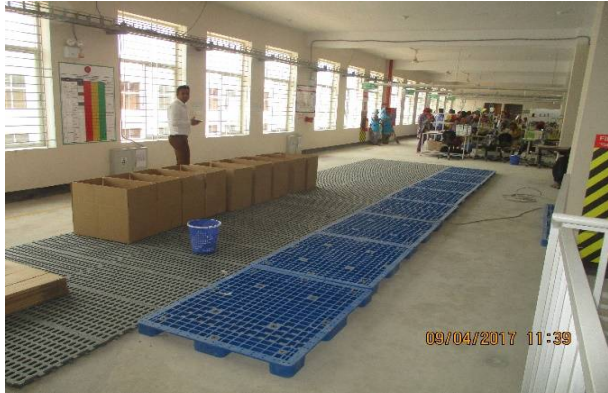
| Sl No. | Category | Findings | Required Action | Remediation Time Frame | Pictorial Evidence |
|---|---|---|---|---|---|
| 4 | Fire Rated Construction | Areas used for in-process storage (Inspection Goods) of combustible materials are open to the surrounding occupancy. | <p>Provide defined storage areas and limit the storage arrangement as: Maximum height of 2.4m and maximum area of 23m<sup>2</sup>. Separate areas of unenclosed combustible storage by a minimum clear distance of 3m</p> | Within 2 months | |

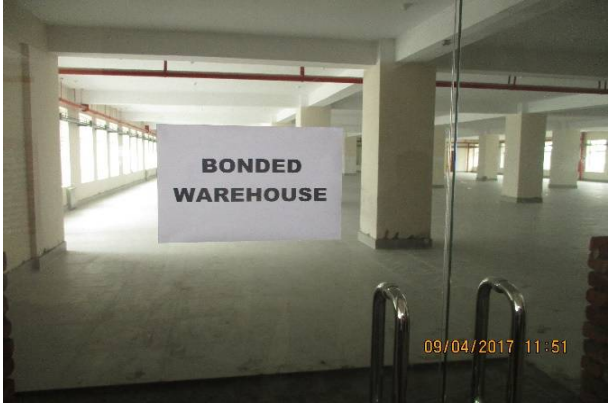
| Sl No. | Category | Findings | Required Action | Remediation Time Frame | Pictorial Evidence |
|---|---|---|---|---|---|
| 5 | Fire Rated Construction | Room used for storage of combustible materials (Accessories store & Bonded Ware House) is not separated from the surrounding occupancy. | Rooms used for storage of combustible materials shall be separated from the surrounding occupancy with a minimum 1 hour construction. | Within 3 months | |

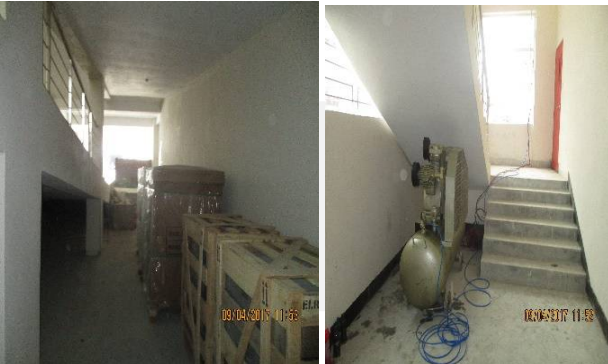
| Sl No. | Category | Findings | Required Action | Remediation Time Frame | Pictorial Evidence |
|---|---|---|---|---|---|
| 7 | Storage in the exit stair. | Storage was located in the exit stair. | Remove all storage from exit stairs. | Immediate | |

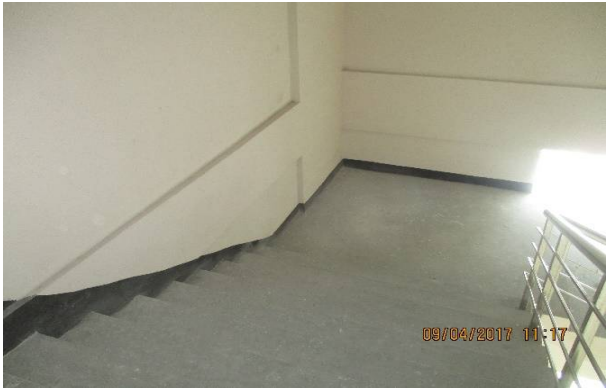
| SI No. | Category | Findings | Required Action | Remediation Time Frame | Pictorial Evidence |
|---|---|---|---|---|---|
| 8 | Handrail | Handrails are not provided on both sides of the exit stairs. | Provide handrails on both sides of the exit stair. New handrails shall have a minimum height of 865mm (34 in.) and a maximum height of 965 mm (38 in.) as measured from the leading edge of the tread. Intermediate handrails shall be provided when the stair width exceeds 2.2 m (87 in.) | Within 3 months | |

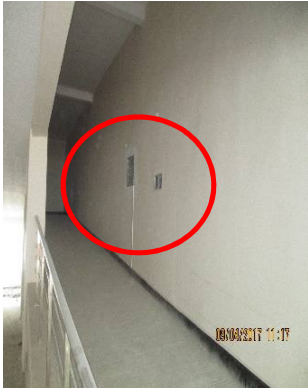
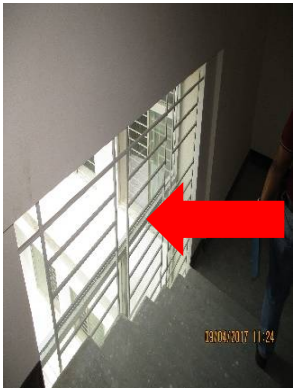
| SI No. | Category | Findings | Required Action | Remediation Time Frame | Pictorial Evidence |
|---|---|---|---|---|---|
| 9 | Unsealed Floor/Ceiling Penetrations | Unsealed penetrations and openings are located in exit stair enclosures. | Seal all penetrations and openings in the wall of exit enclosure walls (full thickness of the wall) by fire rated materials to maintain the fire resistance rating. | Within 2 months | |

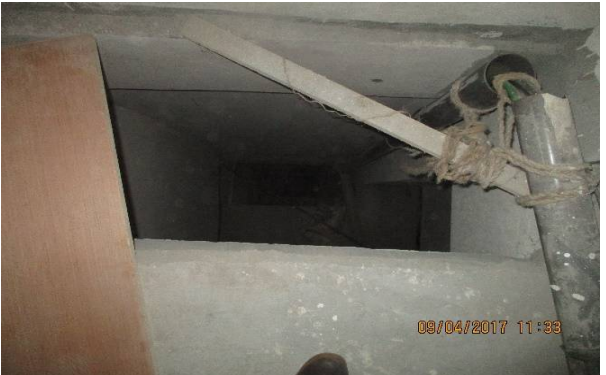
| SI No. | Category | Findings | Required Action | Remediation Time Frame | Pictorial Evidence |
|---|---|---|---|---|---|
| 10 | Unsealed Floor/Ceiling Penetrations | Unsealed penetrations and openings are located in the fire rated floor/ceiling assemblies. Location: Electrical room (SW & SE side) | Provide a minimum 2-hr fire rated shaft to separate the utility risers from each floor level. Seal all penetrations and openings in floors/ceiling assemblies to maintain the fire separation. | Within 2 months | |

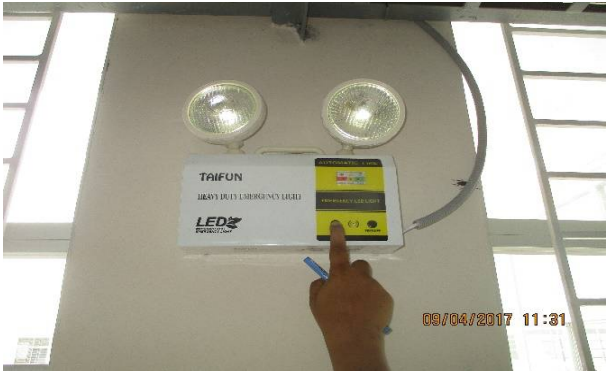
| Sl No. | Category | Findings | Required Action | Remediation Time Frame | Pictorial Evidence |
|---|---|---|---|---|---|
| 11 | Manual On/Off Switch | Manual on-off switch is provided for [emergency lighting / exit signage] units. | Remove manual on/off switches from emergency lighting / exit signage units to prevent them from being switched off. | Within 1 month | |

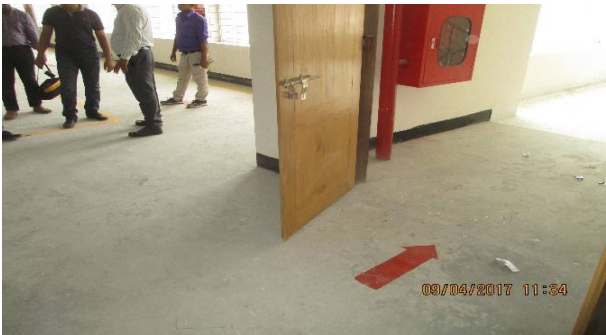
| Sl No. | Category | Findings | Required Action | Remediation Time Frame | Pictorial Evidence |
|---|---|---|---|---|---|
| 14 | Door Swing | Egress door serving 50 or more occupants but does not swing in the direction of egress travel. (Specify locations) | Modify swing direction of egress doors to the direction of egress travel. Doors serving an occupant load of more than 50 shall swing in the direction (out-ward) of egress travel . | Within 1 month | |

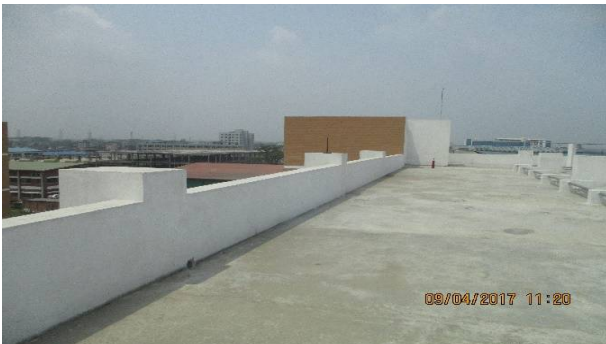
| Sl No. | Category | Findings | Required Action | Remediation Time Frame | Pictorial Evidence |
|---|---|---|---|---|---|
| 15 | Parapets or Guards | Parapets or guards are less than 42 inches in occupiable roof | Provide parapets or guards with a minimum height of 1067mm (42 inch.). | Within 3 months | |

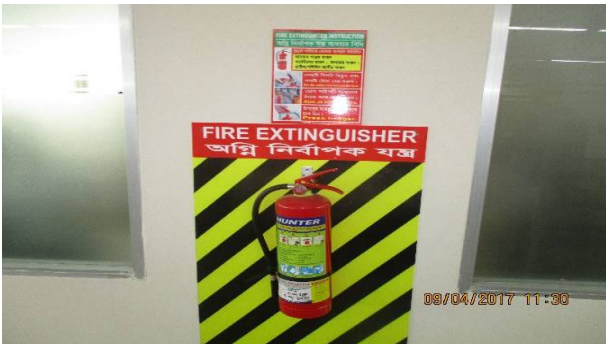
| Sl No. | Category | Findings | Required Action | Remediation Time Frame | Pictorial Evidence |
|---|---|---|---|---|---|
| 16 | Inspection, testing, and maintenance | Inspection, testing and maintenance of portable fire extinguishers is not in accordance with NFPA 10. | Inspect, test and maintain the portable fire extinguishers and keep written records onsite, in accordance with NFPA 10. | Within 1 month | |

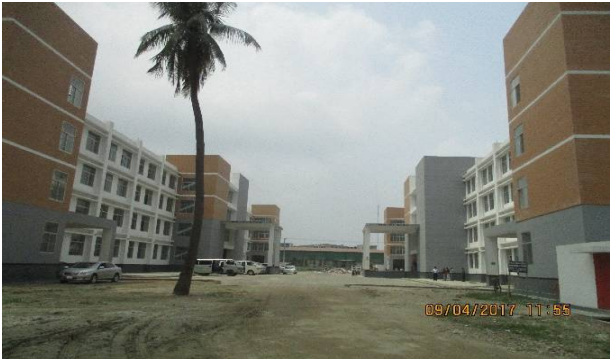
| Sl No. | Category | Findings | Required Action | Remediation Time Frame | Pictorial Evidence |
|---|---|---|---|---|---|
| 17 | Fire Fighting system | The existing buildings have an occupied floor greater than 10 meter (33 feet) and is not provided with standpipe protection. | Install a new class III standpipe system & fire department connection in accordance with NFPA 14. A class I system shall be permitted in buildings protected throughout by an automatic sprinkler system. | Design within 3 months, Install within 6 months | |
