# **FIRE SAFETY INSPECTION REPORT**

**Factory Name: JAROMS INDUSTRIES LTD.**

**ACCORD ID: 11719**

**ADDRESS: 13/2, Abdus Sattar Masttar Road, Tongi Gazipur, Bangladesh.**

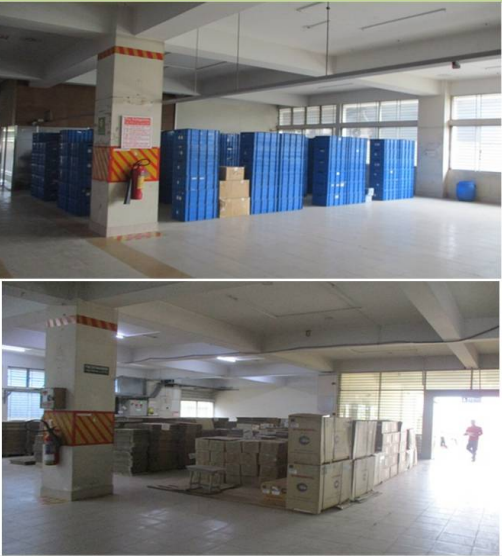
| Sl No. | Category | Findings | Required Action | Remediation Time Frame | Pictorial Evidence |
|---|---|---|---|---|---|
| 1 | Fire Rated Construction | Areas used for combustible storage are not separated by fire rated construction. [ Location: Ground and 1st floor] | <p>Provide dedicated storage rooms separated by minimum 1-hr fire-rated construction. Provide minimum 0.75 hrs. fire rated door on the door openings.</p> <p>Where separate storage rooms are not feasible, provide defined storage areas and limit the storage arrangement as follows: - Maximum height of 2.45m (8ft.) and maximum area of 23m<sup>2</sup> (250 ft<sup>2</sup>) - If sprinkler protected: maximum height of 3.66m (12ft.) and maximum area of 93m<sup>2</sup> (305ft<sup>2</sup>) Separate areas of unenclosed combustible storage by a minimum clear distance of 3m (10ft.).</p> | Within 3 months | |

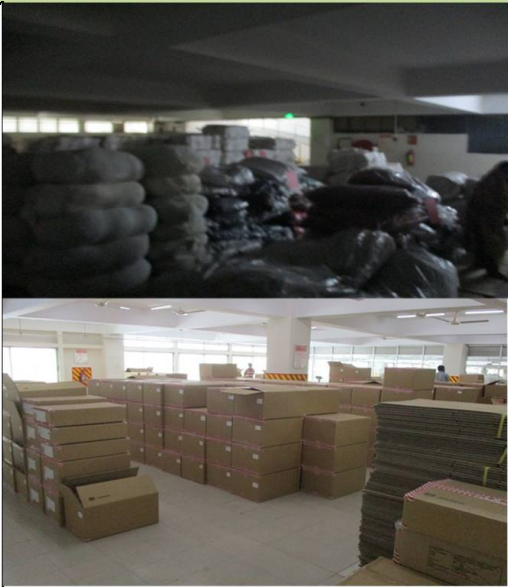
| SI No. | Category | Findings | Required Action | Remediation Time Frame | Pictorial Evidence |
|---|---|---|---|---|---|
| 2 | Fire Rated Construction | Rooms used for storage of combustible materials are not separated from the surrounding occupancy/areas | Rooms used for storage of combustible materials shall be separated from the surrounding occupancy with a minimum 1 hour construction. | Within 3 months | |

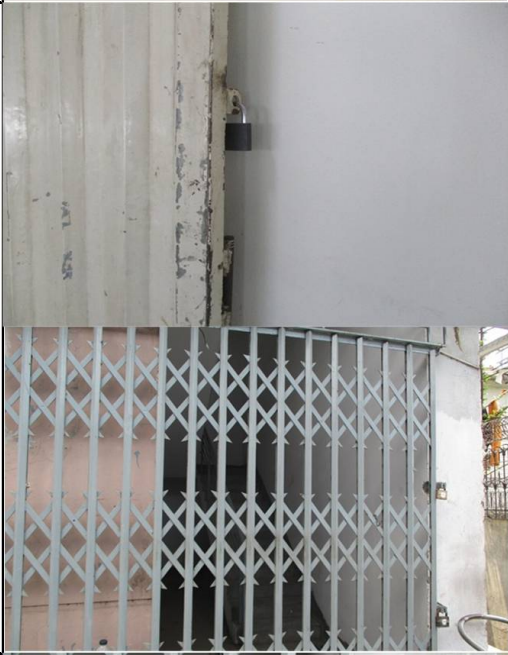
| SI No. | Category | Findings | Required Action | Remediation Time Frame | Pictorial Evidence |
|---|---|---|---|---|---|
| 3 | Egress | Egress doors / gates with locking features are provided at all exits of the main building. | <p>Remove locking features from all egress doors / gates.</p> <p>If locks are required for security reasons, utilize special door locking features complying with NFPA 101.</p> | Immediate | |

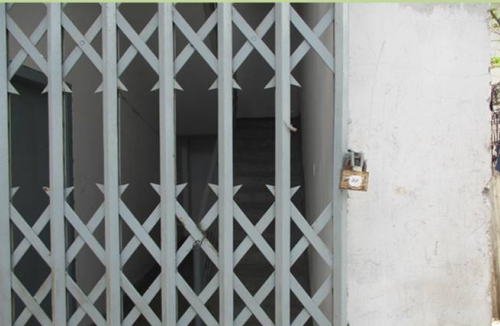
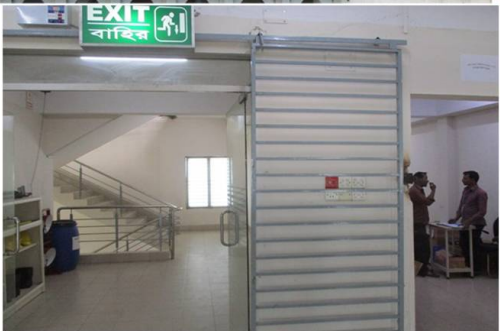
| Sl No. | Category | Findings | Required Action | Remediation Time Frame | Pictorial Evidence |
|---|---|---|---|---|---|
| 4 | Sliding Door & Gates | Collapsible gates/sliding doors/rolling shutter doors are provided at [building exits, exit stairs, along egress routes, exit discharge] | Replace all collapsible gates/ sliding doors/ rolling shutter doors along the means of egress with side-hinged, swinging egress doors. | Within 1 month | |

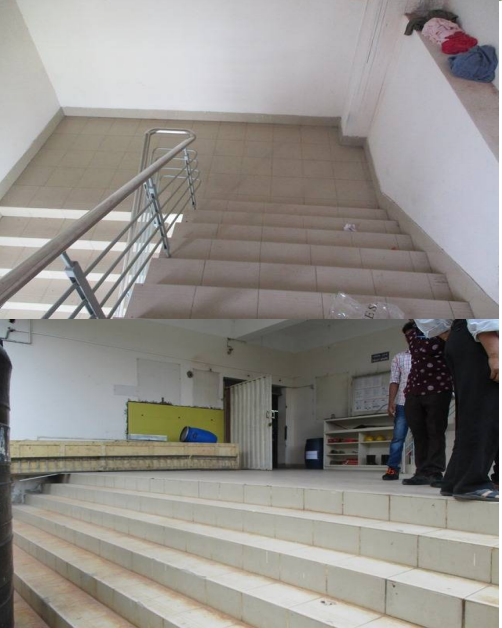
| SI No. | Category | Findings | Required Action | Remediation Time Frame | Pictorial Evidence |
|---|---|---|---|---|---|
| 6 | No Handrails | Handrails are not provided on both sides of each exit stairs on all floors. Having handrails on one side of said staircase, may pose as a falling hazard during evacuation.<br>Or, Handrails are not provided at exit stairs. | Provide handrails on both sides of the exit stair. New handrails shall have a minimum height of 865 mm (34 in.) and a maximum height of 965 mm (38 in.) as measured from the leading edge of the tread. Intermediate handrails shall be provided when the stair width exceeds 2.2 m (87 in.) | Within 3 months | |

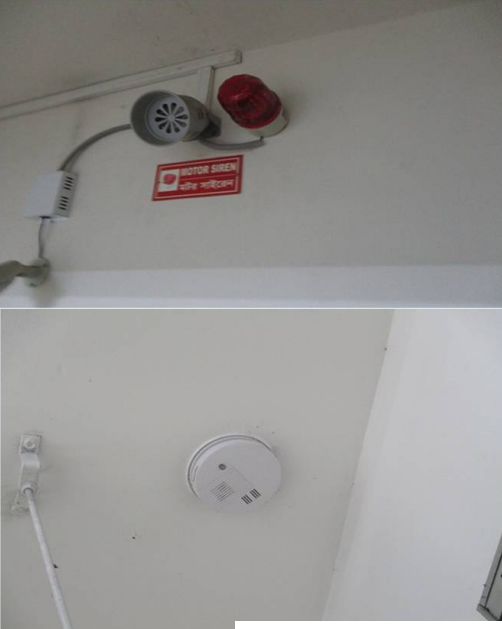
| SI No. | Category | Findings | Required Action | Remediation Time Frame | Pictorial Evidence |
|---|---|---|---|---|---|
| 7 | Antiquated Fire Detection System | The fire detection system is antiquated, not a listed system, and does not provide alarm and notification features consistent with acceptable standards. | Replace the fire detection system with a new, listed addressable fire detection system in accordance with NFPA 72. | Design within 4 months, Install within 9 months | |

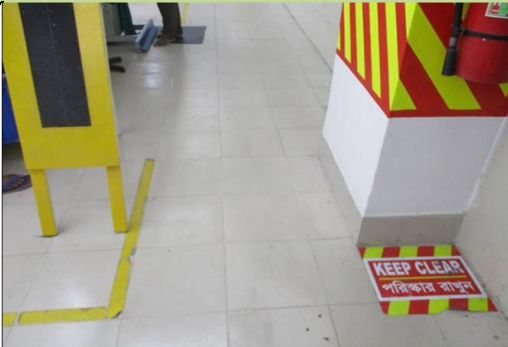
| Sl No. | Category | Findings | Required Action | Remediation Time Frame | Pictorial Evidence |
|---|---|---|---|---|---|
| 8 | Aisle Width | The width of egress aisles is less than 36-in. on the ground floor. | Provide minimum aisle widths of 36-in. | Within 3 months | |

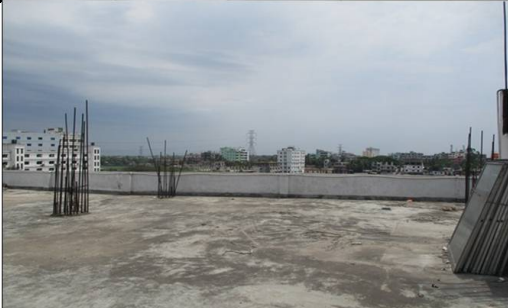
| Sl No. | Category | Findings | Required Action | Remediation Time Frame | Pictorial Evidence |
|---|---|---|---|---|---|
| 9 | Parapets or Guards | Parapets or guards are not provided in occupiable roof. | Provide parapets or guards with a minimum height of 1067mm (42 inch.). | Within 3 months | |

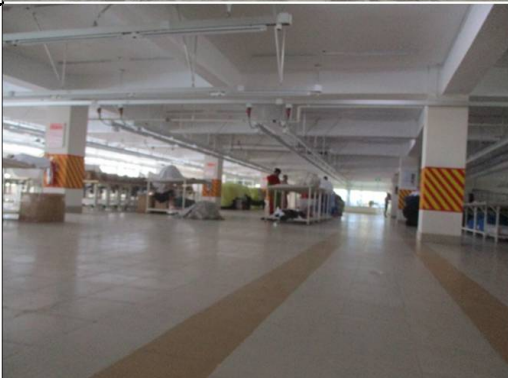
| Sl No. | Category | Findings | Required Action | Remediation Time Frame | Pictorial Evidence |
|---|---|---|---|---|---|
| 10 | Emergency Egress Lighting | Based on the number and location of emergency lights observed, adequate illumination levels are not anticipated along egress routes. | Test the emergency lighting system on each floor and provide additional emergency fixtures to provide adequate illumination along the means of egress. Provide a minimum illumination of 10 lux at the floor level within exit stairs and exit discharge paths and minimum 2.5 lux along exit access aisles. | Within 3 months | |

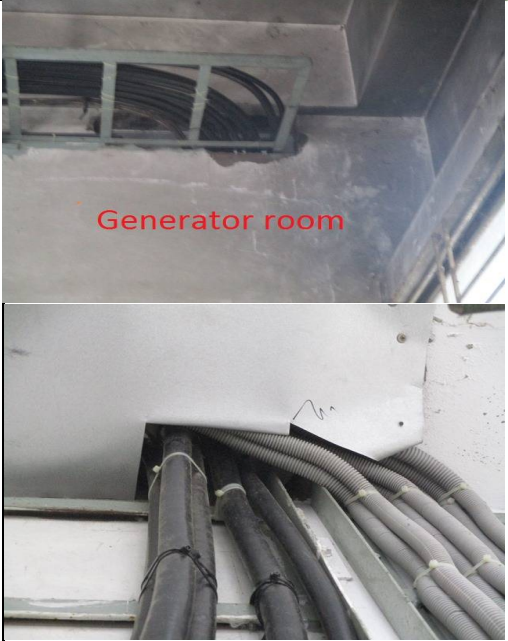
| SI No. | Category | Findings | Required Action | Remediation Time Frame | Pictorial Evidence |
|---|---|---|---|---|---|
| 11 | Opening/Penetration through Floor/Ceiling | Penetrations through floor/ceiling assemblies are found unsealed. | Seal all penetrations and openings in floor/ceiling (full thickness of the floor/ceiling) assemblies by fire rated materials to maintain the fire resistance rating.<br>Provide a minimum 2-hr fire rated shaft to separate the utility risers from each floor if required. | Within 3 months | |

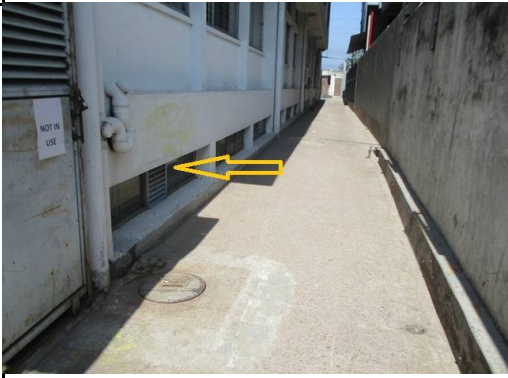
| SI No. | Category | Findings | Required Action | Remediation Time Frame | Pictorial Evidence |
|---|---|---|---|---|---|
| 12 | Discharge path | The exit discharge paths serving the North and Southeast exit stairs were less than 10 ft wide and were not separated from the building interior. | Seal all penetrations and openings to the interior of the building along the discharge path, up to a height of 10 ft., to provide a minimum 1-hr fire separation.<br>Alternatively, provide a second remote discharge path to the public way (only include this if feasible) | Within 3 months | |

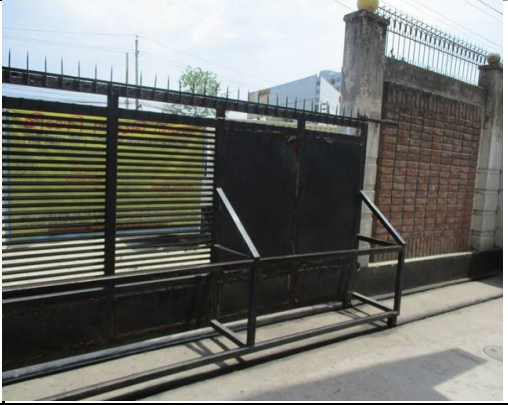
| Sl No. | Category | Findings | Required Action | Remediation Time Frame | Pictorial Evidence |
|---|---|---|---|---|---|
| 16 | Door Swing | Egress door serving 50 or more occupants but does not swing in the direction of egress travel. Location : Main gate. | Modify swing direction of egress doors to the direction of egress travel. Doors serving an occupant load of more than 50 shall swing in the direction (out-ward) of egress travel . | Within 1 month | |
