INITIAL FIRE ASSESSMENT REPORT (FAR)

Factory Name: **Anowara Fashions Ltd**

Assessor: **Bureau Veritas**

Date: **04 Jun 2014**

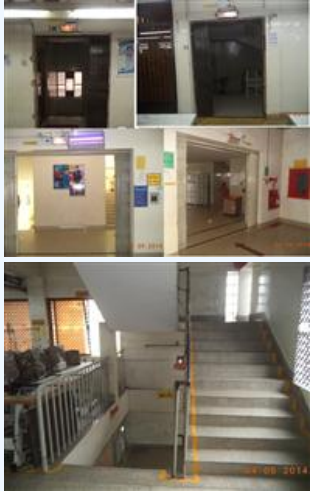
Priority Level:	High	
Non-Compliance Level:	3	
Description:	There are 5 stairs available in legacy main production building and 3 stairs available in Anowara main production building. All stair enclosures are not provided with fire rated doors. Some fire doors are found fitted at some exit enclosures but no credible certificates are available for those fire doors. Moreover, in Anowara building one stair is not enclosed with proper separation barrier.	
Source of Findings:	Visual Assessment: Exit enclosures without proper fire-resistive rated construction barriers were found.	
Suggested Plan of Action:	Provide 2 hr fire-resistive rated construction barriers at exit enclosures. Fit side-swinging, self-closing, non-lockable fire doors that swing in the direction of egress of 1.5 hr rating in all stairwell enclosures. Consult a qualified fire protection engineer to design the required rated construction barriers.

Suggested Deadline Date:	26 Sep 2014
