# INITIAL FIRE ASSESSMENT REPORT (FAR)

Factory Name: **MENS FASHION LIMITED**  
Address: **49 NP kalurghat Heavy Industrial area, Chittagong  
Chittagong Chittagong Bangladesh**  
Assessor: **Sumerra**  
Date: **11 May 2014**

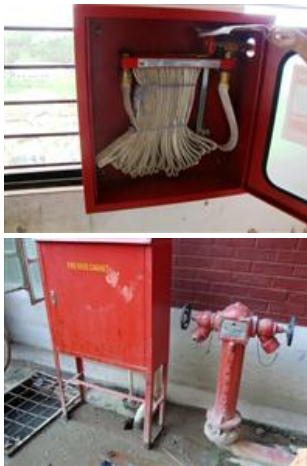
| Question: | Does the building have a Standpipe System? | |
| Description: | Factory has a standpipe system, however, it is not compliant with standard. In each floor there are 03 Nos. of Class II (38mm) hose reels. There is 06 Nos. of 65mm connections at outside wall of GF for attachment of fire brigade hoses as well as fire department connections to supply the system manually. | |
| Source of Findings: | Photograph: Photo of Class I and II connections | |

| Suggested Plan of Action: | Install a standpipe system designed by a qualified fire protection engineer in accordance with NFPA 14 and Alliance Standard. System should include Class I standpipe hose connections (65 mm) in each stairwells at each floor level including occupiable roof. | |
