# INITIAL FIRE ASSESSMENT REPORT (FAR)

Factory Name: **Next Collections Limited**  
Address: **Mouza-Diakhali, 1323, 1324, 1325. Beron, Ashulia, Savar  
Ashulia, Savar Dhaka Bangladesh**  
Assessor: **CCRD**  
Date: **22 Jun 2013**

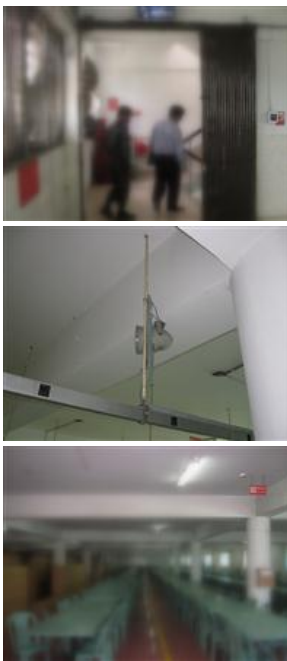
| Description: | The factory does not have a fire pump to supply adequate pressure for hose stations/connections. | |
| Source of Findings: | Visual Assessment: Only provided with roof tank. | |

| Suggested Plan of Action: | Install a dedicated fire pump for the facility in accordance with NFPA 20. Also, install a water storage tank in accordance with NFPA 22. | |
