# INITIAL FIRE ASSESSMENT REPORT (FAR)

Factory Name: **DENIM PLUS (BD) LTD**

Assessor: **Bureau Veritas**

Date: **10 May 2014**

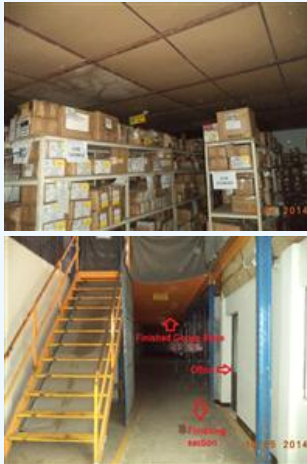
| Description: | The elevator (cargo lift) in the main building is open to the production floor, and the door of the elevator shaft is not fire rated as required. | |
| Source of Findings: | Photograph: Photograph shows the cargo lift in the main building. | |

| Suggested Plan of Action: | Provide a fire door of the required rating as the door of the elevator/cargo lift. Provide fire-resistive rated construction barriers for shafts in accordance with Alliance Standard Section 4.5.7. Consult a qualified fire protection engineer to design the required rated construction barrier. | |

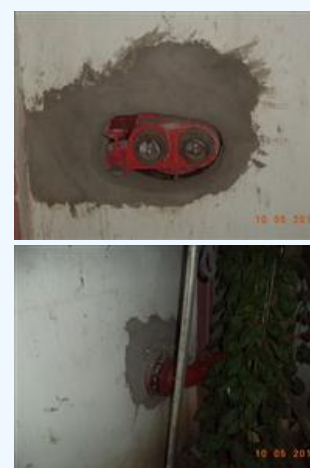
| Description: | Fire department (Siamese) inlet connections are provided as per clause 5.5.4. Connections are clearly identifiable for the fire protection system. However, fire department outlet connections are not provided on the premises. | |
| Source of Findings: | Visual Assessment: Fire department outlet connections are not provided on the premises. | |

| Suggested Plan of Action: | According to Alliance Standard, Part-5, Section-5.5.4, fire department (Siamese) inlet connections shall be provided to allow fire department pumper equipment to supplement the fire protection systems. Fire department outlet connections shall be provided to allow fire department pumper vehicles to draw water from ground-level or underground water storage tanks. Are there water storage tanks available? This may not be applicable unless a means for water storage is required or available. Connections shall match the Fire Service and Civil Defense hose thread standard. | |
