# BOILER SAFETY REPORT

## Masihata Sweaters Ltd (Extension)

# EXECUTIVE SUMMARY

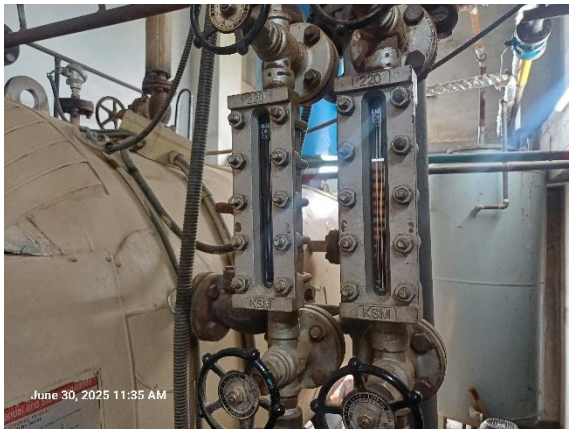
| **FINDING NO:** | B-6 | |

| **FINDING:**<br>Low Low Water Level (LLWL) was not marked properly on water level gauge glass system. | | |

| **RECOMMENDATION:**<br>The Low Low Water Level (LLWL) should be marked beside the gauge glass on a separate arrangement so that the water level can be visualized and identified clearly. | | |

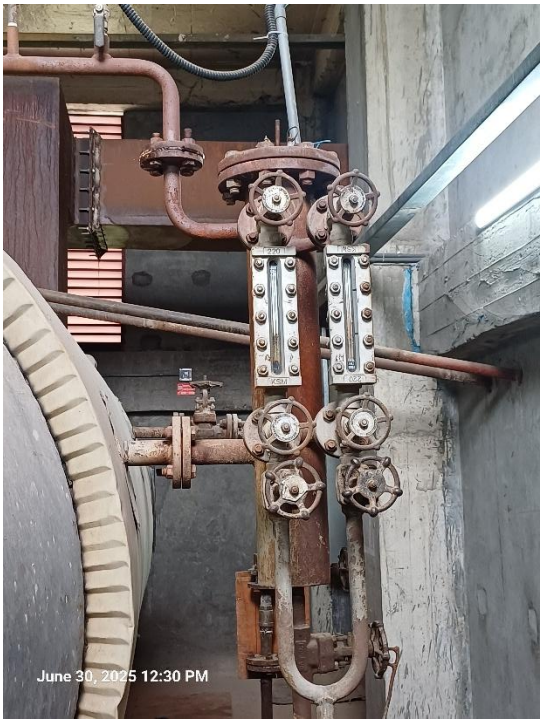
| **FINDING NO:** | B-7 | |

| **FINDING:**<br>Low Low Water Level (LLWL) was not marked properly on water level gauge glass system. | | |

| **RECOMMENDATION:**<br>The Low Low Water Level (LLWL) should be marked beside the gauge glass on a separate arrangement so that the water level can be visualized and identified clearly. | | |

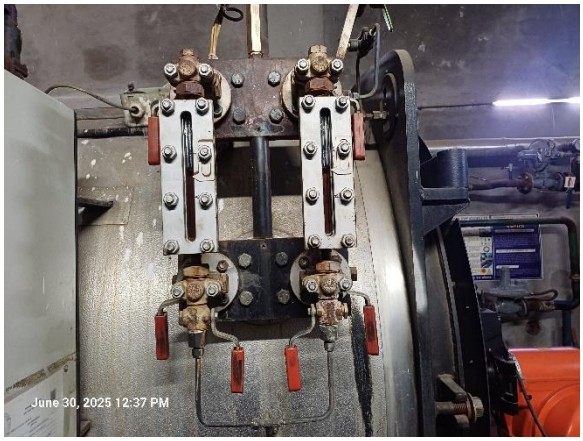
| **FINDING:**<br><br>Low Low Water Level (LLWL) was not marked properly on water level gauge glass system. | |

| **RECOMMENDATION:**<br><br>The Low Low Water Level (LLWL) should be marked beside the gauge glass on a separate arrangement so that the water level can be visualized and identified clearly. | |

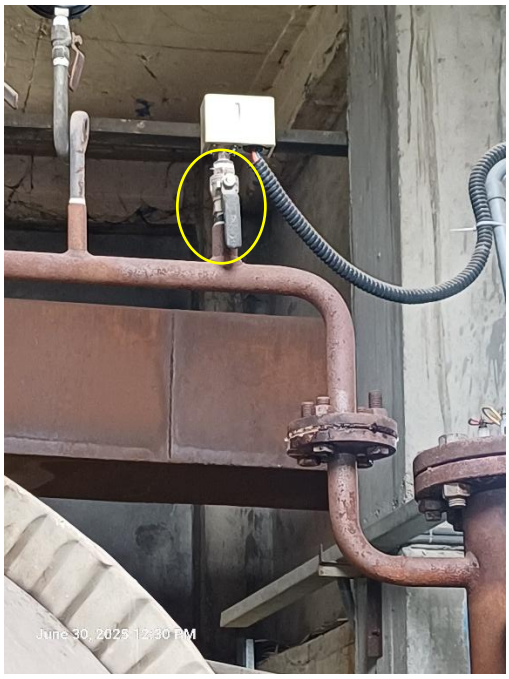
| **FINDING:**<br><br>Valves were observed between the boiler and the pressure controller. | |

| **RECOMMENDATION:**<br><br>The measuring and sensing devices related to boiler safety shall be mounted directly with the boiler without any valves in between. | |

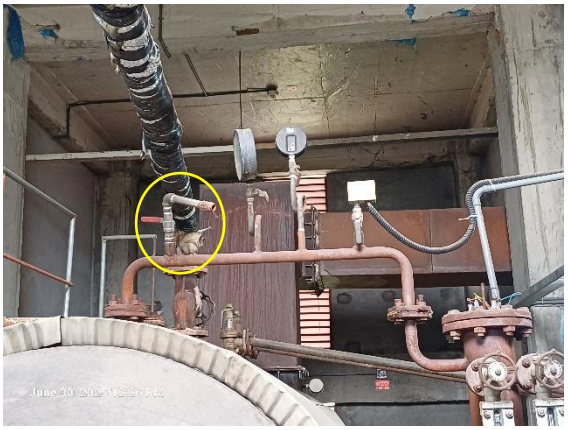
| **FINDING:**<br><br>The boiler air vent line was not directed to the outside of the boiler room. | |

| **RECOMMENDATION:**<br><br>The boiler vent line should be directed outside of the boiler room with proper support. | |

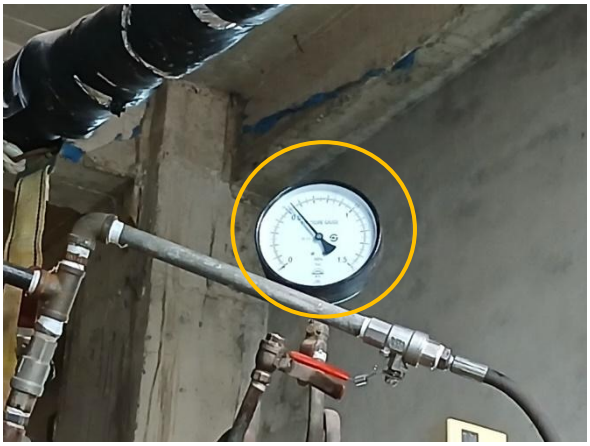
| **FINDING:**<br><br>The steam pressure gauge range was insufficient. | |

| **RECOMMENDATION:**<br><br>The boiler pressure gauge range should be at least twice the boiler's maximum allowable working pressure mentioned in the boiler license or in accordance with any recognized international standard. | |

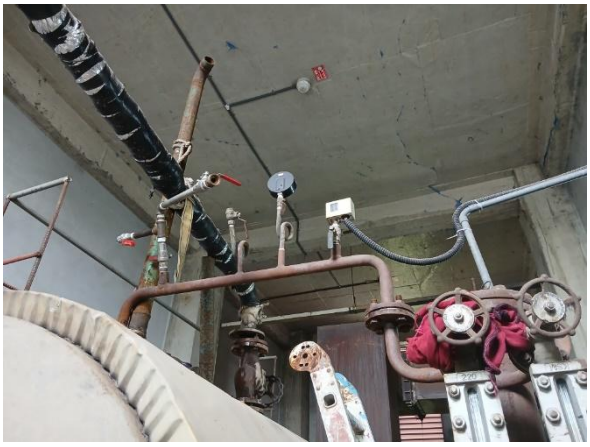
| **FINDING:**<br><br>Boiler exhaust gas pipeline inside the boiler room was found with improper insulation. | |

| **RECOMMENDATION:**<br><br>Proper insulation to boiler exhaust gas pipeline inside the boiler room causing heat exposure for personnel shall be provided. | |

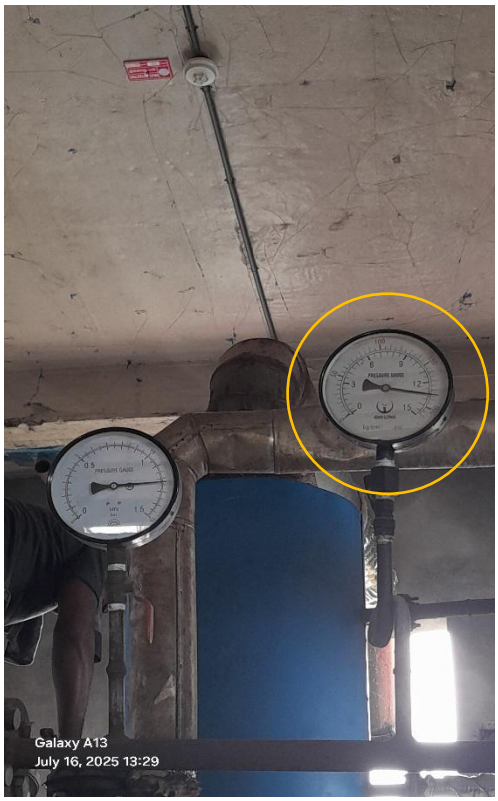
| **FINDING:**<br><br>An inconsistency was observed between the readings of the boiler pressure gauge and the calibrated pressure gauge. | |

| **RECOMMENDATION:**<br><br>Defective pressure gauge(s) shall be replaced with functional gauge(s) as per Bangladesh Boiler Regulation (BBR). | |

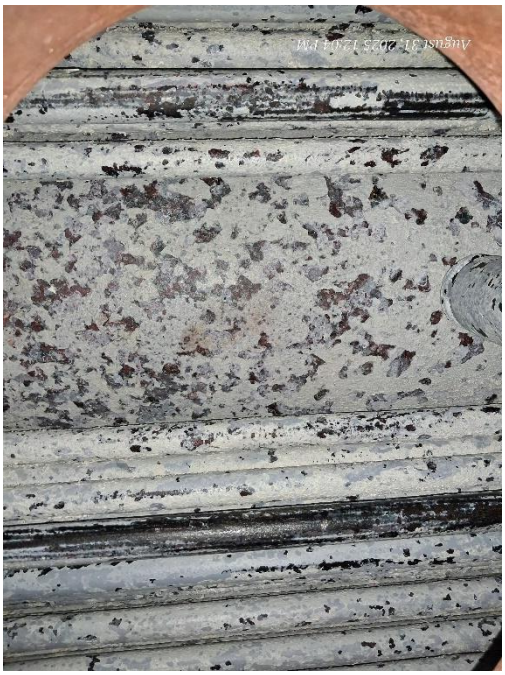
| **FINDING NO:** | B-29 | |

| **FINDING:**<br><br>Salt and scale (hard & medium) formation was observed on the waterside. | | |

| **RECOMMENDATION:**<br><br>Cleaning is required. A water treatment station is to be used. Feed and boiler water quality and conditioning should be verified and monitored. The boiler operator should operate the boiler with proper blowdown. | | |
