BOILER SAFETY REPORT

Nafa Apparels Ltd. 2

Factory ID: 12861

Factory List	:	Nafa Apparels Ltd. 2 (12861)
		Nafa Apparels Ltd. 2 (Extension) (24853)
Number of Boilers	:	03
Boiler Registration Numbers	:	BB 8214, BB 13199, BB 14554

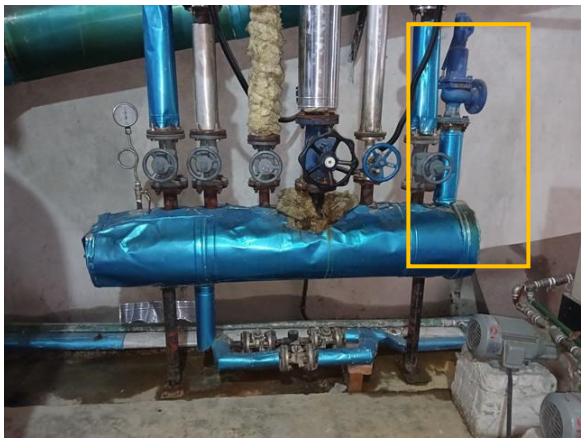
FINDING NO:	B-5
CATEGORY:	SAFETY VALVE
BOILER REGISTRATION NO:	BB 8214
FINDING: Boiler (Steam Header) Safety Valve outlet line was not directed outside of the boiler room.	
RECOMMENDATION: Boiler Safety Valve outlet line should be directed outside of the boiler room with proper support and drainage system.	
PRIORITY:	P2
REMEDIATION TIME FRAME:	1 MONTH

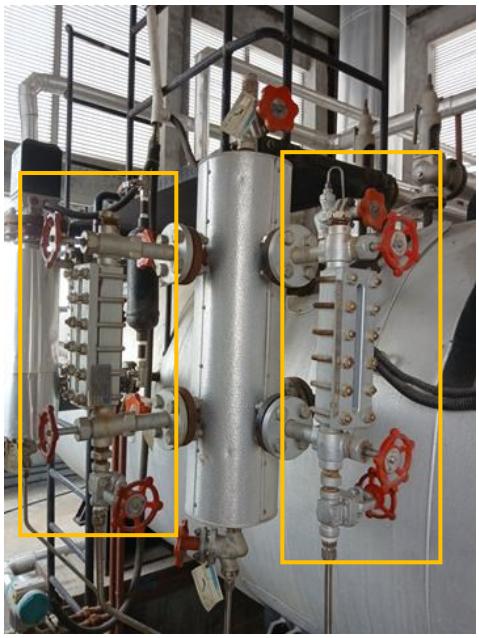
FINDING NO:	B-7
CATEGORY:	MONITORING AND CONTROL SYSTEM
BOILER REGISTRATION NO:	BB 13199
FINDING: Low Low Water Level (LLWL) was not marked properly on water level gauge glass system.	
RECOMMENDATION: The Low Low Water Level (LLWL) should be marked beside the gauge glass on a separate arrangement so that the water level can be visualized and identified clearly.	
PRIORITY:	P3
REMEDIATION TIME FRAME:	2 MONTHS

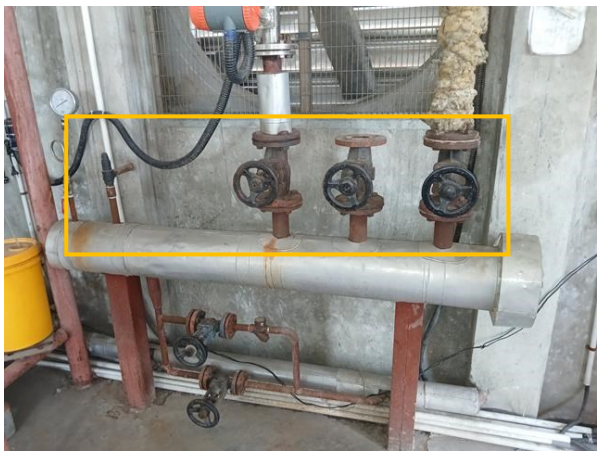
FINDING NO:	B-8
CATEGORY:	THERMAL INSULATION
BOILER REGISTRATION NO:	BB 13199
FINDING: Boiler steam header and steam pipeline were found with improper insulation.	
RECOMMENDATION: Proper insulation to exposed parts of the boiler body and steam distribution pipelines should be provided.	
PRIORITY:	P2
REMEDIATION TIME FRAME:	1 MONTH

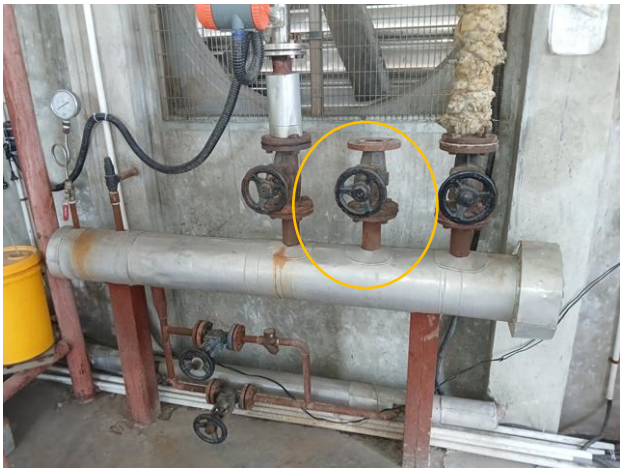
FINDING NO:	B-9
CATEGORY:	STEAM DISTRIBUTION NETWORK
BOILER REGISTRATION NO:	BB 13199
FINDING: Unused steam line connection was not terminated properly.	
RECOMMENDATION: Any unused & unprotective steam line shall be terminated in an appropriate manner that does not create any possibility of burn hazard for the operator(s).	
PRIORITY:	P1
REMEDIATION TIME FRAME:	2 WEEKS

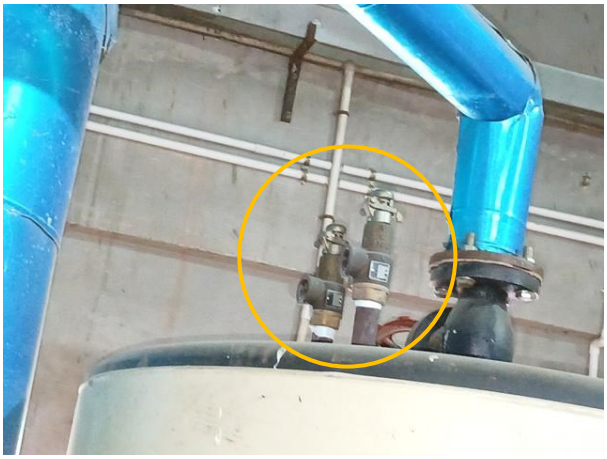
FINDING NO:	B-14
CATEGORY:	SAFETY VALVE
BOILER REGISTRATION NO:	BB 14554
FINDING: Boiler Safety Valve outlet line was not directed outside of the boiler room.	
RECOMMENDATION: Boiler Safety Valve outlet line should be directed outside of the boiler room with proper support and drainage system.	
PRIORITY:	P2
REMEDIATION TIME FRAME:	1 MONTH
