# BOILER SAFETY REPORT

## Zaber & Zubair Fabrics Ltd

**Factory ID:** 9276

# EXECUTIVE SUMMARY

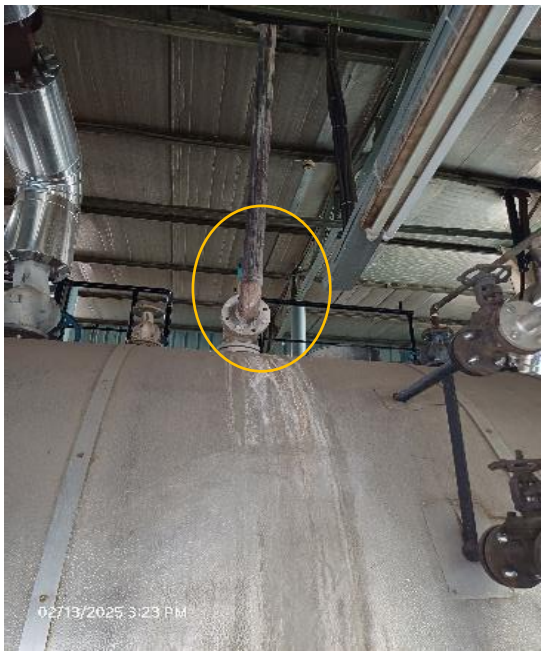
| **FINDING NO:** | B-80 |

| **CATEGORY:** | SAFETY VALVE |
| **PRIORITY:** | P3 |

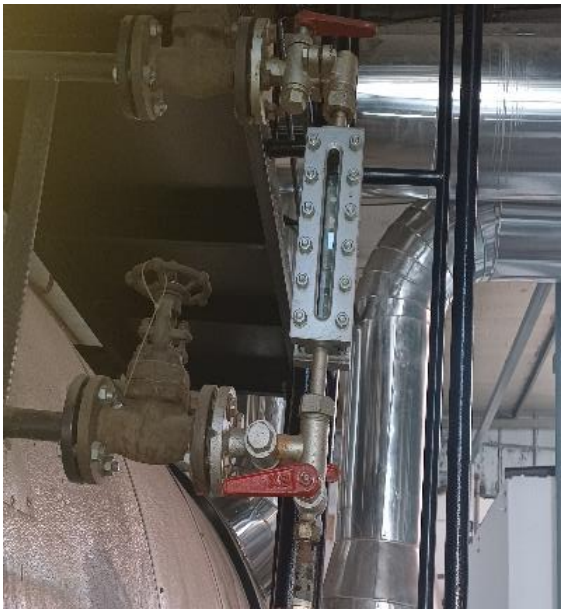
| **FINDING NO:** | B-81 |

| **CATEGORY:** | MONITORING AND CONTROL SYSTEM |
| **PRIORITY:** | P3 |

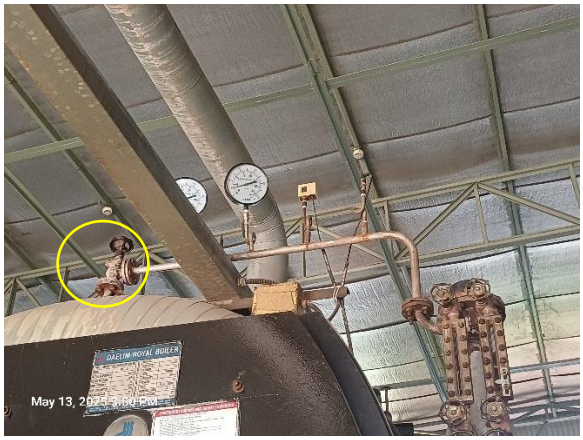
| **FINDING NO:** | B-87 | |

| **CATEGORY:** | MONITORING AND CONTROL SYSTEM | |
| **BOILER REGISTRATION NO:** | BB 5821 | |

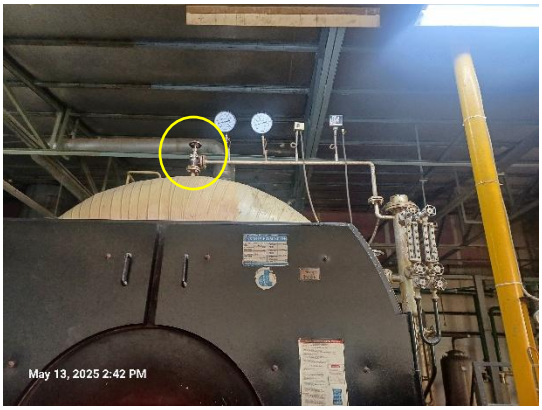
| **FINDING NO:** | B-88 | |

| **CATEGORY:** | MONITORING AND CONTROL SYSTEM | |
| **BOILER REGISTRATION NO:** | BB 5338 | |

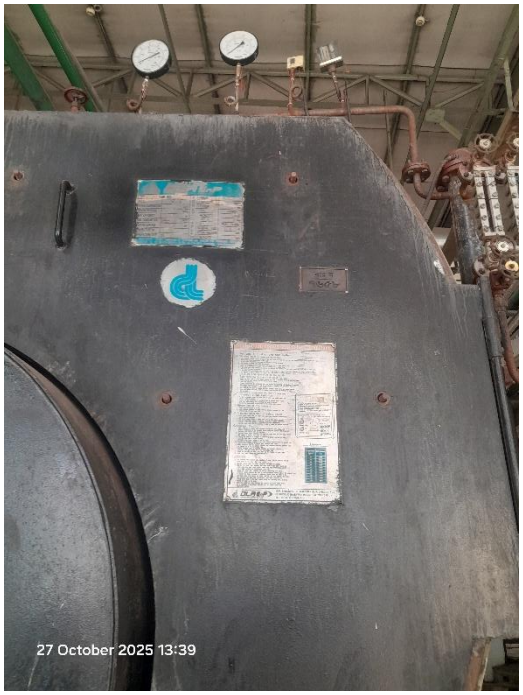
| **FINDING NO:** | B-109 | |

| **CATEGORY:** | MONITORING AND CONTROL SYSTEM | |
| **BOILER REGISTRATION NO:** | BB 12015 | |
