BOILER SAFETY REPORT

Rahimaaziz Knitspin Ltd

Factory ID: 9677

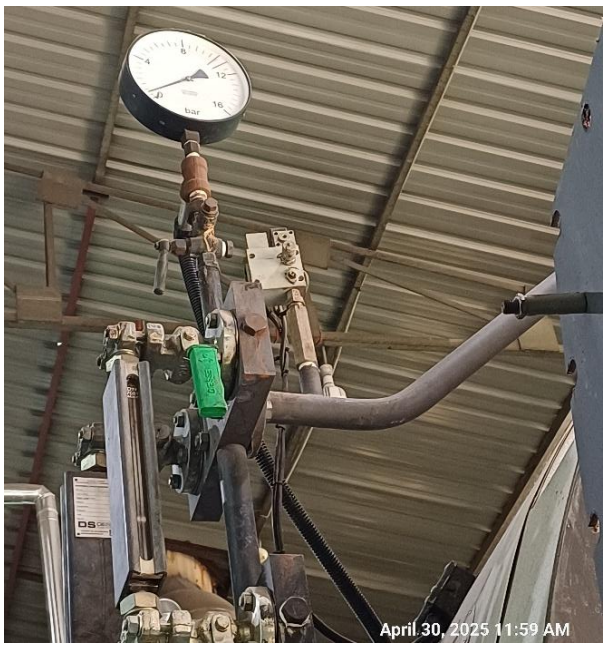
FINDING NO:	B-32
CATEGORY:	MONITORING AND CONTROL SYSTEM
BOILER REGISTRATION NO:	BB 13507
FINDING: The steam pressure gauge range was insufficient.	
RECOMMENDATION: The boiler pressure gauge range should be at least twice the boiler's maximum allowable working pressure mentioned in the boiler license or in accordance with any recognized international standard.	
PRIORITY:	P2
REMEDIATION TIME FRAME:	1 MONTH

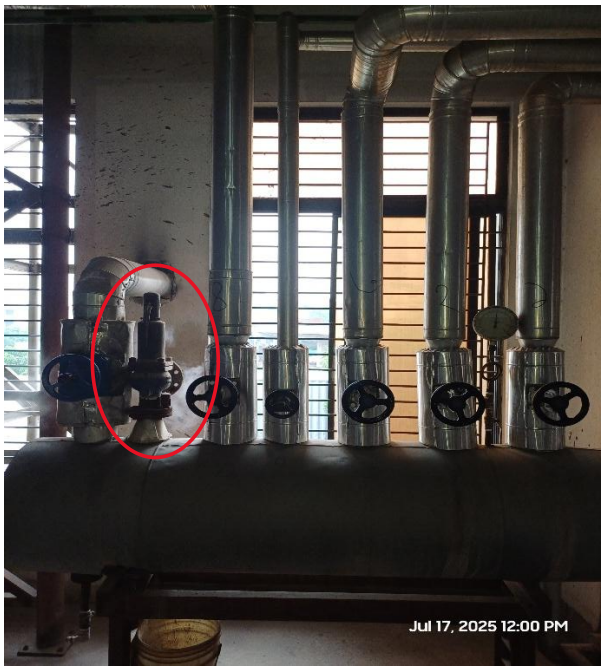
FINDING NO:	B-35
CATEGORY:	SAFETY VALVE
BOILER REGISTRATION NO:	BB 9022
FINDING: Boiler Steam Header Safety Valve outlet line was not directed outside of the boiler room.	
RECOMMENDATION: Boiler Steam Header Safety Valve outlet line should be directed outside of the boiler room with proper support and drainage system.	
PRIORITY:	P2
REMEDIATION TIME FRAME:	1 MONTH

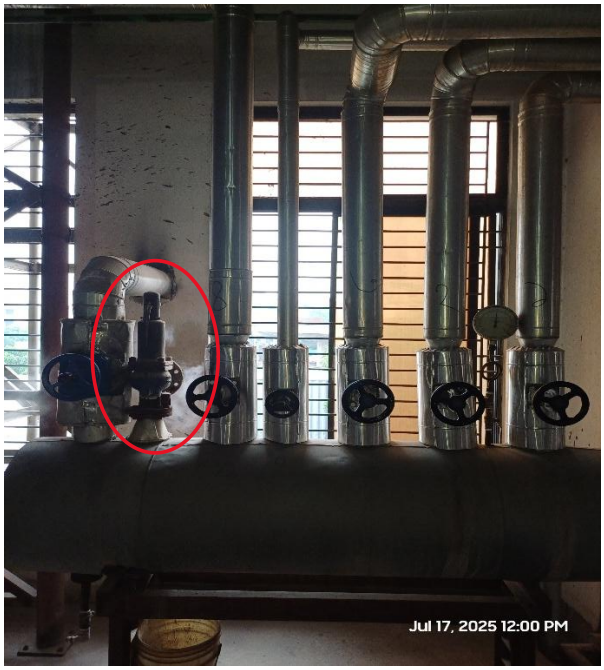
FINDING NO:	B-36
CATEGORY:	SAFETY VALVE
BOILER REGISTRATION NO:	BB 12459
FINDING: Boiler Steam Header Safety Valve outlet line was not directed outside of the boiler room.	
RECOMMENDATION: Boiler Steam Header Safety Valve outlet line should be directed outside of the boiler room with proper support and drainage system.	
PRIORITY:	P2
REMEDIATION TIME FRAME:	1 MONTH

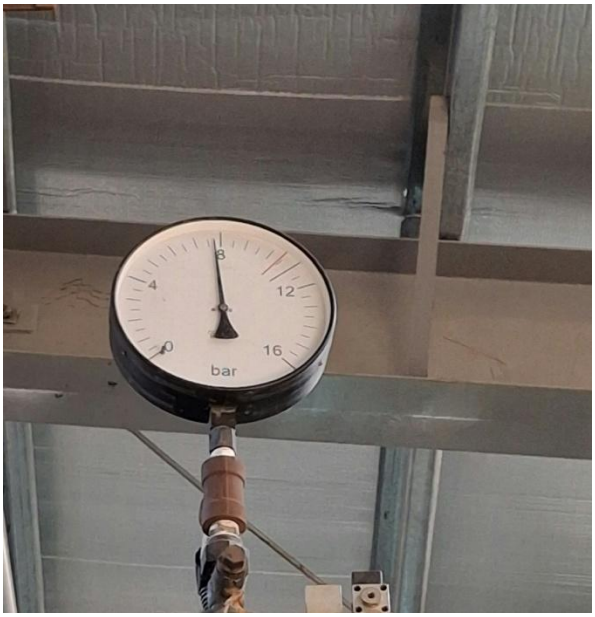
FINDING NO:	B-39
CATEGORY:	MONITORING AND CONTROL SYSTEM
BOILER REGISTRATION NO:	BB 13507
FINDING: Installed pressure gauge was inadequate in dial size and pressure rating according to manufacturing standard.	
RECOMMENDATION: Appropriate pressure gauge(s) shall be provided according to Bangladesh Boiler Regulation (BBR)/manufacturing standard/any standard recognized by the CIoB with consistent functionality.	
PRIORITY:	P3
REMEDIATION TIME FRAME:	2 MONTHS
