BOILER SAFETY REPORT

Newage Garments Ltd.

Factory ID: 9603

RSC RMG SUSTAINABILITY COUNCIL

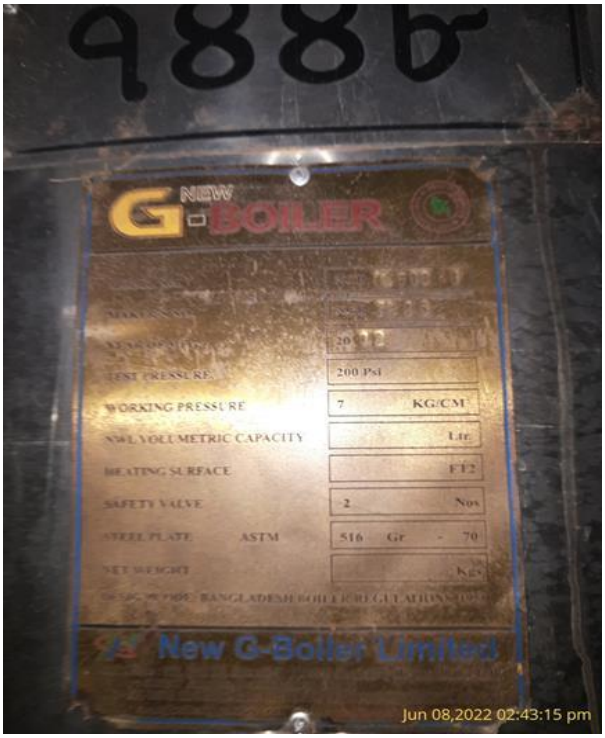
FINDING NO:	B-53

CATEGORY:	Identification	
BOILER REGISTRATION NO:	BB 7446	
FINDING: Inconsistency was observed between the nameplate data and the CIoB provided certificate copy for the boiler regarding manufacturing year.		
RECOMMENDATION: Information provided in the nameplate and in the CIoB provided certificate shall be consistent. Any alteration shall be approved from the CIoB and a copy to be preserved on site.		
PRIORITY:	P2	
REMEDIATION TIME FRAME:	2 MONTHS

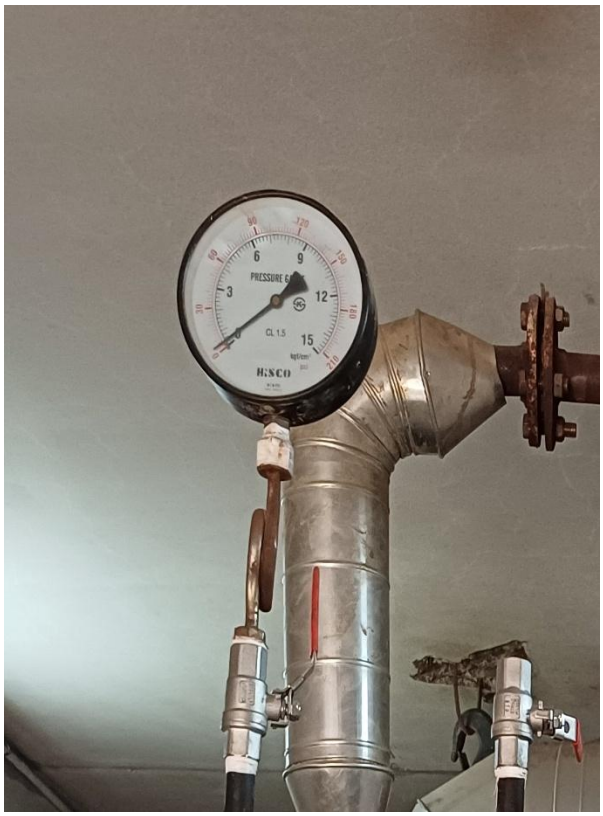
FINDING NO:	B-68
CATEGORY:	Monitoring and Control System
BOILER REGISTRATION NO:	BB 13066
FINDING: The steam pressure gauge range was insufficient.	
RECOMMENDATION: The boiler pressure gauge range should be at least twice the boiler's maximum allowable working pressure mentioned in the boiler license or in accordance with any recognized international standard.	
PRIORITY:	P2
REMEDIATION TIME FRAME:	1 MONTH

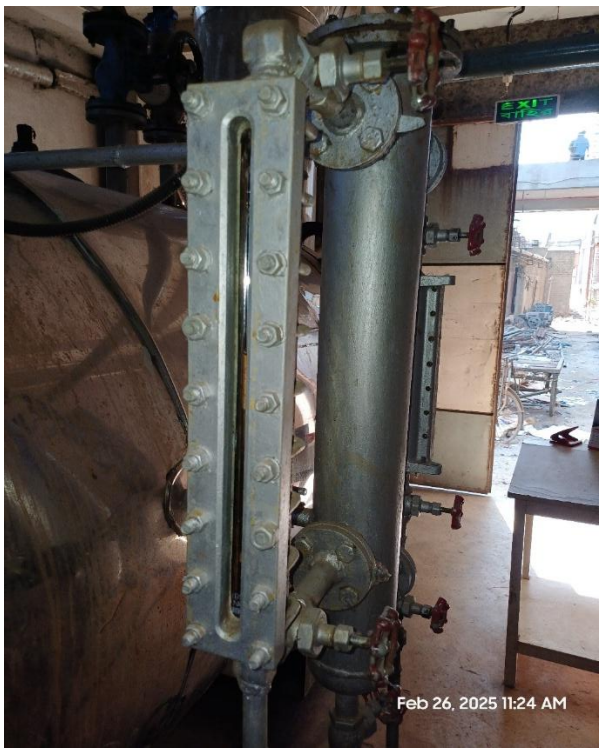
FINDING NO:	B-73
CATEGORY:	Monitoring and Control System
BOILER REGISTRATION NO:	BB 14856
FINDING: Low Low Water Level (LLWL) was not marked properly on water level gauge glass system.	
RECOMMENDATION: The Low Low Water Level (LLWL) should be marked beside the gauge glass on a separate arrangement so that the water level can be visualized and identified clearly.	
PRIORITY:	P3
REMEDIATION TIME FRAME:	2 MONTHS

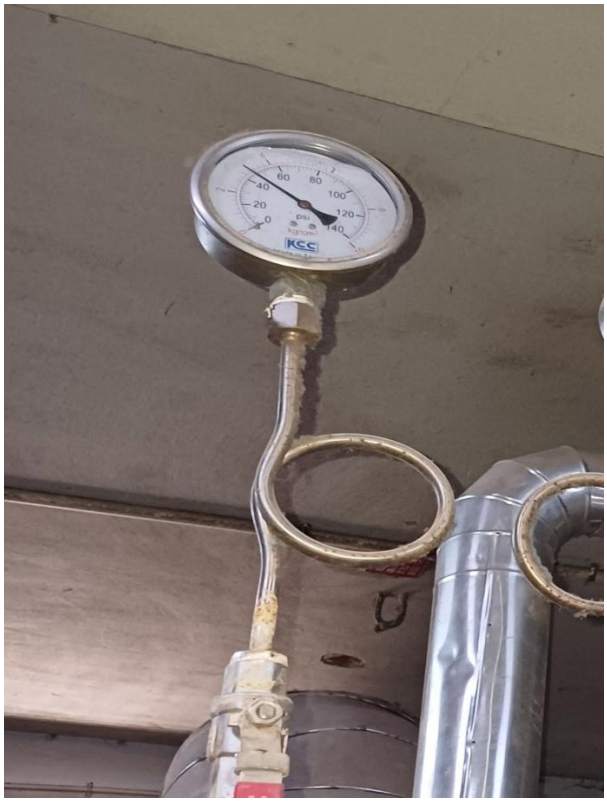
FINDING NO:	B-76
CATEGORY:	Monitoring and Control System
BOILER REGISTRATION NO:	BB 14856
FINDING: The steam pressure gauge range was insufficient.	
RECOMMENDATION: The boiler pressure gauge range should be at least twice the boiler's maximum allowable working pressure mentioned in the boiler license or in accordance with any recognized international standard.	
PRIORITY:	P2
REMEDIATION TIME FRAME:	1 MONTH

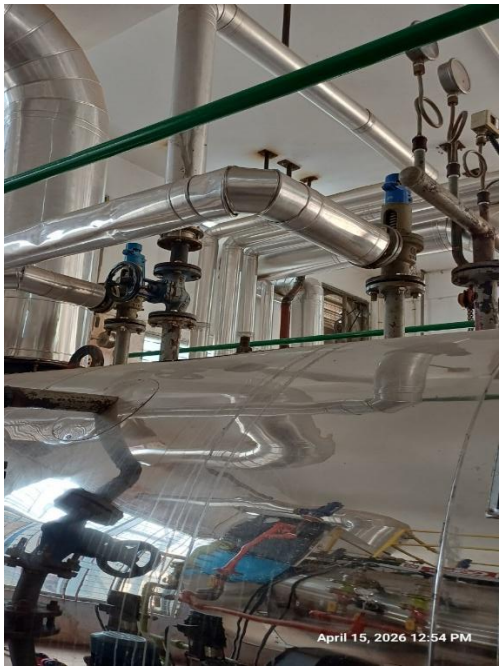
FINDING NO:	B-80
CATEGORY:	Safety Valve
BOILER REGISTRATION NO:	BB 14856
FINDING: Drainage arrangement was not installed or installed in an inadequate manner for one or more safety valves.	
RECOMMENDATION: Drainage arrangement must be installed for all safety valves as per manufacturer published guideline or at the lowest point of outlet line.	
PRIORITY:	P3
REMEDIATION TIME FRAME:	2 MONTHS

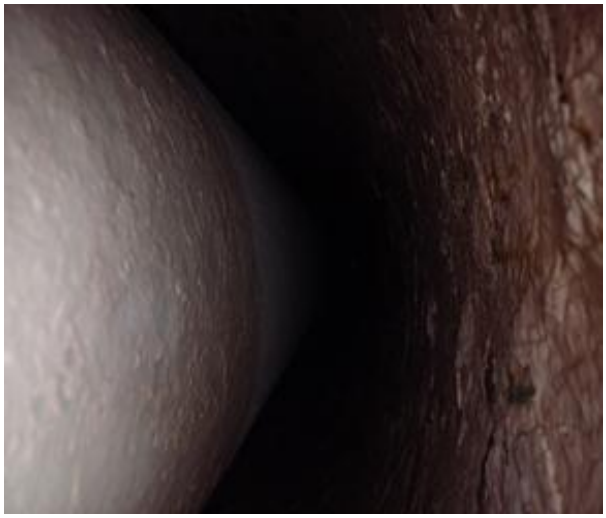
FINDING NO:	B-95
CATEGORY:	Scales and Deposits
BOILER REGISTRATION NO:	BB 7448
FINDING: Salt and scale formation was observed on the waterside of the boiler.	
RECOMMENDATION: Cleaning is required. A water treatment station is to be used. Feed and boiler water quality and conditioning should be verified and monitored. The boiler operator should operate the boiler with proper blowdown.	
PRIORITY:	P2
REMEDIATION TIME FRAME:	1 MONTH

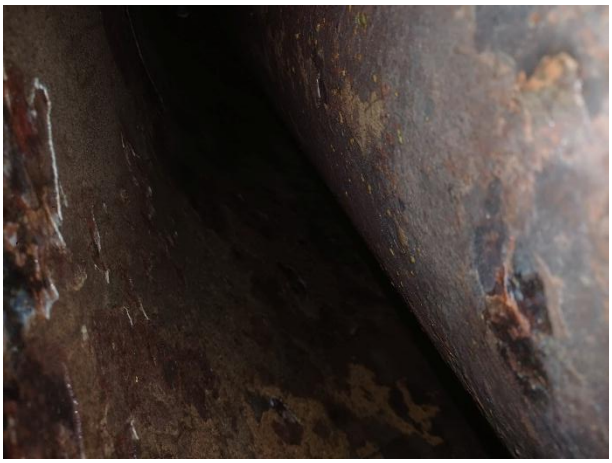
FINDING NO:	B-99
CATEGORY:	Scales and Deposits
BOILER REGISTRATION NO:	BB 6336
FINDING: Salt and scale formation was observed on the waterside of the boiler.	
RECOMMENDATION: Cleaning is required. A water treatment station is to be used. Feed and boiler water quality and conditioning should be verified and monitored. The boiler operator should operate the boiler with proper blowdown.	
PRIORITY:	P2
REMEDIATION TIME FRAME:	1 MONTH

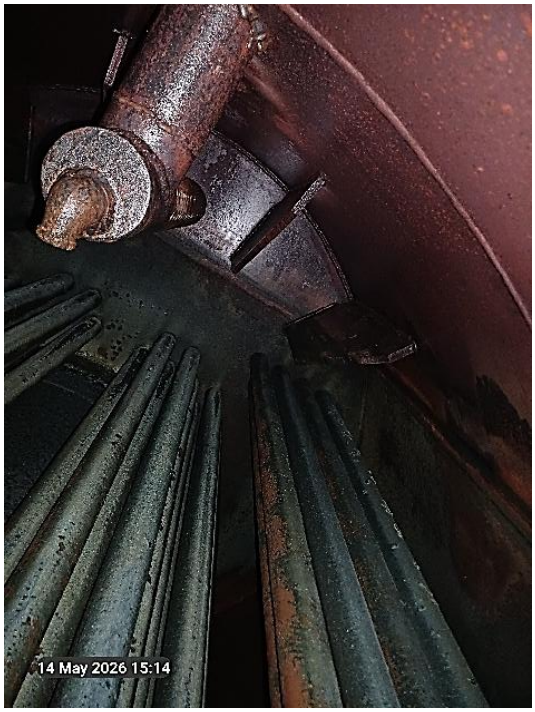
FINDING NO:	B-100
CATEGORY:	Scales and Deposits
BOILER REGISTRATION NO:	BB 15346
FINDING: Salt and scale formation was observed on the water side of the boiler (Furness tube, end plate, and the bottom end plate). Nature of scale is thin (1 mm).	
RECOMMENDATION: Cleaning is required. A water treatment station is to be used. Feed and boiler water quality and conditioning should be verified and monitored. The boiler operator should operate the boiler with proper blowdown.	
PRIORITY:	P2
REMEDIATION TIME FRAME:	1 MONTH
