# Mega Washing & Dyeing Ltd

BK Bari, Taltoli, Hotapara, Mirzapur, Gazipur

06<sup>th</sup> March, 2017

# Observations

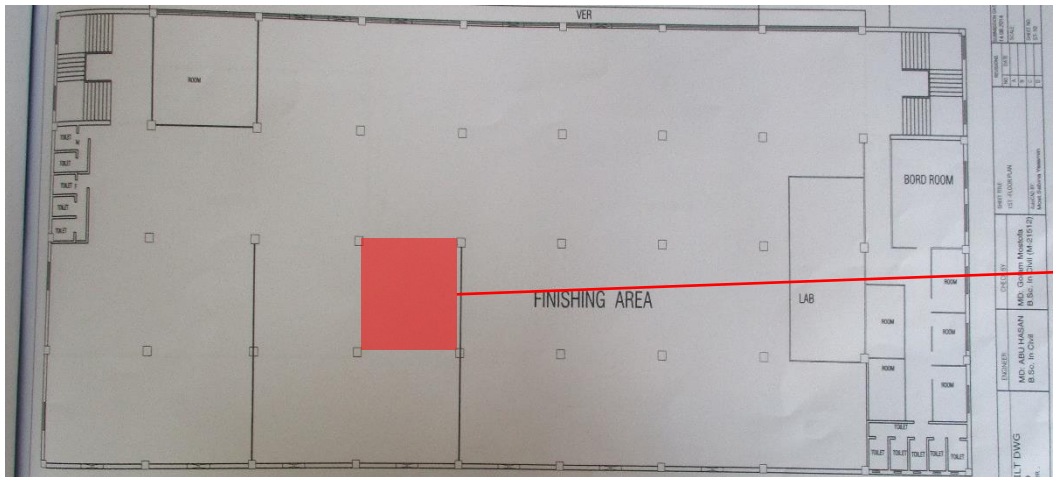
1<sup>st</sup> Floor layout plan.

Hairline cracking was observed on the soffit of 1<sup>st</sup> floor slab in several location. Building Engineer to investigate extend of crack and suggest remedial actions as required.

| Item No. | Observation | Recommended Action Plan | Recommended Timeline |
|---|---|---|---|
| 1 | Production Building<br>Hairline cracking on 1st floor slab soffit | Building Engineer to monitor cracks at slab soffit. | 6-weeks |
| 2 | Production Building<br>Hairline cracking on 1st floor slab soffit | Building Engineer to investigate the extend of crack, if cracks are only in the plaster. | 6-weeks |
| 3 | Production Building<br>Hairline cracking on 1st floor slab soffit | Building Engineer to advise remedial actions(if required). | 6-months |

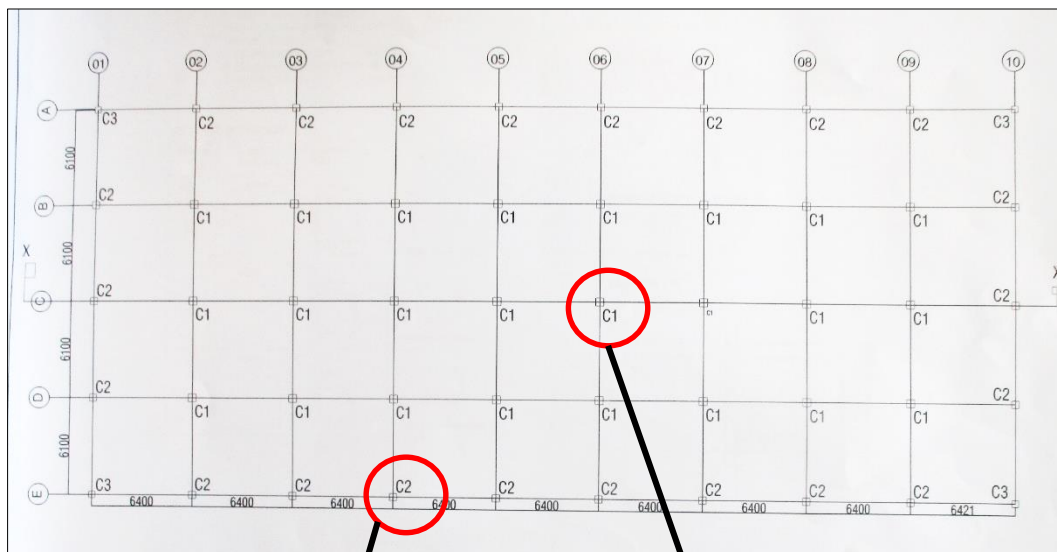
Column Layout

Dimensions of all columns were found 480mmX480mm with render on 1<sup>st</sup> floor where column schedule indicates that the dimensions of C1 type column should be 500mm x 500mm and C2 type should be 450mmx 450mm

| Item No. | Observation | Recommended Action Plan | Recommended Timeline |
|---|---|---|---|
| 7 | Production Building:<br>Discrepancy between as built drawing and site observation | Building engineer to survey the whole shed and produce as-built documentation reflecting the as constructed condition. | 6-weeks |

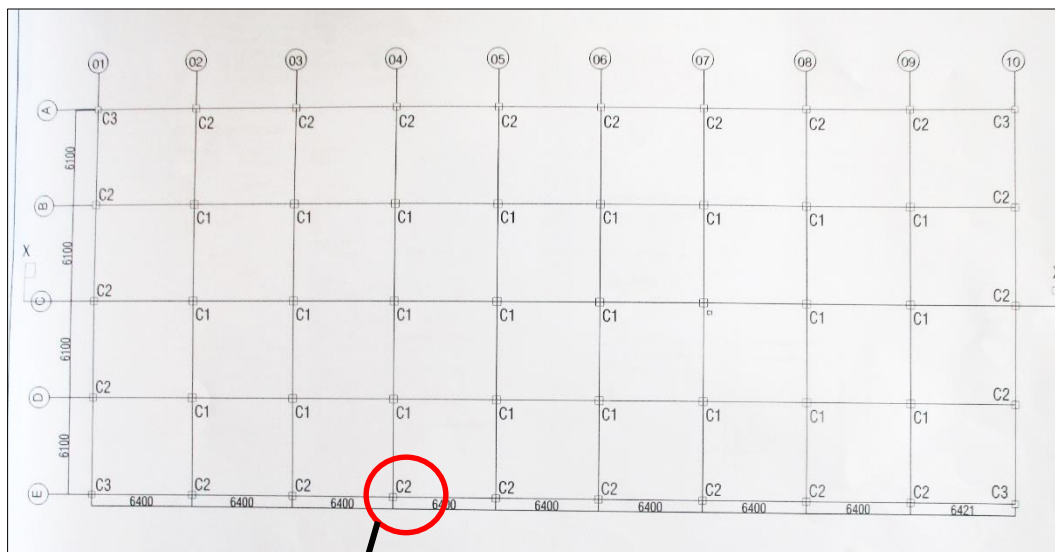
Column Layout

3 nos. bar was found on each side with ferro scanning.

From the column schedule of as-built structural drawing C2 type column has 4no's rebar at each side. But from ferro scanning Image it was confirmed that there is 3 no's of rebar in each side of this type of column.
