# Lintas Bangladesh Co. Ltd

Adamjee EPZ, Siddhirganj  
(23.677561, 90.525548)  
27<sup>th</sup> April, 2017

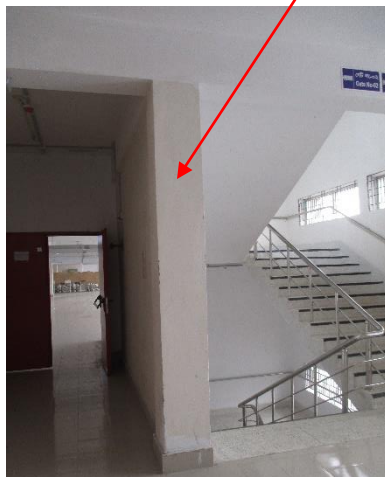
Additional Column

**Foundation system of additional columns are required to verify**

Additional columns have observed in highlighted area. No foundation system is shown on drawings for those additional columns. So the load path and foundation system of the columns are required to investigate by factory engineer.

| Item No. | Observation | Recommended Action Plan | Recommended Timeline |
|---|---|---|---|
| 1 | Foundation system of additional columns are required to verify | Building Engineer is required to investigate the foundation system of the additional columns. Also load path of the additional columns are required to verify. | 6-weeks |
| 2 | Foundation system of additional columns are required to verify | Update the drawings considering additional columns. | 6-weeks |
