# Dekko Knitwear Ltd

Plot # I/5, I/7, I/9, I/11 and I/13, Road # 6, Section-7, Mirpur, Dhaka  
(23.819708, 90.364331)  
16<sup>th</sup> May, 2017

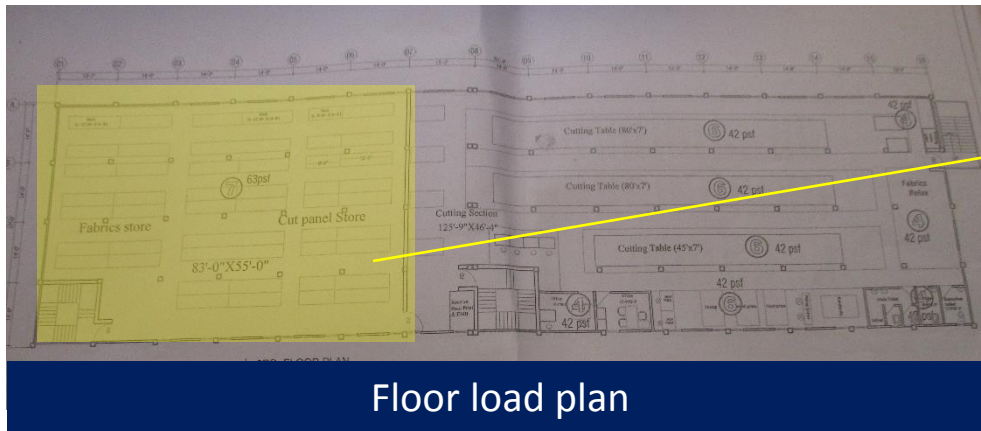
Floor load plan

Live load plan of 3kpa(63psf)  
not maintain properly

No load management programs were visible except post of load plan. Factory is required to implement load management program as per its floor loading capacity and Follow the load plans for all floors of the buildings and make sure that the workers understand the loading requirements.
