Comptex Bangladesh Ltd

Robintex (BD) Ltd

Vulta, Rupganj, Narayangonj, Bangladesh
(+23.772621N, 90.560453E)
17 May 2014

Observations

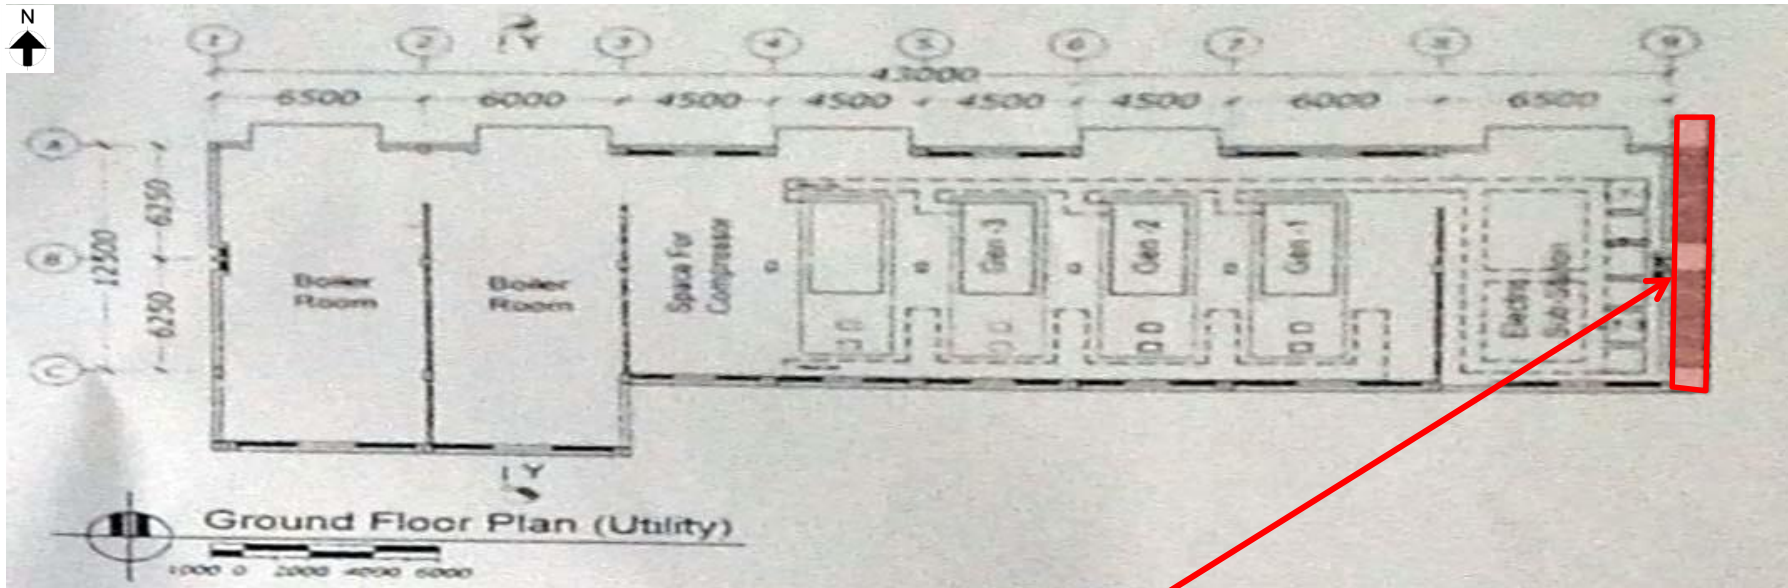
Defective Handrail to stairs

Defective handrail to a steep stairs, danger to people using it. Handrail and fixing to concrete to be reviewed by Building Engineer.
