# TM Textiles & Garments Ltd.

Kashor, Hobibari, Bhaluka, Mymensing  
(24.298229 N, 90.366558E)

25 May 2014

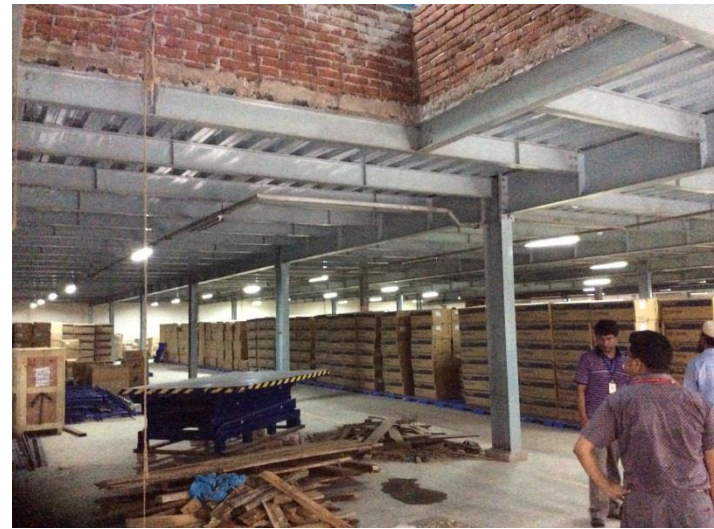
# Storage Loading on the new mezzanine in the Knitting Building

The majority of the mezzanine level in the knitting building was used for storage area, with the remaining area either used as walkways or unused on the day of inspection

Item No.	Observation	Recommended Action Plan	Recommended Timeline
7	Storage Loading on the new mezzanine in the Knitting Building	The capacity of the mezzanine structure is to be assessed by the Building Engineer to confirm that the mezzanine structure is designed to carry the loading from the storage noted.	6-months
8	Storage Loading on the new mezzanine in the Knitting Building	Produce and actively manage a loading plan for all elevated floor plates for all buildings within the factory complex giving consideration to floor capacity and column capacity.	6-months
9	Water Tank loading on the roof of Medical and Day Care Building	The capacity of the roof structure is to be assessed by the Building Engineer to confirm that the roof structure is designed to carry the loading from the water tanks noted.	6-months
10	Water Tank loading on the roof of Medical and Day Care Building	Produce and actively manage a loading plan for all elevated floor plates for all buildings within the factory complex giving consideration to floor capacity and column capacity.	6-months
