# New Age Garments Ltd New Age Apparels Ltd Kei Lock Garments Ltd

Nishchintopur, Asulia, Savar, Dhaka  
(23.924895, 90.308234)  
9<sup>th</sup> April 2014

# Executive Summary (continued)

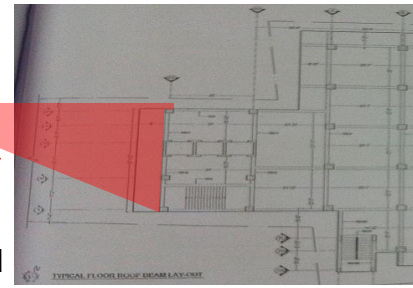
Undocumented  
Horizontal  
Extension

Lack of relevant structural design or documentation (Building 3)

- Carry out all recommendations from the engineering assessment.
- Undertake strengthening as required.
- Finalise appropriate structural as-built drawings incorporating any strengthening works to the structural frame.
