Haesong Korea Ltd.

Han Complex, Bara Rangamatia, Zirabo, Savar, Dhaka, Bangladesh
(23.909859, 90.303641)
10th June, 2014

Observations

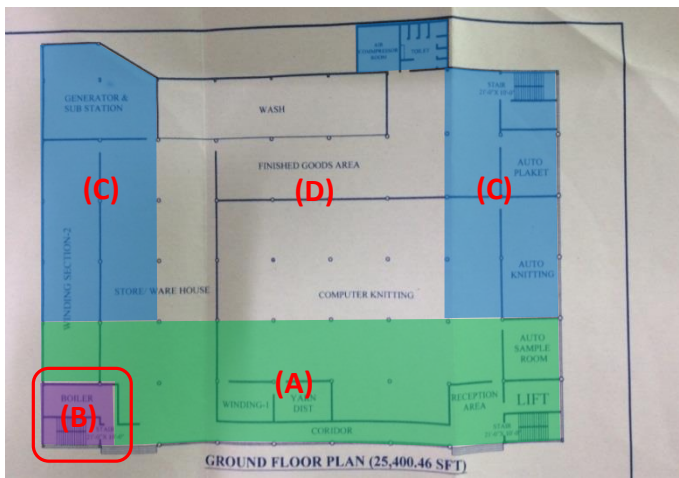
Indicative Roof Plan

RC Tank over North East Stair Core

- Cursory calculations indicate that weight of roof-top concrete tank and its contents contribute significantly to the potential overloading of supporting columns, assuming typical concrete strength

Weight of Tank over North-East Stair Core

Item No.	Observation	Recommended Action Plan	Recommended Timeline
1	High concrete stress in some columns	Empty roof level water tank	Immediate - Now
2	High concrete stress in some columns	The imposed load in all areas on all levels must not exceed 1.5 kN/m ²	Immediate - Now
3	High concrete stress in some columns	Qualified Structural Engineer to review design, loads and stresses in all columns as part of a Detailed Engineering Assessment (DEA) (see scope below).	Immediate - Now
4	High concrete stress in some columns	Verify in-situ concrete strength by testing 100mm diameter cores taken from 4 no. columns (minimum). Qualified Structural Engineer to determine safe locations for coring. Prior to coring, the floor beams supported by the column should be propped through all levels to ground floor. The column reinforcement should be exposed to ensure that it will not be damaged during coring. Following coring, the column should be repaired using suitable repair mortar before de-propping the floor beams.	Immediate - Now

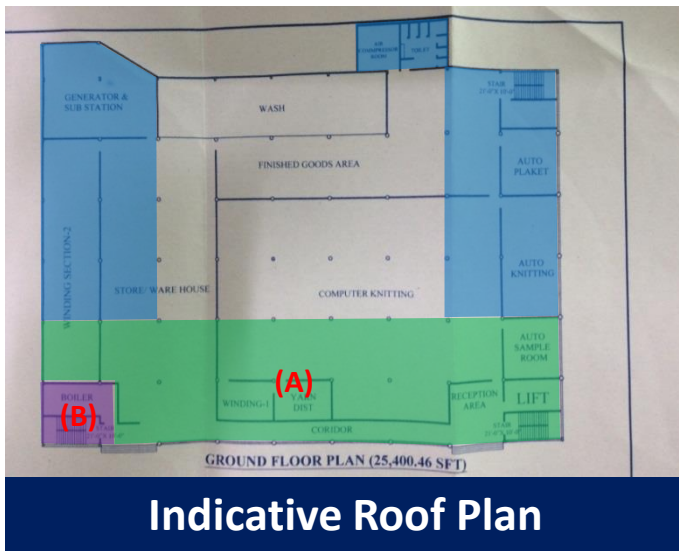
Indicative Roof Plan

- Permit drawings show a 5 storey building and Slab & Beam construction to Roof Slab, similar to typical floor slabs, and no water tank.
- As constructed:
 - Roof slab (A) has not yet been constructed over full building footprint
 - Flat Slab has been used in lieu of Slab & Beam construction to roof slab (A)
 - North-east stair core lid (B) is higher than roof slab (A)
 - Steel roof frames have been installed to dining and prayer rooms (C)
 - Area of the Fourth Floor Slab is acting as a roof to the Third Floor (D)
 - Two additional columns constructed at 4th Floor to support Flat Slab roof edges near raised stair core lid. These columns bear on 4th Floor beams.

Building permit drawings do not match as-built building details

Item No.	Observation	Recommended Action Plan	Recommended Timeline
10	Building permit drawings do not match as-built building details: * North-East Stair Core Lid and Concrete Roof * Metal roof frames to Dining and Prayer Rooms * Childcare and Residence Building	Building engineer to check, collect information and produce accurate and complete as-built documentation as part of the Detailed engineering Assessment (refer to item 1 above).	6-weeks
11	Building permit drawings do not match as-built building details: * North-East Stair Core Lid and Concrete Roof * Metal roof frames to Dining and Prayer Rooms * Childcare and Residence Building	Building Engineer to review as-built structure and if required, prescribe relevant structural improvements to ensure these meets BNBC requirements for stability, strength and serviceability under all gravity and lateral loads	6-weeks
12	Building permit drawings do not match as-built building details: * North-East Stair Core Lid and Concrete Roof * Metal roof frames to Dining and Prayer Rooms * Childcare and Residence Building	Building Engineer to develop accurate and complete as-built structural drawings	6-months

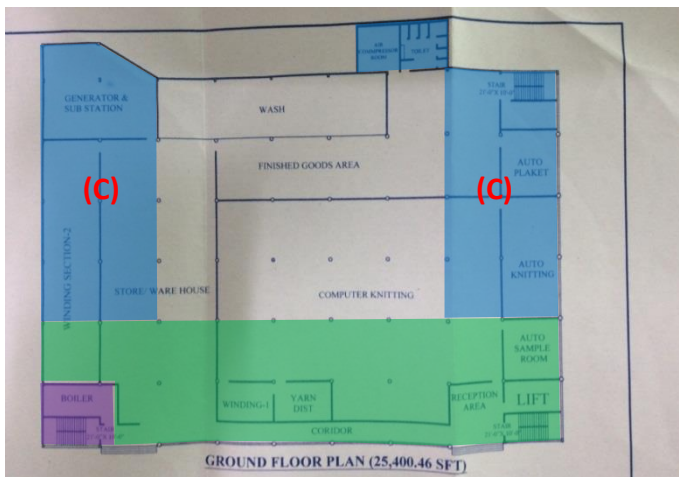
Indicative Roof Plan

- Minor differential movement observed to short infill walls between main roof slab (A) and stair core lid (B)
- No moment continuity exists between the two roof surfaces
- Two columns constructed to support main roof slab bear on Fourth Floor beams
- Minor flexural cracking observed to main roof slab (A) approximately between additional columns

Building permit drawings do not match as-built building details

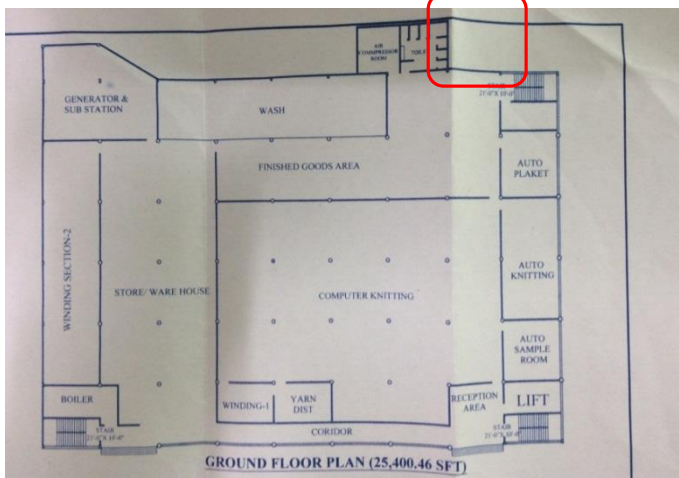
Permit Drawing Floor Plan

- Light metal roof frames have been installed over columns and walls to prayer and dining areas
- Lateral stability and tie down details do not appear to be engineer-designed

Building permit drawings do not match as-built building details
