Parkscene Bangladesh Ltd

Mouza Kunia . JL No,. 406, Gazipur Sadar. Gazipur

(23.934767N, 90.387349E)
20th April 2014

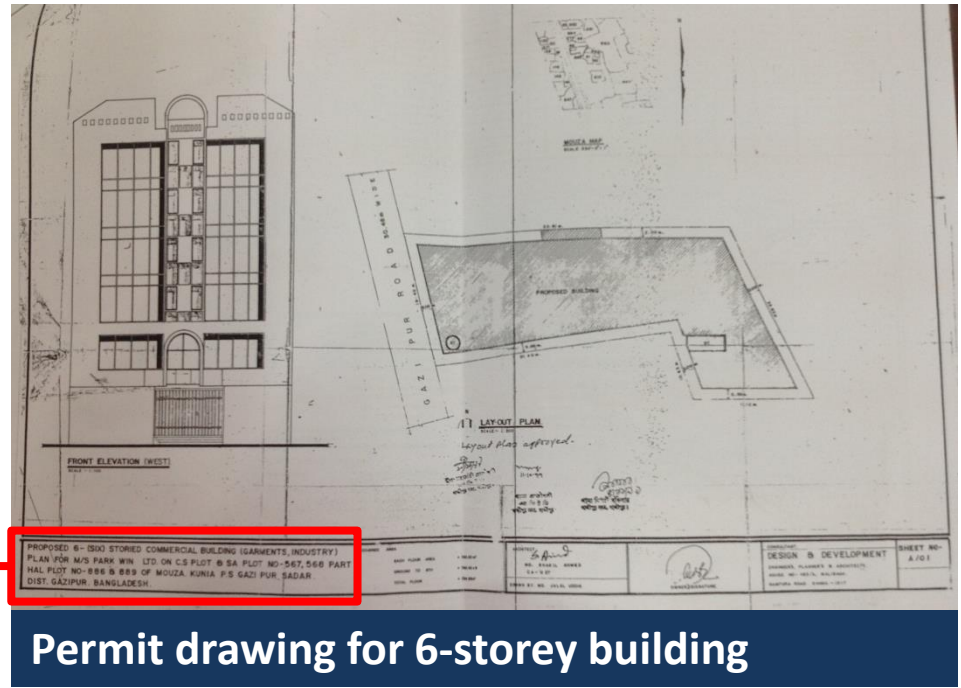
Non-Permitted Additional Storey

A shed roof has been erected over the former R.C. roof to create a usable floor space at the roof level (6th Floor), so the building now has seven (7) occupied storeys. The Building Permit is for a 6-storey building. The 6th Floor is currently being used for sewing and prayer, and it has also been used for dining.

PROPOSED 6- (SIX) STORIED COMMERCIAL BUILDING (GARMENTS, INDUSTRY)
PLAN FOR M/S PARK WIN LTD. ON C.S PLOT & SA PLOT NO-567, 568 PART
HAL PLOT NO-886 & 889 OF MOUZA. KUNIA P.S GAZI PUR, SADAR.
DIST. GAZIPUR, BANGLADESH.

Item No.	Observation	Recommended Action Plan	Recommended Timeline
10	Heavy loading due to build up of material in toilets	As part of the DEA (see Item1)Engineer to carry out calculations to justify floor slab in the area of the toilets. Large build up of load noted as a result of raised floor	Immediate - Now
11	Heavy loading due to build up of material in toilets	Complete assessment	6-weeks
12	Heavy loading due to build up of material in toilets	Carry out alterations as a result of the engineering study	6-months
13	Non – permitted additional storey and associated non engineered structure	As-built documents to be completed as part of DEA	6-weeks
14	Non – permitted additional storey and associated non engineered structure	Engineer inspect and design and detail remedial works	6-weeks
15	Non – permitted additional storey and associated non engineered structure	Carry out remedial works as required	6-months
