# D. S. Fashion Ltd.

Mamun Nagar, Bara Vabanipur, Kasimpur, Gazipur  
(23.81179, 90.25374)

10<sup>th</sup> May 2014

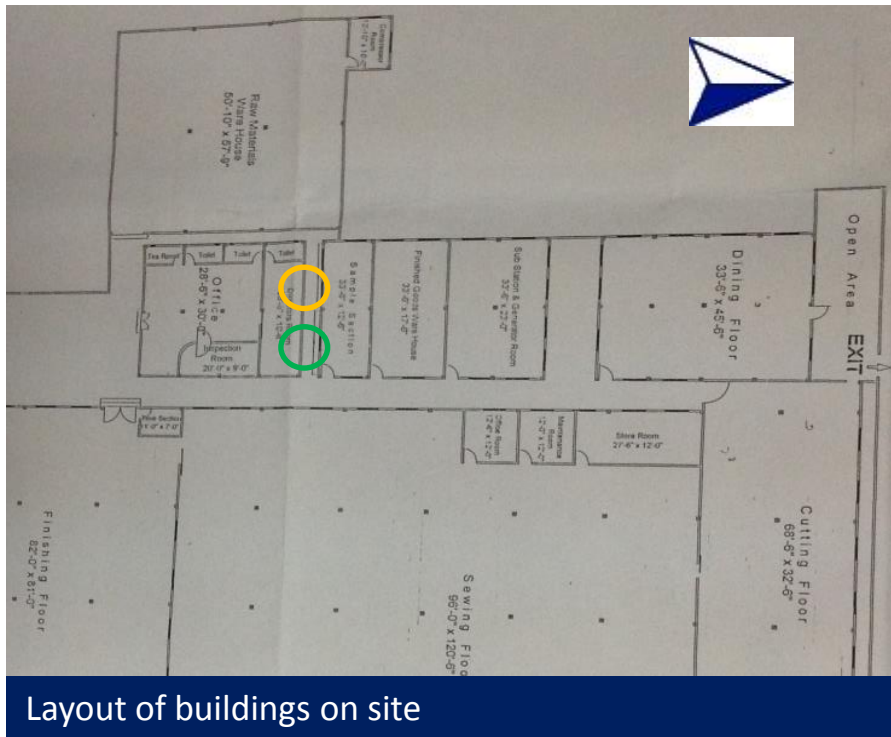
Layout of buildings on site

- Support structures for two 2000-litre water tanks were observed on the eastern side of the site, between the Office and the Sample Room.
- The support structure to one tank is concrete framed.
- The other tank is supported by a non-engineered steel frame. This tank is to be emptied to reduce the load until such time as the steel-framed structure is strengthened or replaced as advised by the Building Engineer.

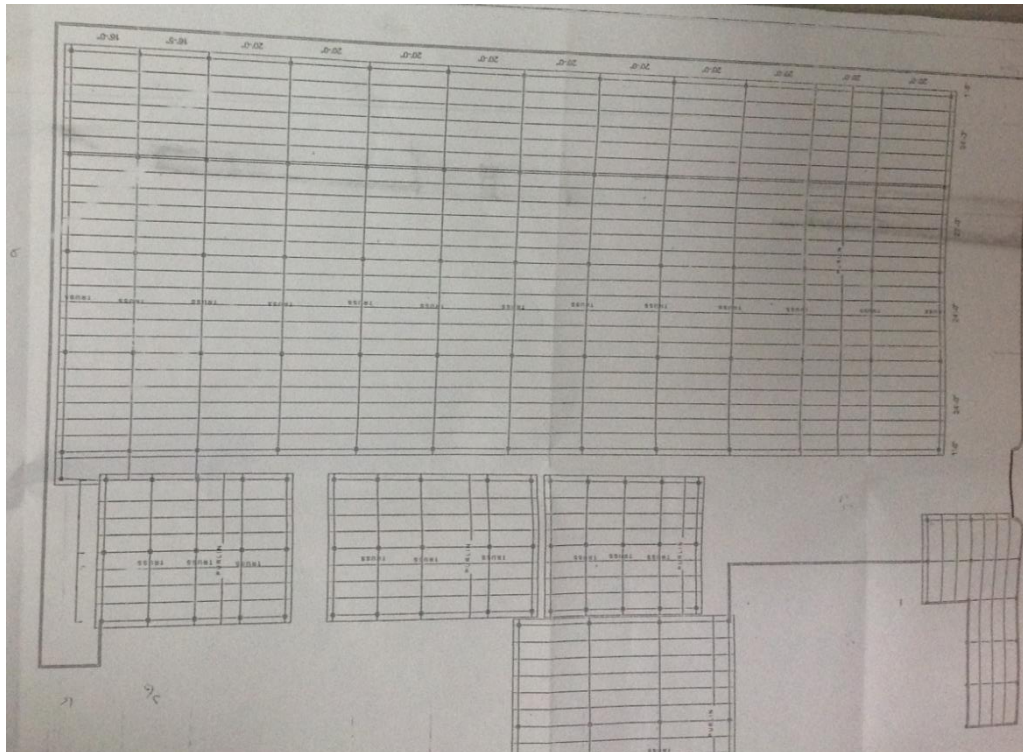
Layout of roof framing for all buildings on site

- The lateral stability system to the all buildings on the site is unclear – no vertical or horizontal bracing has been provided.
- Provision for lateral stability is not highlighted in the as-built drawings.
- It is likely that the reinforced columns currently provide lateral stability through cantilever action.
- Building Engineer to carry out a lateral stability analysis of the buildings to review the design of the cantilevered columns, to assess if they can adequately resist the horizontal loads imposed
- If necessary, provide details of remedial works for the provision of vertical and horizontal bracing.

| Item No. | Observation | Recommended Action Plan | Recommended Timeline |
|---|---|---|---|
| 5 | Lateral stability system unclear | Building Engineer to provide guidance on the requirement for horizontal bracing in the plane of the roof, so that the horizontal wind loads can be transferred to foundation level. | 6-weeks |
