# A-One Polar Ltd

Bhulta, Rupgonj, Narayangonj.  
(23.754782, 90545710)  
27th April 2014

# Observations

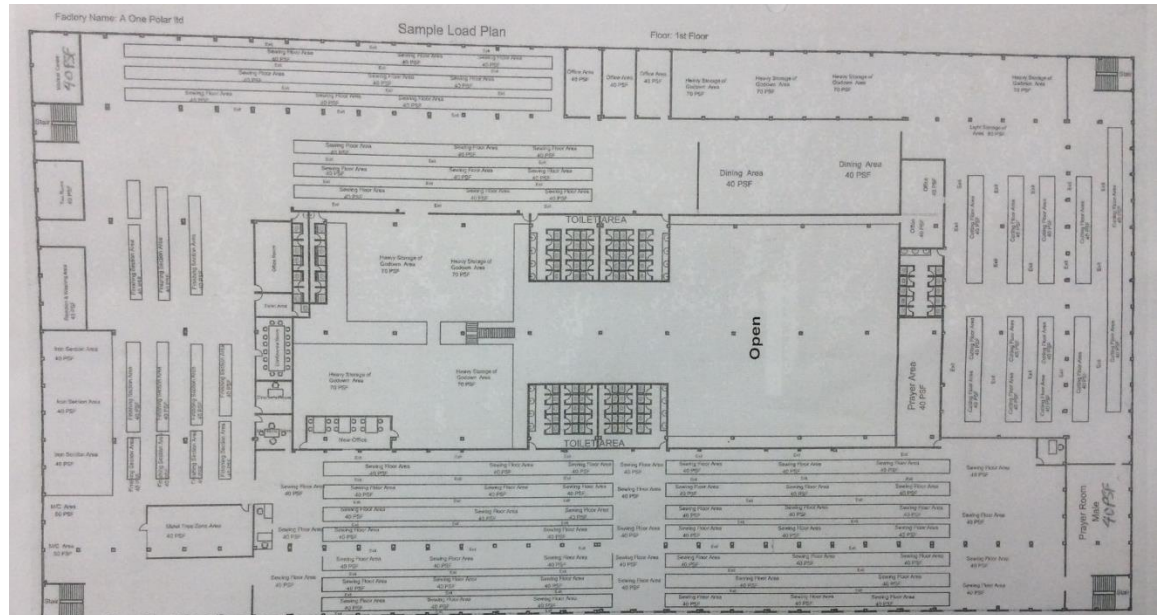
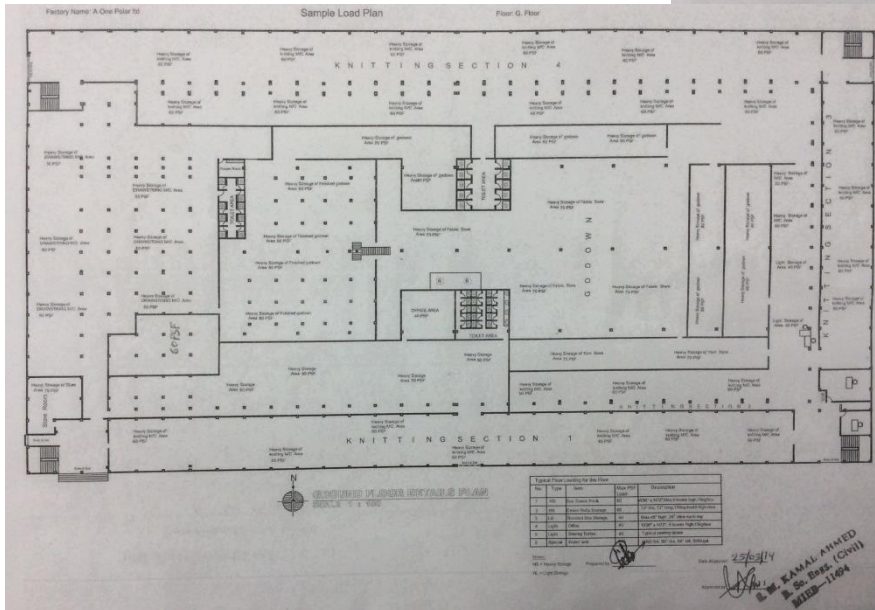
1st floor

**Heavy loadings on 1<sup>st</sup> floor slab**

**Storage ± 3 kN/m<sup>2</sup>**

Loading plan provided dated 25-03-14

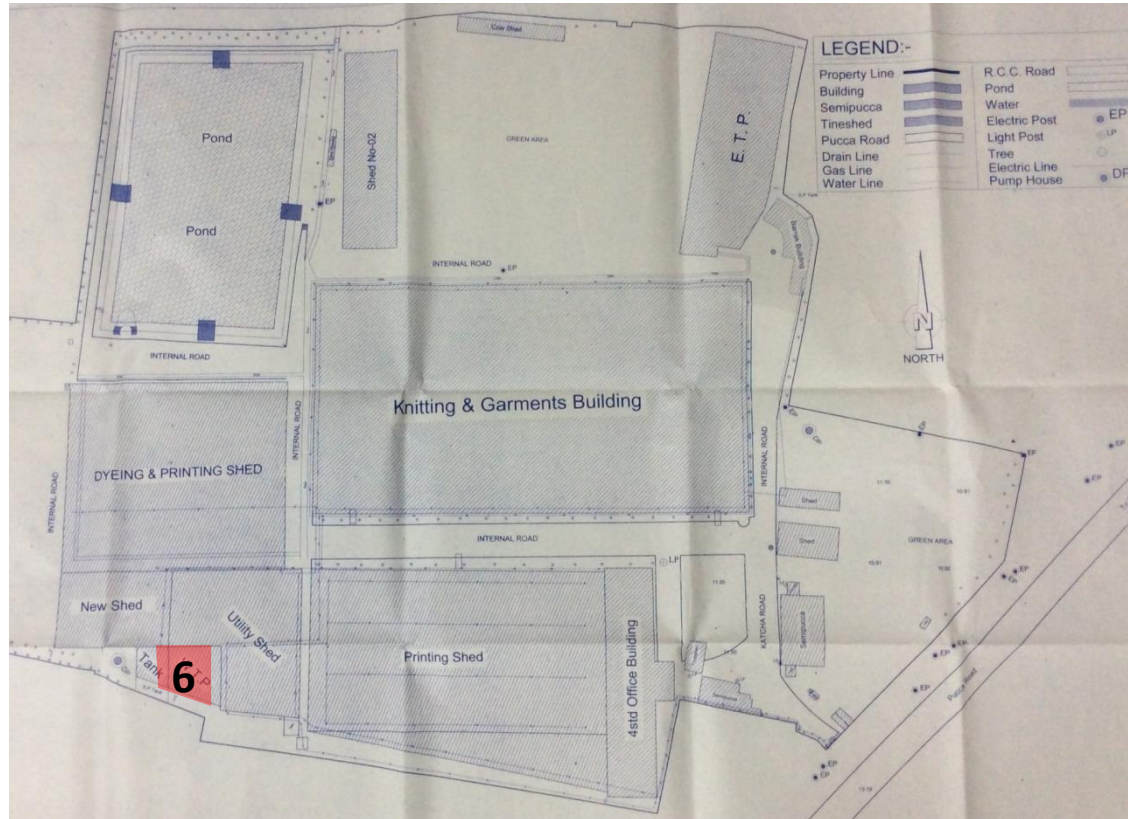
# Observations WTP Building Building 6

We were informed that as-constructed columns were made larger (collar of concrete cast around original columns) with addition corbels to facilitate higher floor loading. This was to enhance the capacity of the original cast beams and columns.

No permit drawing

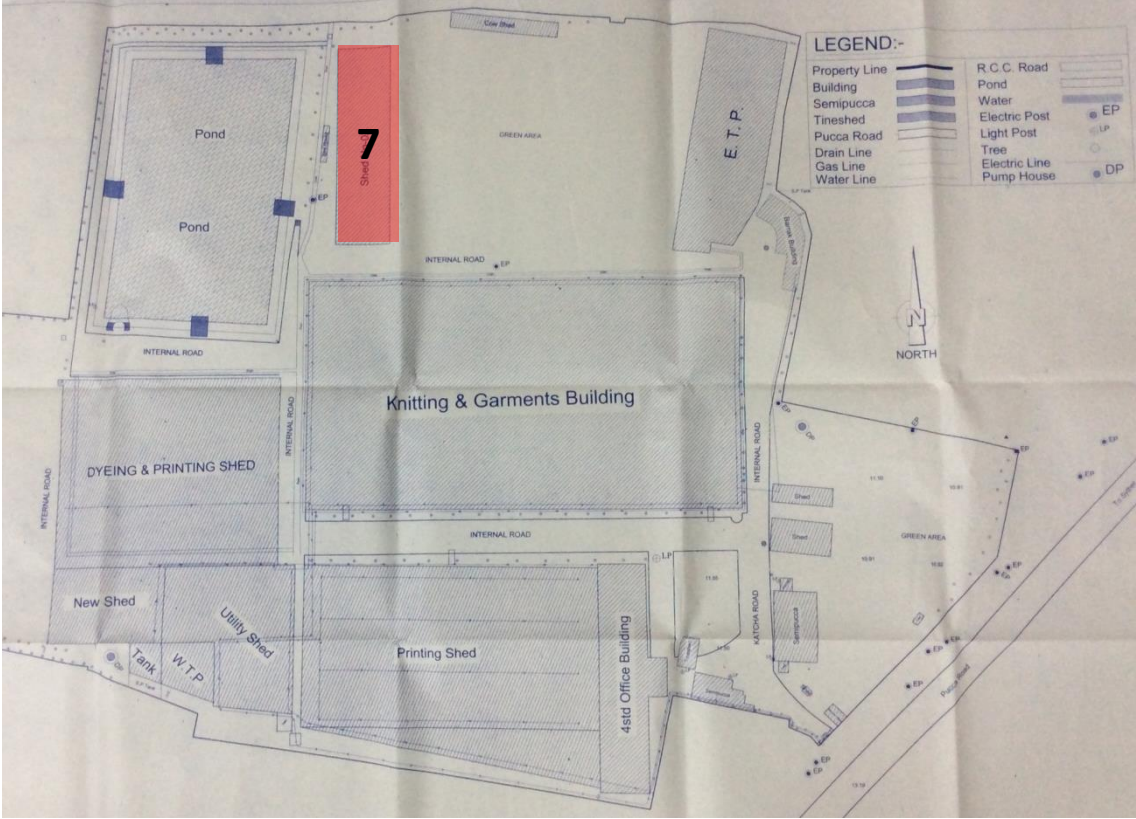
# Observations Canteen Building 7

# Roof structure: no roof bracing

**Stability: No roof bracing observed  
Structure relies on roof deck for  
transferring horizontal loads to  
façade walls.**
