# **GH Haewae Co. Ltd.**

Sector-8, Plot-19-24, CEPZ, Chittagong, Bangladesh  
(22.28172N 91.77527E)

22 APRIL 2014

# Observations Main Building 1

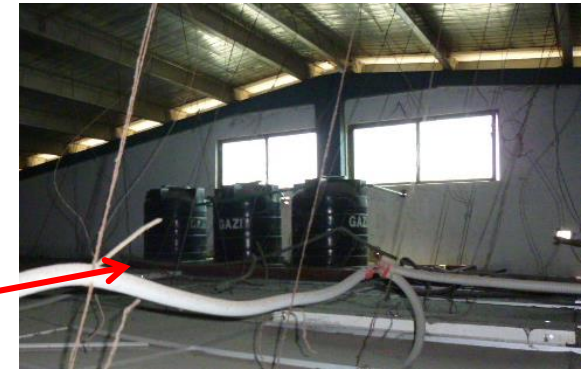
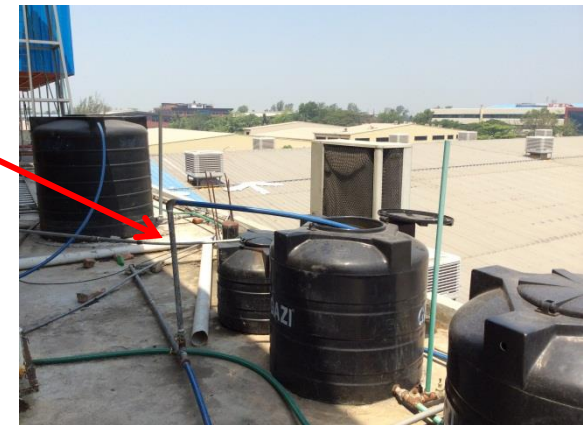
Water tanks on roofs

Damage on concrete water tank  
and steel roof due to water leakage

| Item No. | Observation | Recommended Action Plan | Recommended Timeline |
|---|---|---|---|
| 9 | Damaged structural elements supporting the high-level RC water tank outside the sewing shed. | Building Engineer to assess the structure supporting the water tanks. | Immediate - Now |
| 10 | Damaged structural elements supporting the high-level RC water tank outside the sewing shed. | Carry out all structural repairs to the support structure arising from engineering assessment. | 6-weeks |
| 11 | Damaged structural elements supporting the high-level RC water tank outside the sewing shed. | Take measures to prevent any further damage to the support structure in the future. | 6-months |
