Geebee (Bangladesh) Ltd.

Plot # 74~77, sector # 02, KEPZ, North Patenga, Chittagong-4204.

10th June 2014

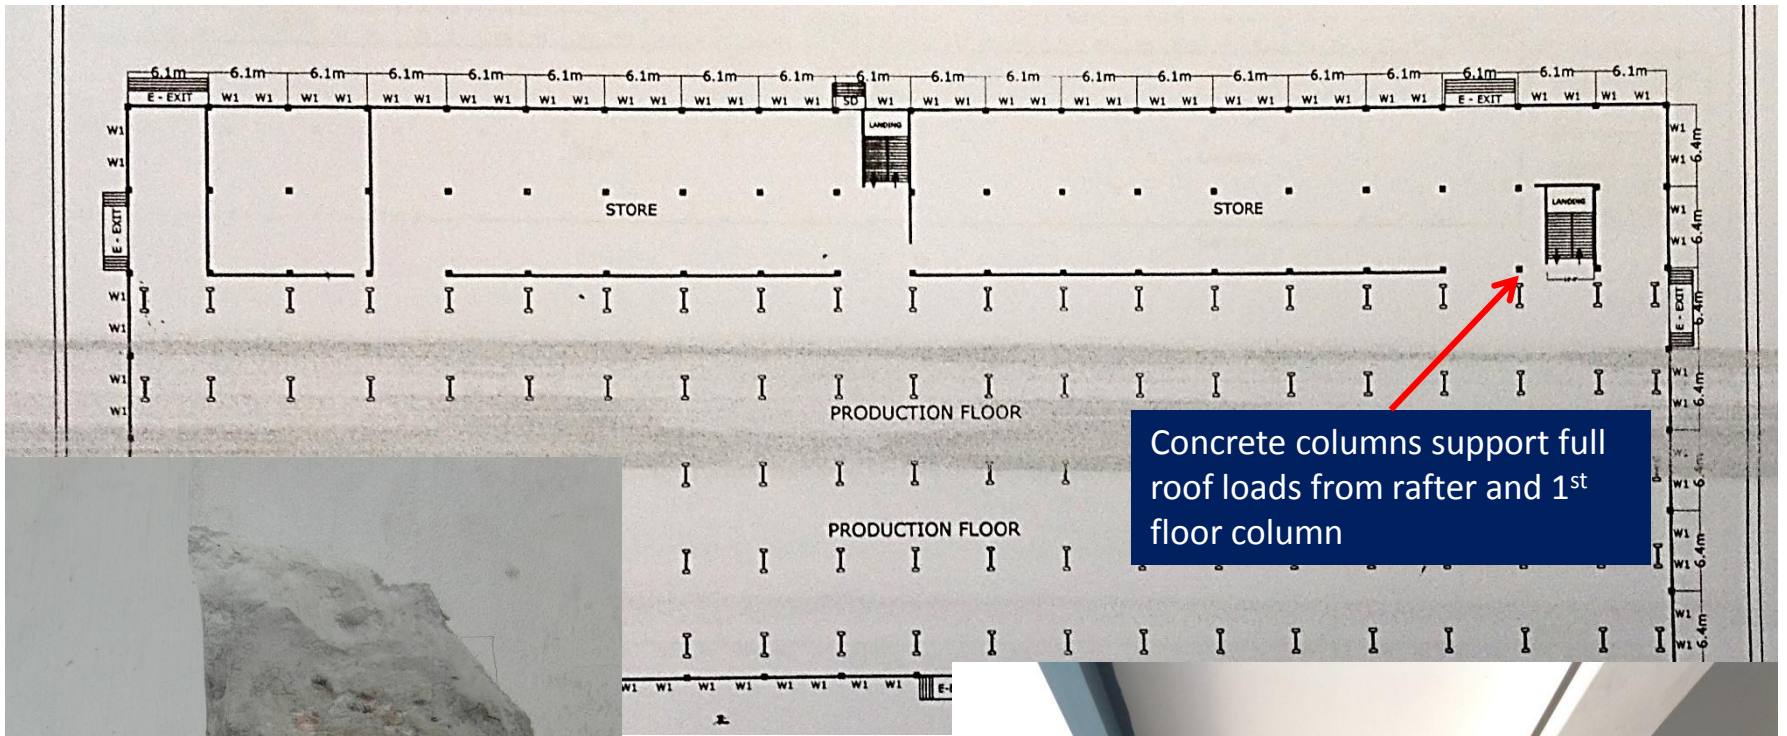
High column stresses

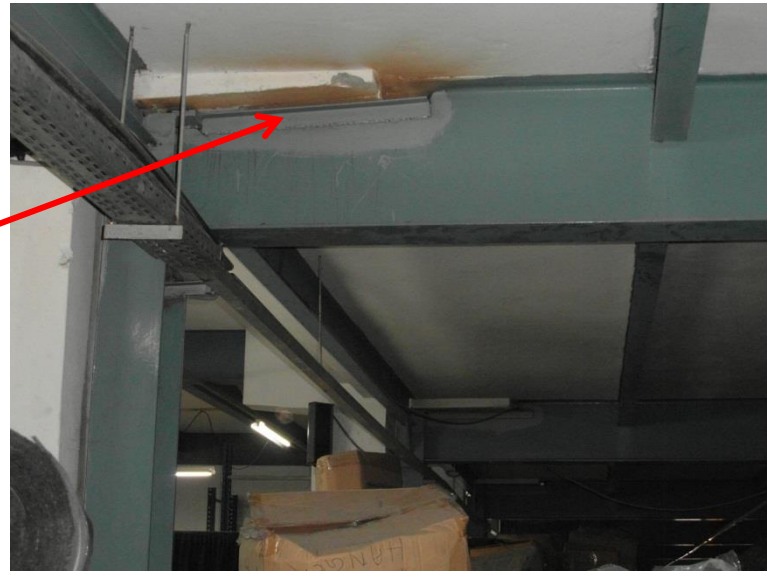
Top flange cut away and additional angle poorly welded with poor detailing – reduced flexural and shear capacity of beam

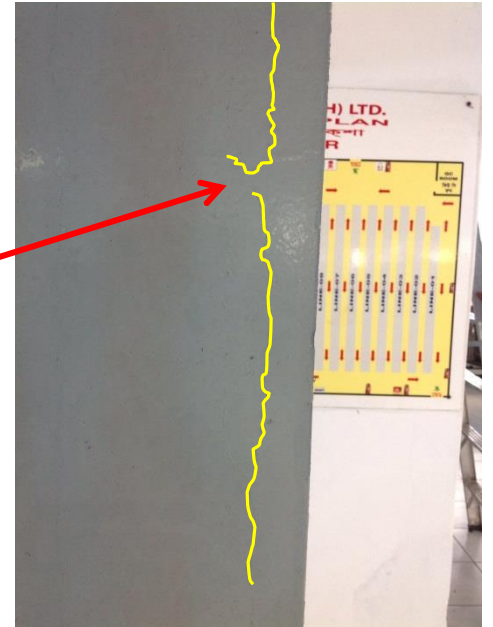
Cracks to paint and bowing of plates suggest flanges may have locally buckled slightly. L-sections were apparently welded on later to strengthen the column

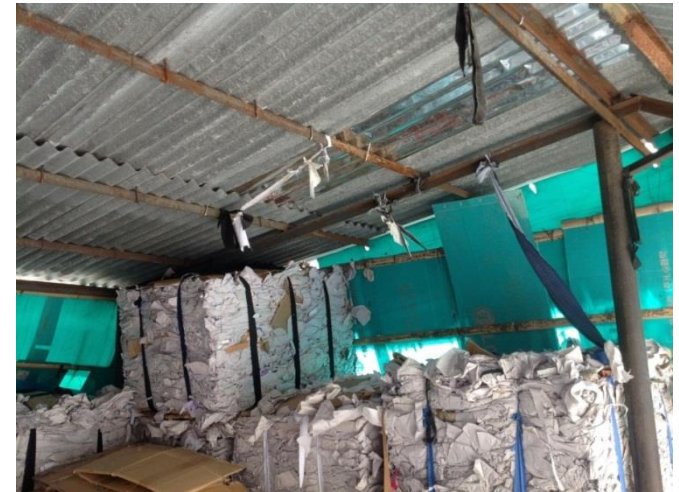
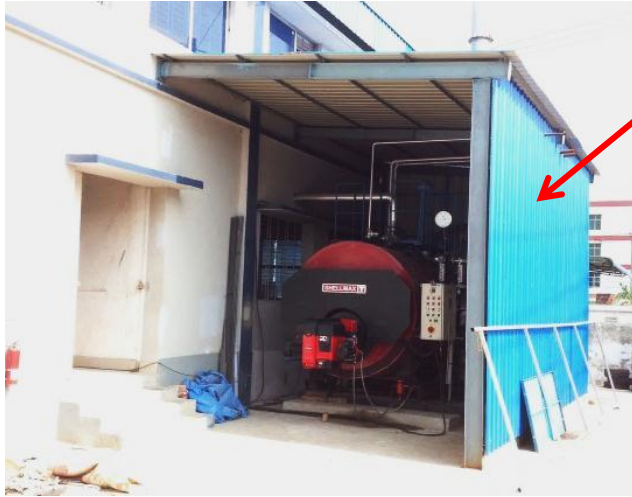
Generator room
outside the
building

Apparently non-engineered steel structure outside the building

Item No.	Observation	Recommended Action Plan	Recommended Timeline
8	Poor portal frame haunch detailing	Building Engineer to review portal frame design as built, including haunches, column sizes and weld quality	6-weeks
9	Poor portal frame haunch detailing	Provide remedial details as appropriate	6-weeks
10	Poor portal frame haunch detailing	Carry out remedial work as required	6-months
11	Poor steel detailing	Building Engineer to review steel detailing and weld quality	6-weeks
12	Poor steel detailing	Provide remedial details as appropriate.	6-weeks
13	Poor steel detailing	Carry out remedial work as required	6-months
14	Apparently non-engineered external structures	Building Engineer to review design of ancillary steel structures with regard to their capacity to support code vertical and wind loads	6-months
15	Apparently non-engineered external structures	Carry out remedial works as necessary, or replace structures	6-months

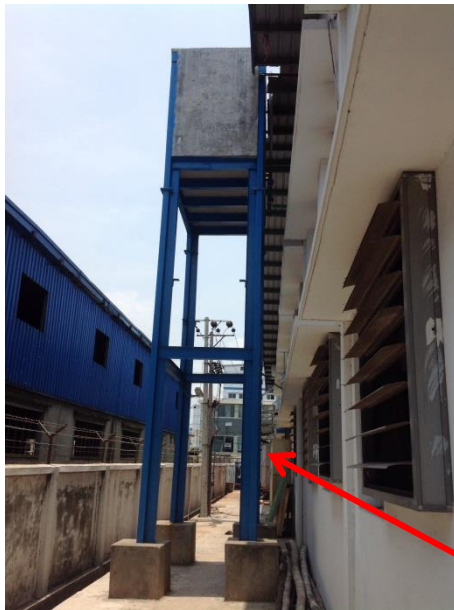
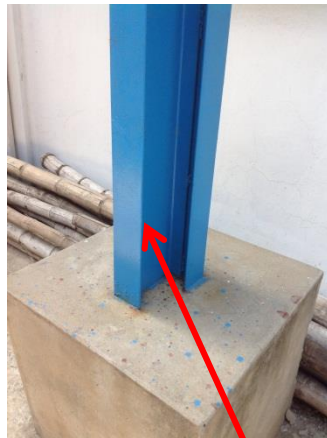
Support structure for concrete water tank (not connected to the building)

No information available for these apparently engineered structures

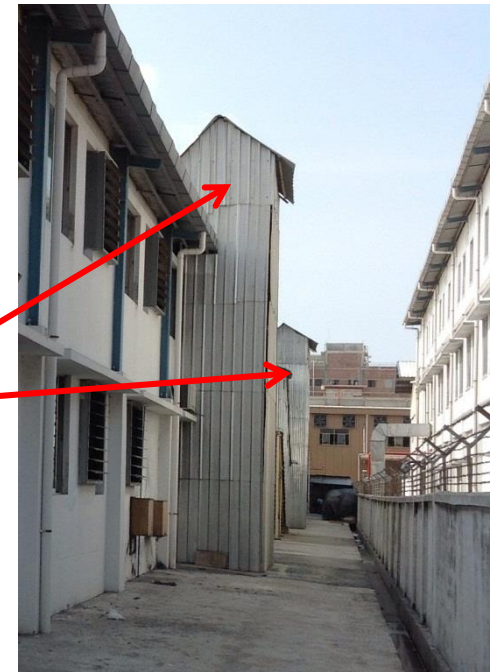
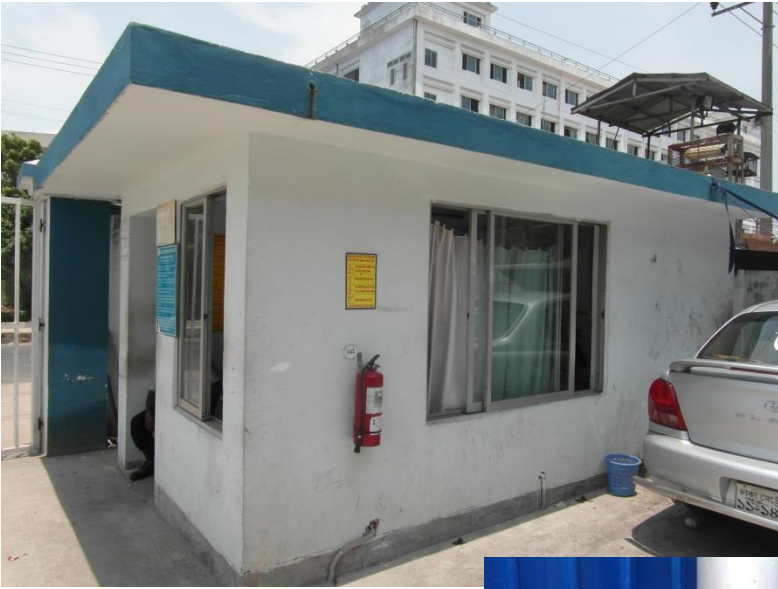
Elevator shafts

No information available for these apparently engineered structures
