# Integra Apparel (Bangladesh) Co., Ltd.(11376)

16.MARCH.2014

**ACCORD**  
on Fire and Building Safety in Bangladesh

## Site Observations

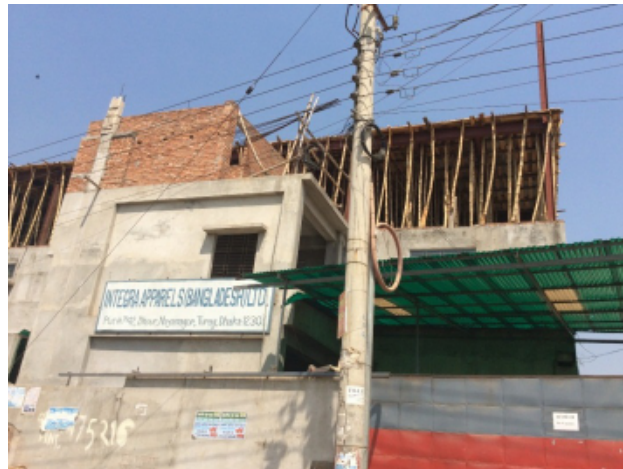
**Adequacy of column and foundation capacities are required to be investigated and confirmed.**

**Load rundown based on the 4 storey structural drawings** - at a key steel column, it is found that the steel column has a FOS between 1.25 and 1.50 which gives an AMBER rating.

**Load rundown based on the 6 storey architectural drawings** - at a key steel column, it is found that the steel column has a FOS lower than 1.00 which is RED rating.

**NOTE:** The structural drawings don't match with the architectural drawings. The adequacy of the columns and foundations must be investigated and confirmed.

- A Detailed Engineering Assessment of factory to be carried out and in particular column capacity and foundation aspects to be investigated in detail.
