# Unisense Apparels Ltd.

Beraider Chala, Sreepur, Gazipur  
(24.2000004, 90.420685)

15<sup>th</sup> May 2017

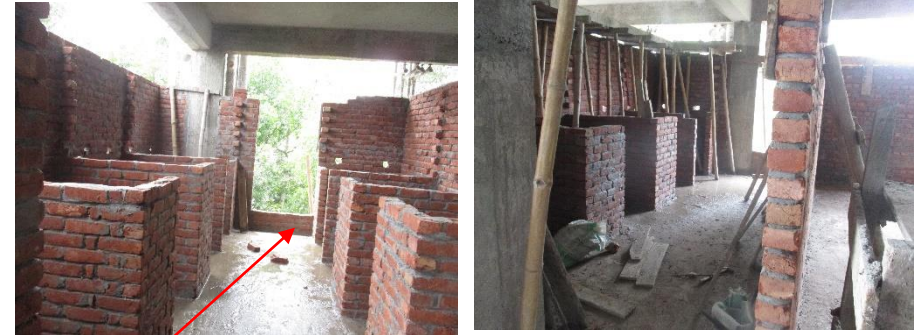
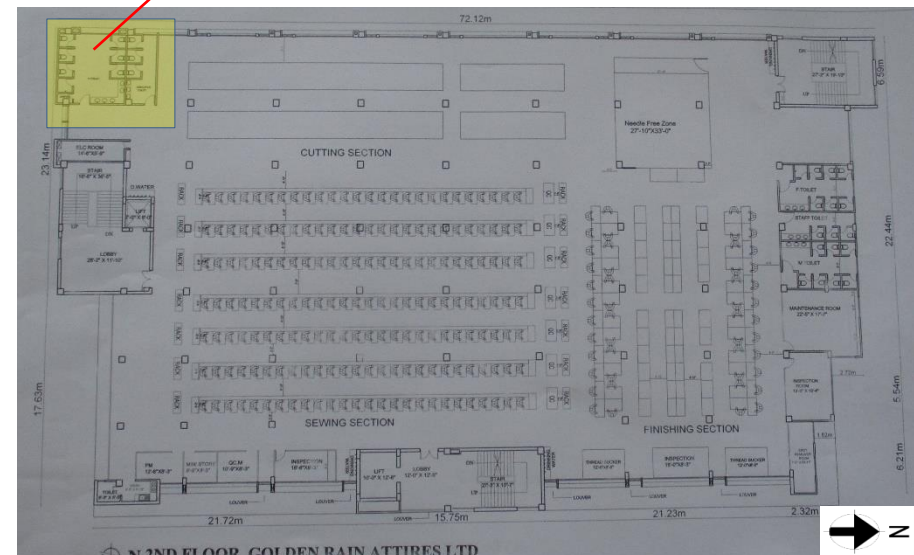
Floor Layout Plan

Minor mismatch in beam layout. Mismatch shown in red on beam layout.

Also some mismatch found in architectural drawings. Partition walls of toilet block at South-west corner does not match with layout plan.

| Item No. | Observation | Recommended Action Plan | Recommended Timeline |
|---|---|---|---|
| 1 | (Production Building)<br>Discrepancies between drawings and on site condition | Engage a qualified engineer for producing correct “as-built” drawings which reflect the actual site condition with complete structural and architectural information. | 6-weeks |

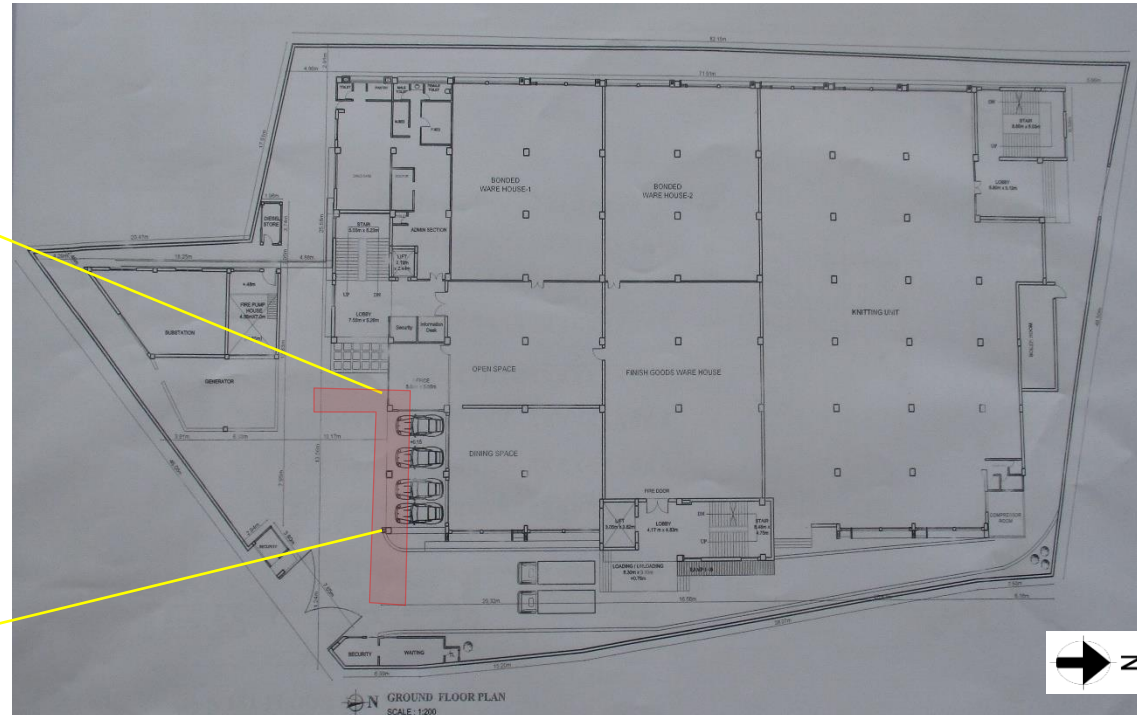
Ground floor Layout Plan

Impact protection not provided to columns at loading – unloading area. Columns are susceptible to impact loading from vehicles.
