Body Fashion (PVT) Ltd.

Naogor kadda, Konabari, Gazipur, Dhaka.
(23.991440N, 90.356099E)

15 June 2014

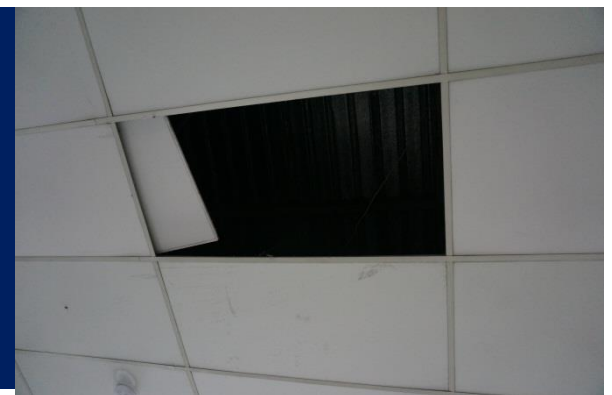
General note:
Limited access/visibility to steel roof structure. Load path and bracing system to be verified by building engineer.

Original structural plans differ from as-built condition

Beam supporting roof slab does not match the beam depth shown on the structural engineers drawings.

Item No.	Observation	Recommended Action Plan	Recommended Timeline
16	Undocumented and lightweight roof structure	As part of Detail Engineering Assessment, Building Engineer to provide detailed calculations for the lightweight steel roof structure. These should confirm its ability to withstand all wind loading pressure, suctions and uplift forces.	6-weeks
17	Undocumented and lightweight roof structure	Implement any remedial works arising from Detail Engineering Assessment.	6-months
18	Undocumented and lightweight roof structure	Provide accurate as-built drawings.	6-months
19	RC beam size constructed on roof does not match the section size shown on the original drawings	As part of Detail Engineering Assessment, Building Engineer to provide detailed calculations for the roof beam noted above.	6-weeks
20	RC beam size constructed on roof does not match the section size shown on the original drawings	Carry out remedial works / strengthening to beam as required.	6-months
