# Modiste (CEPZ) Ltd.

Plot 1-4, Sector #6, Export Processing Zone, Chittagong

22 June 2014

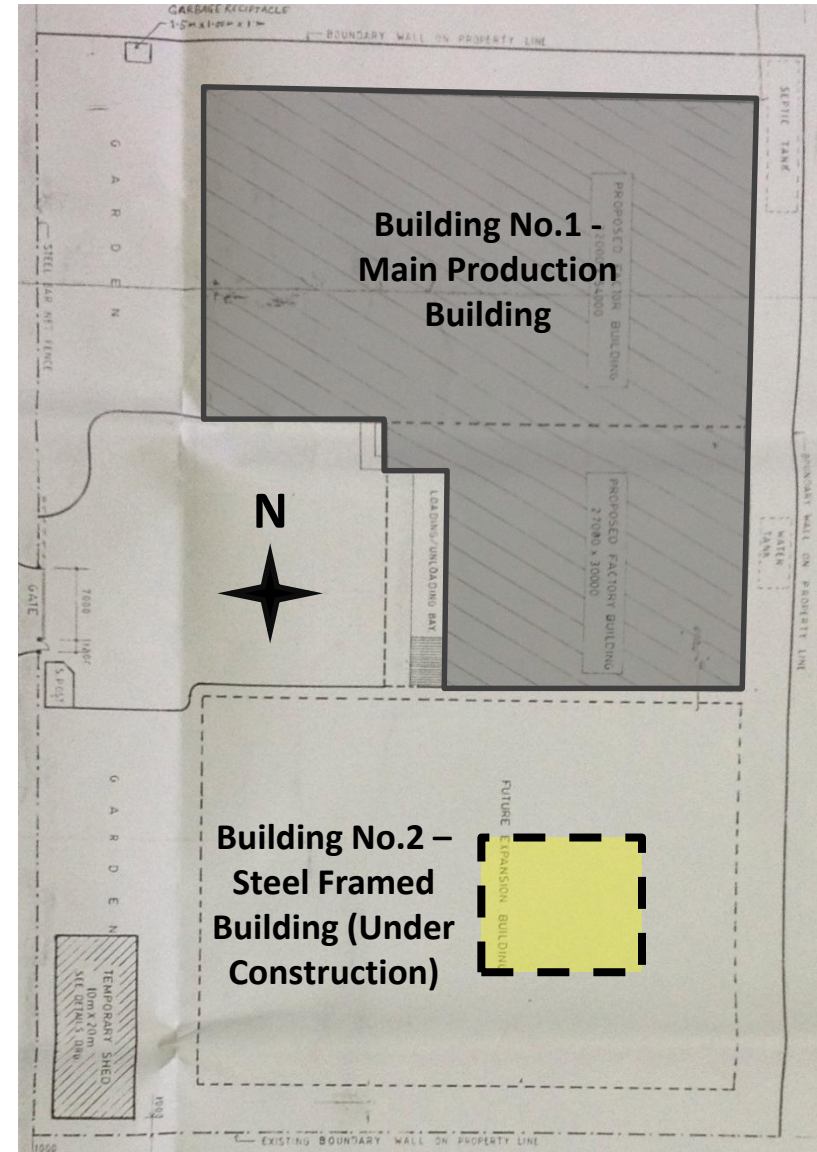
**2m High Rolled  
Unworked Fabric,  
Live Load  $7\text{kN/m}^2$**

**1.8m High Rolled Unworked Fabric,  
Live Load  $6.3\text{kN/m}^2$**

**Localised areas of high loading observed in Building 2**

| Item No. | Observation | Recommended Action Plan | Recommended Timeline |
|---|---|---|---|
| 2 | Localised areas of high loading observed in Building 2 | Stored materials to be spread apart such that the total live load is limited to no more than 350kg/m <sup>2</sup> in accordance with the structural design. | 6-weeks |
| 3 | Localised areas of high loading observed in Building 2 | Loading plans for buildings to be correctly implemented throughout Buildings 1, 2 and 3. | 6-months |

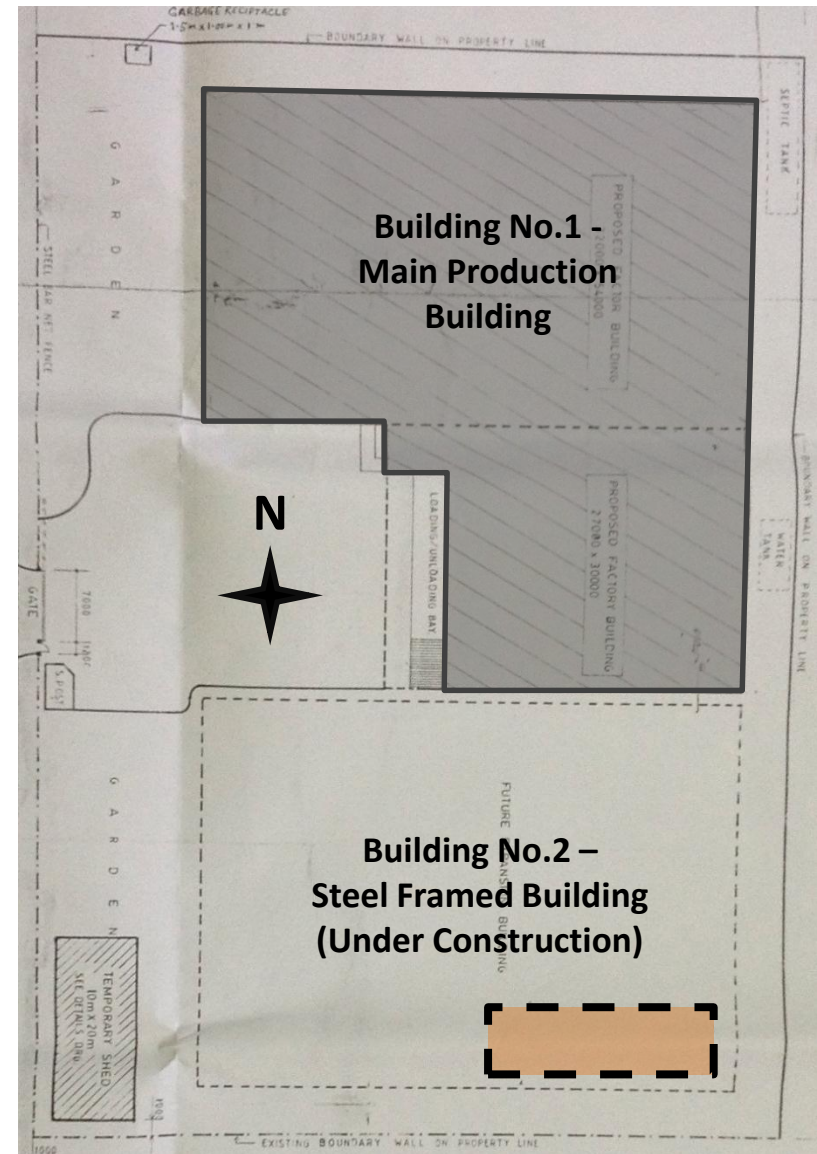
## Loading Observed Building No.2 Second Floor

**1.5m High Bags/Disordered Bundles  
and Stacked Boxes of Clothes,  
Live Load up to  $4\text{kN/m}^2$**

**Localised areas of high loading observed in Building 2**

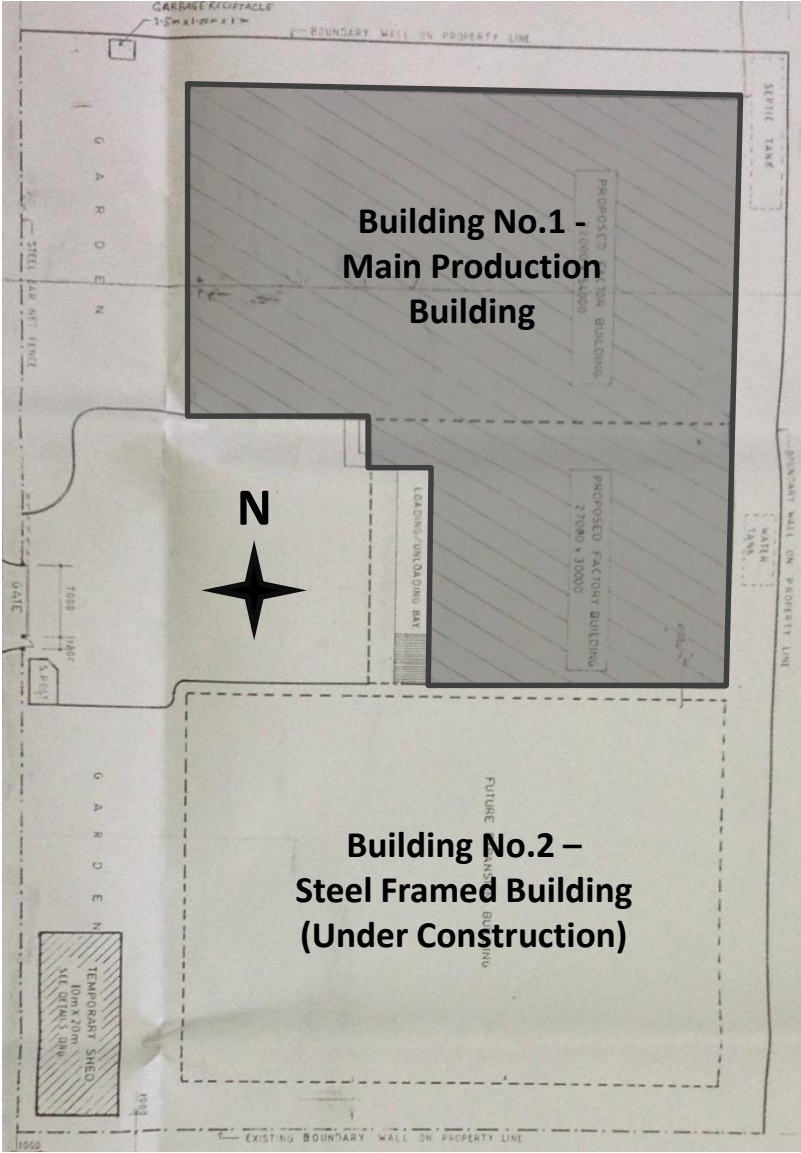
**Building No.2**  
**Design Live Load indicated to be 3.5kN/m<sup>2</sup>**

**Localised areas of high loading observed in Building 2**

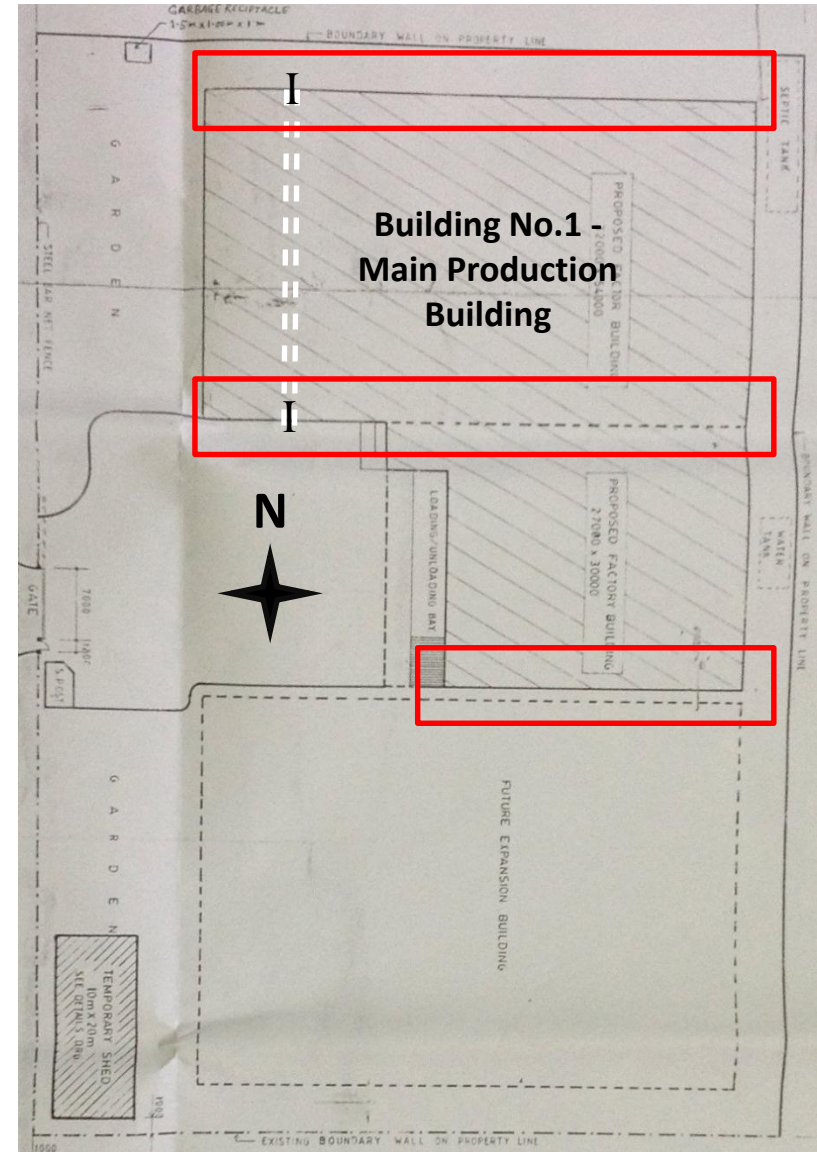
## Cracking at Beam – Column Connection

Horizontal cracking observed at the RC Beam to Steel Column connection.  
Observed in a large number of connections.  
No standard drawing/detail provided showing connection type.

| Item No. | Observation | Recommended Action Plan | Recommended Timeline |
|---|---|---|---|
| 8 | Cracking observed at the connection between RC beam and steel column | Structural Engineer to assess the as-built connection detail provided between concrete beam and steel column. | 6-months |
| 9 | Cracking observed at the connection between RC beam and steel column | Retrofitting to be carried out as directed by the Structural Engineer. | 6-months |

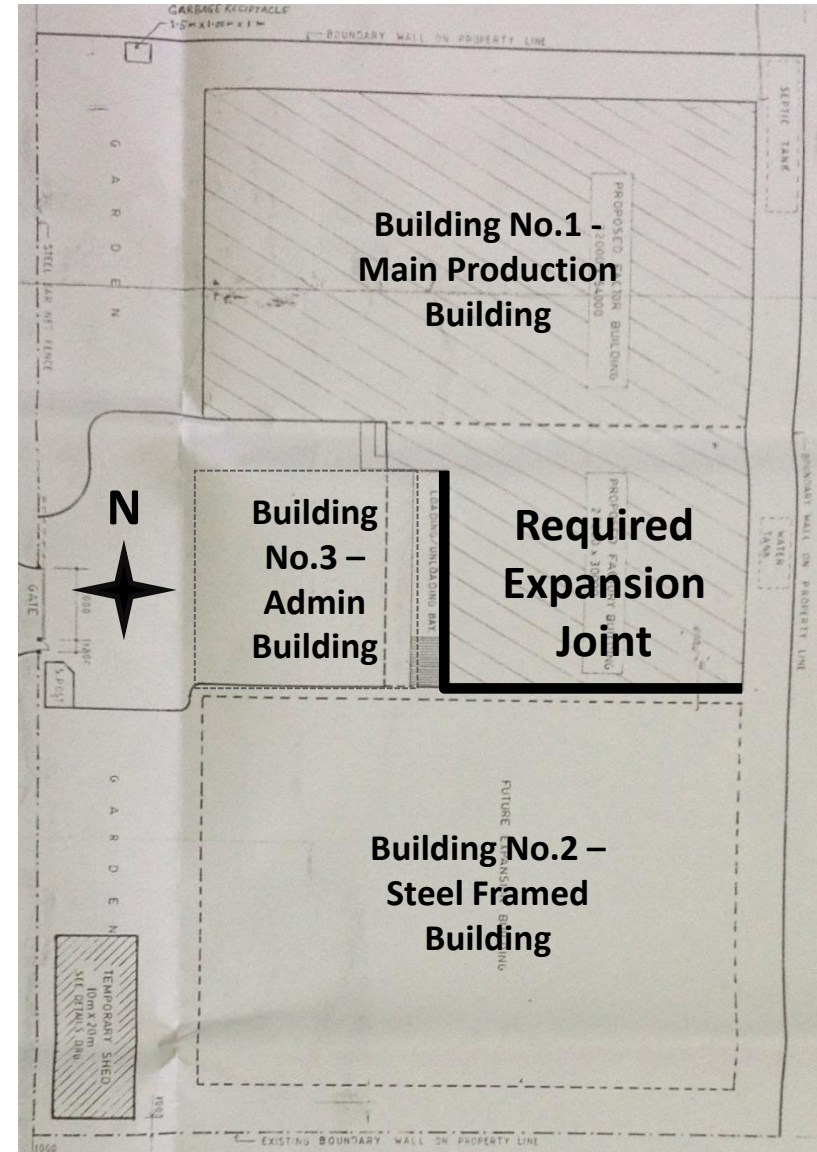
## Movement Joint

Existing movement joint between Building No.1 and 3

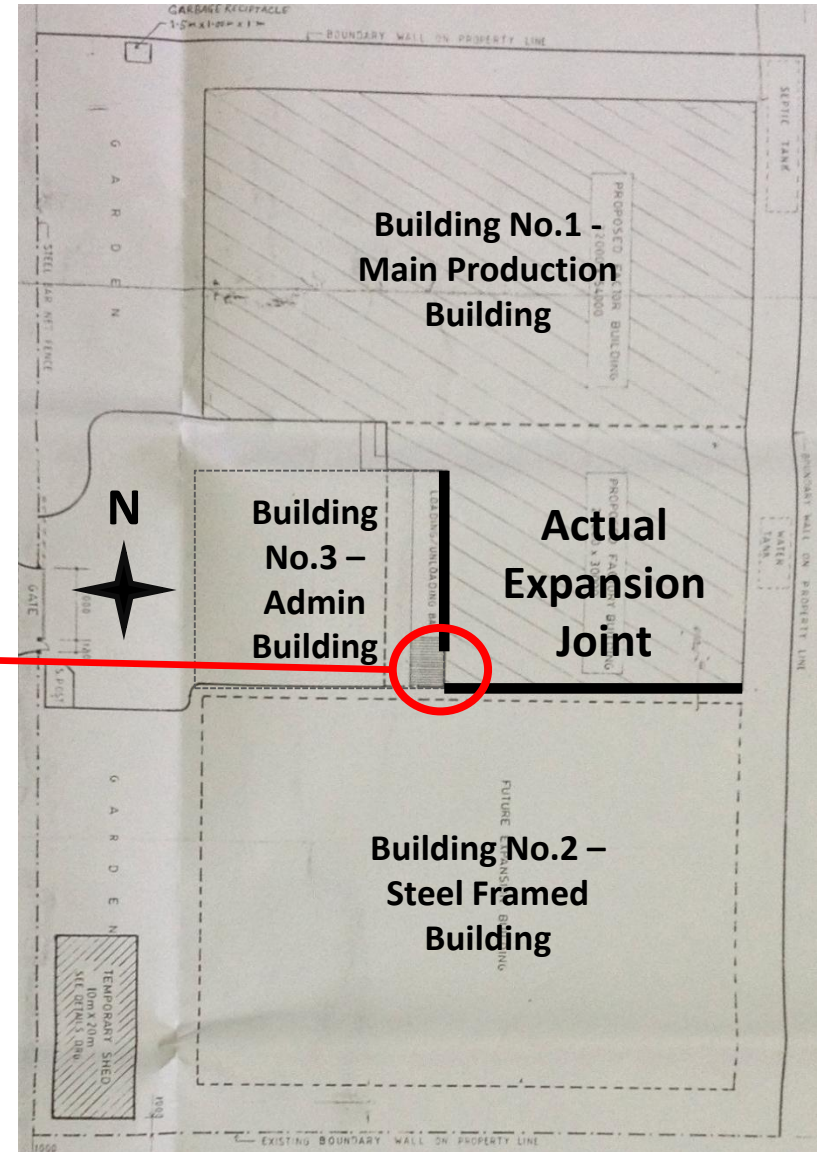
## Movement Joint

**Movement joint does not extend the full length between Building No.1 and No.3**
