# Samad Sweater Limited

Kalmeshwar (Battala Road) Board Bazar, Gazipur  
(23.945658, 90.385032)

07<sup>th</sup> May 2017

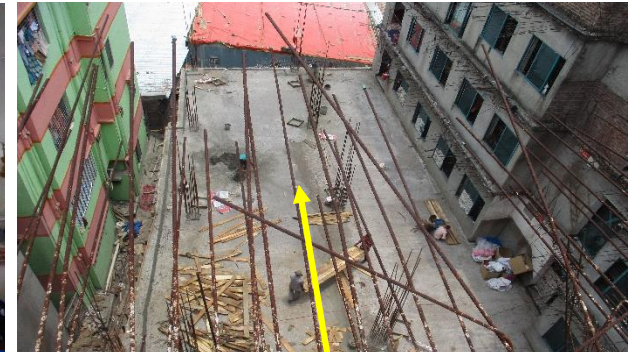
Up to 1<sup>st</sup> floor construction at part-C

In beam layout of Part-B conceal beam was shown but 10" x 20" size beam found. All floor beams are shown as conceal beam in drawings. Also in Part-A cantilever beams were not found in stair and north side toilet which were shown in beam layout.

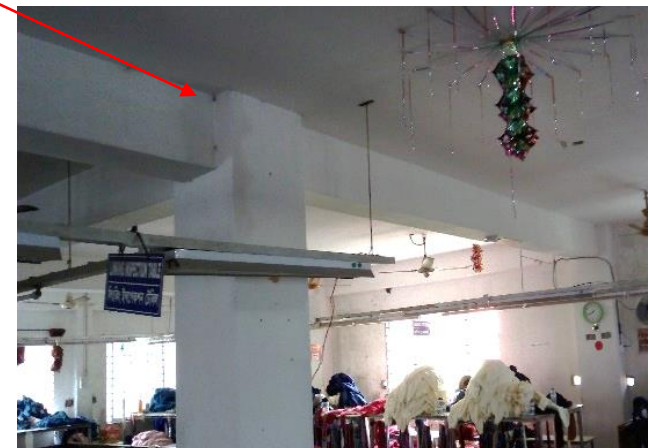
Beam slab

Concerns on the stability system for lateral loading and seismic loading. Flat slab system lack of lateral load resistance.

Factory requires that these items be investigated as part of a Detailed Engineering Assessment.

| Item No. | Observation | Recommended Action Plan | Recommended Timeline |
|---|---|---|---|
| 10 | (Production Building)<br>Overall stability system | Carry out all recommendations of the Detail Engineering Assessment. | 6-months |
