# **Baxter Brenton (BD) Ltd**

SFB #7, 1st Floor, DEPZ(Old Zone), Ganakbari, Ashulia, Savar, Dhaka - 1349  
(23.94997N 90.27216E)

10th May 2014

# Observations

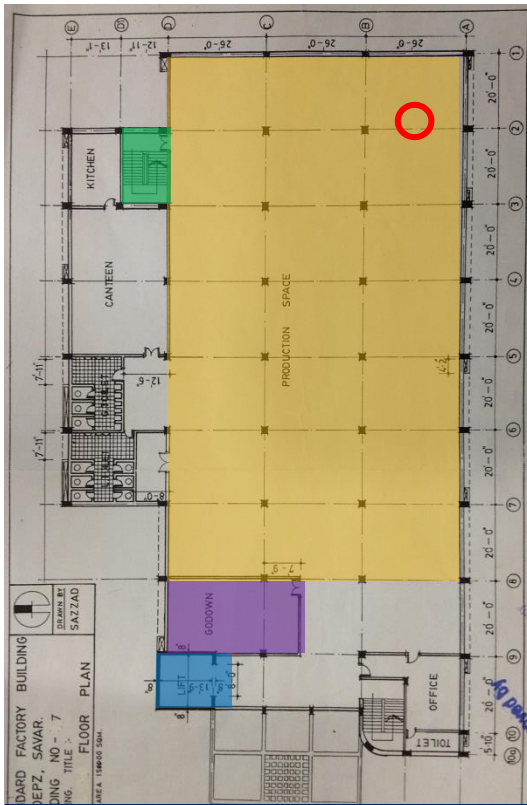
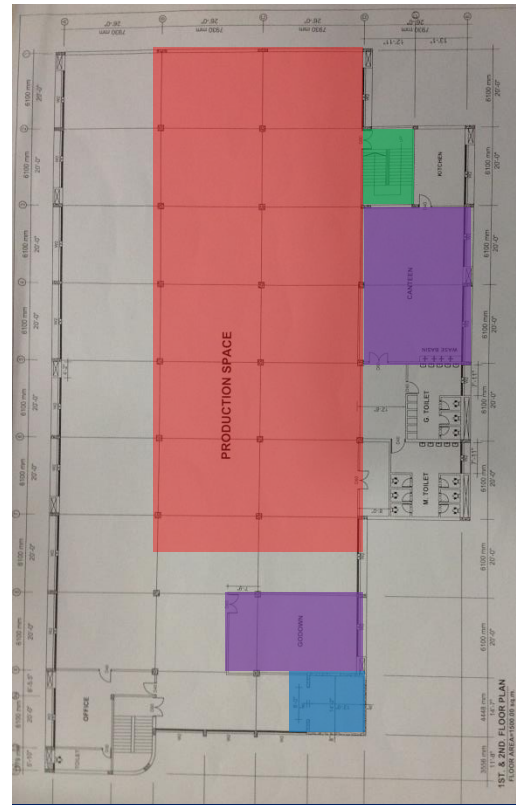
**Heavy loading in both buildings, particularly Building 2, and lack of a Loading Plan**

- Areas of very high loading were observed in the fabric storage area at 1<sup>st</sup> Floor level of Building 2.
- This of particular concern as extensive cracking to the top of the 1<sup>st</sup> Floor slab at the location of the beams was evident throughout the floor.
- Further areas of high loading were noted at the water tanks and storage rooms at roof level of both buildings, and the storage areas at 2<sup>nd</sup> Floor level of Building 1.
- Building Engineer to check that the different slab constructions have been adequately designed to accommodate these loadings.
- A Loading Plan for all floor plates is to be produced, implemented on the floor and actively managed.

Fabric Storage Area at 1<sup>st</sup> Floor level of Building 2

5000 litre water tanks at Roof Level of Building 1

2m high water tanks above stair-cores of both buildings

Storage Rooms above lift-cores of both buildings

Boxed / Cardboard Storage Area at 2<sup>nd</sup> Floor level of Building 1

Other storage areas at 1<sup>st</sup> & 2<sup>nd</sup> Floors of both buildings

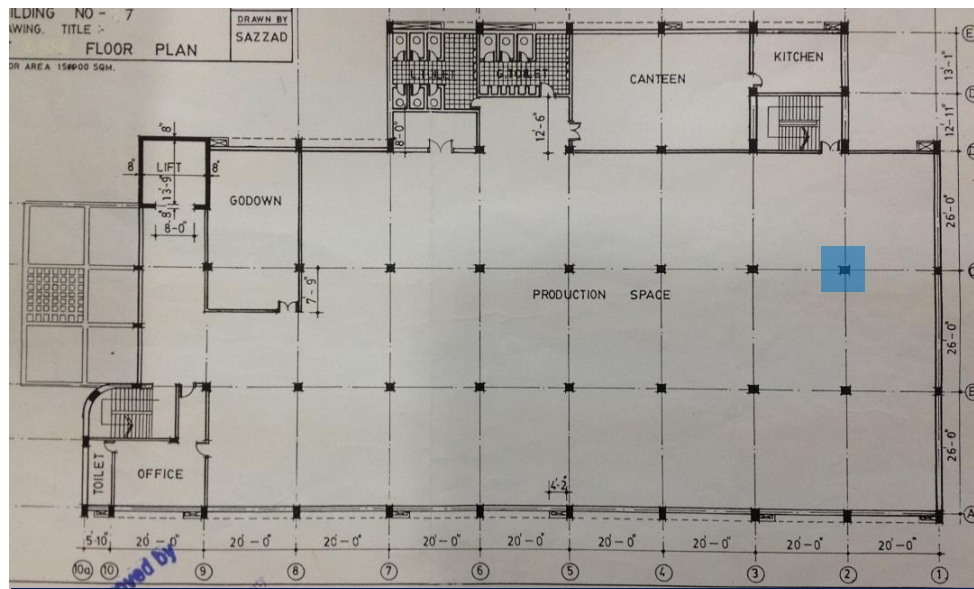
First Floor Plan – Building 1

- Cursory calculations indicate that the working stresses of the columns at Ground Floor level are above normal design limits.
- Building Engineer to verify concrete stresses and in-situ concrete strength.

- Testing of the Ground Floor columns was not possible in either building on the day of the survey, owing to the fact that these floors are currently occupied by other companies.
- Stone aggregate was observed in the 1<sup>st</sup> Floor columns of Building 1.
- The reinforcement quantities observed at 1<sup>st</sup> Floor level coincides with the values shown in the column schedule.
- High yield steel reinforcement is called up in the drawings for both buildings, and was observed at Roof level.

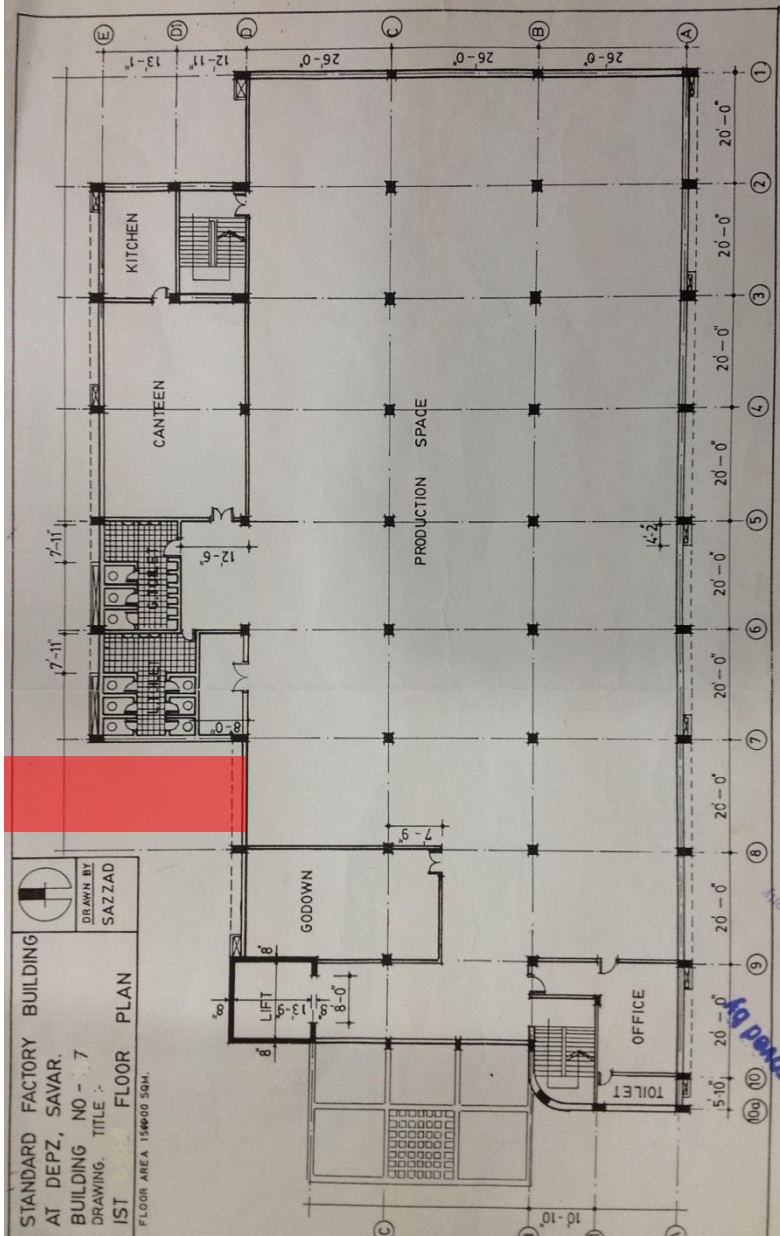
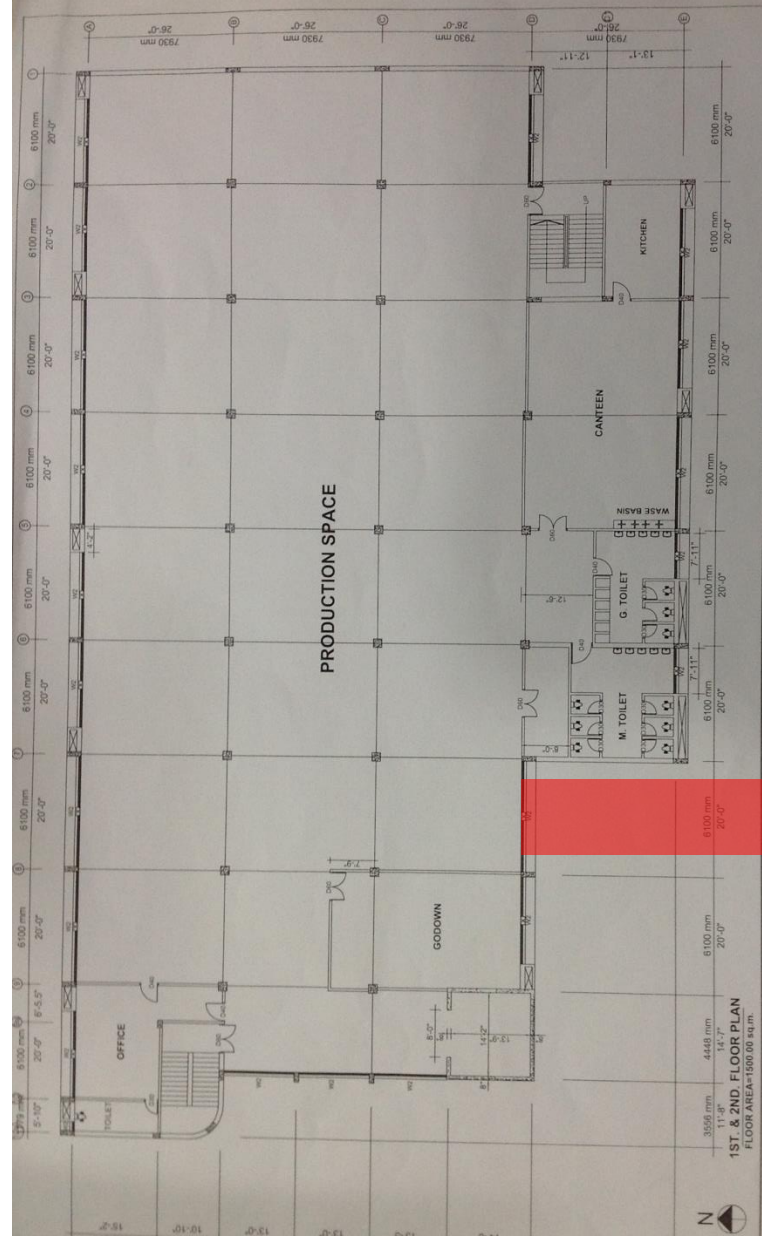
Extent of  
Walkways

**Lack of documentation for the ramp and link  
bridge structures, and concerns over the  
connection the buildings**

- Buildings 1 and 2 are connected to adjacent buildings by a ramp and bridge link structure, which provides elevated pedestrian and delivery access to the buildings at 1<sup>st</sup> and 2<sup>nd</sup> floor levels.

- The design of these structures, particularly the connection detail with the buildings, is not clear.
- Exposed slab and wall reinforcement in the structures was observed to run through, thereby providing connection with the building.

- Relative movement between the buildings and the structures does not appear to have been allowed for, and extensive cracking was observed.
- There were no drawings showing the structures.

- The link bridge appeared to be used as a storage area at 1<sup>st</sup> Floor level.
- Building Engineer to review the design of the ramp and bridge link structure, with special emphasis on the connection detail with the buildings, and to demonstrate that if any load is imparted to the building this has been adequately designed for.

- A full set of as-built drawings is to be provided detailing the buildings and the connecting structures.

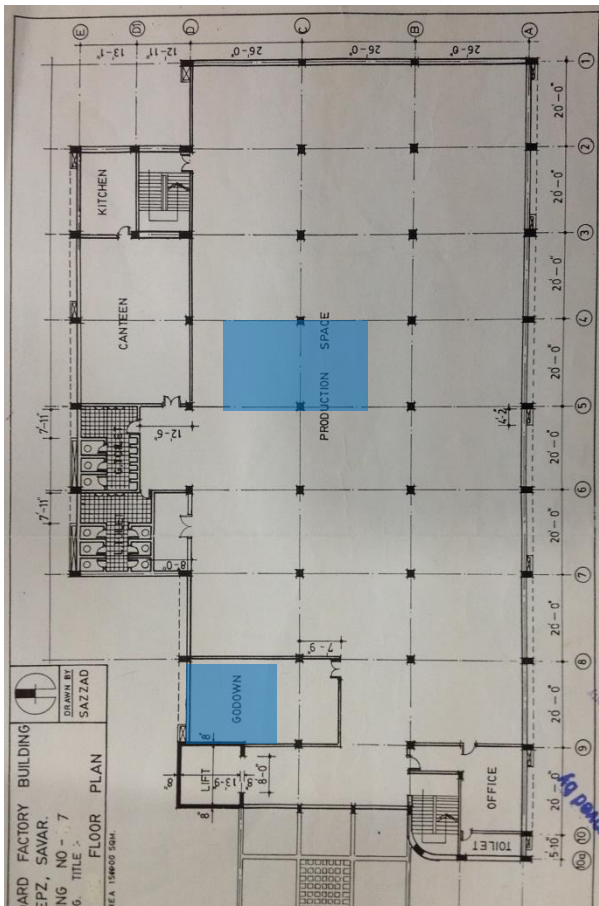
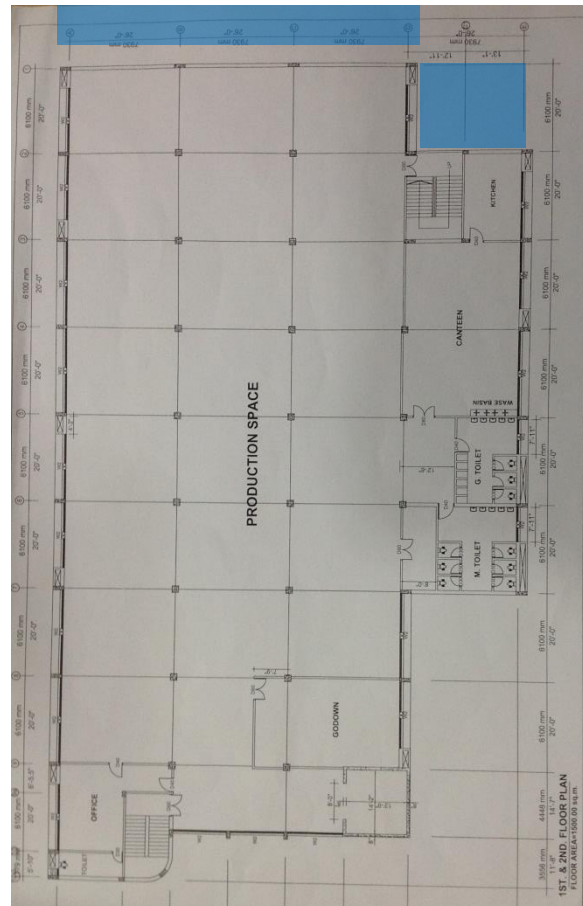
Extent of lightweight structures

- Included in the factories are a number of lightweight structures located on the Roof of Building 1 and at Ground Floor level around Building 2.
- These structures appear to be non-engineered.
- Building Engineer to review the design of these lightweight structures to guard against uplift and lateral instability, with particular emphasis on connections and bracing, and to implement any remedial / upgrade works as required.
