Norban Comtex Ltd (10050)

Mouza-Sarabo, Chakroborty, Kasimpur Union, Gazipur
(+23.975960N, +90.265450E)

20.APRIL.2014

ACCORD
on Fire and Building Safety in Bangladesh

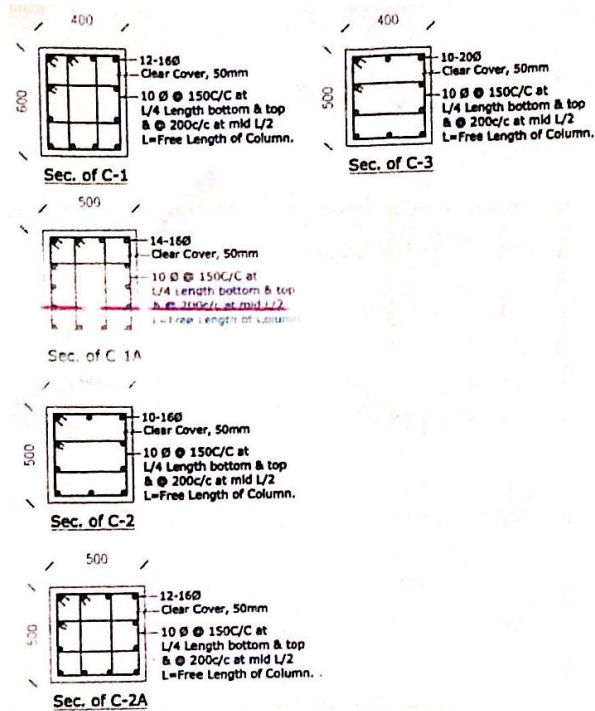
Priority 2 Concern

Within the Services Building and the Garment Pump house column load run-downs indicate higher than desirable levels of stress.
