# Y.K Knitwear Ltd. #10331

Plot S-7 & S-8, Estate Kanabari, Gazipur Sadar

05.May.2014

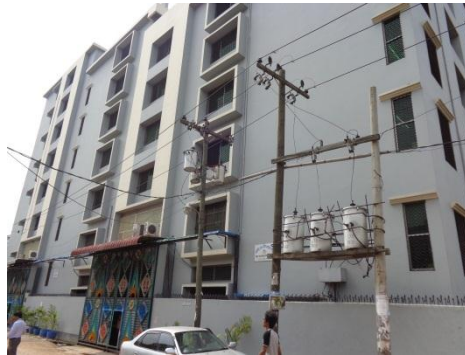
No adequate loading plan is in place – loading to be reduced

The current loading plan evaluates the total load on the total floor area. A proper loading plan is required for every floor which splits the loading into tributary areas associated columns.

Furthermore, heavy loading was found on the cantilever section at the joint on the storage floor. Managing Director and Factory Engineer were advised to reduce loading on cantilevered section

Reduce loading to 3 kPa until capacity assessment is made.

| Item No. | Observation | Recommended Action Plan | Recommended Timeline |
|---|---|---|---|
| 2 | No adequate loading plan is in effect. | Factory engineer to produce and actively manage a loading plan for all floor plates within the factory giving consideration to slab beam, column and foundation capacity | 6-weeks |
