# Vintage Denim Studio Ltd. #9208

Plot #99 & 102-128, Ishwardi EPZ, Ishwardi, Pabna

07.May.2014

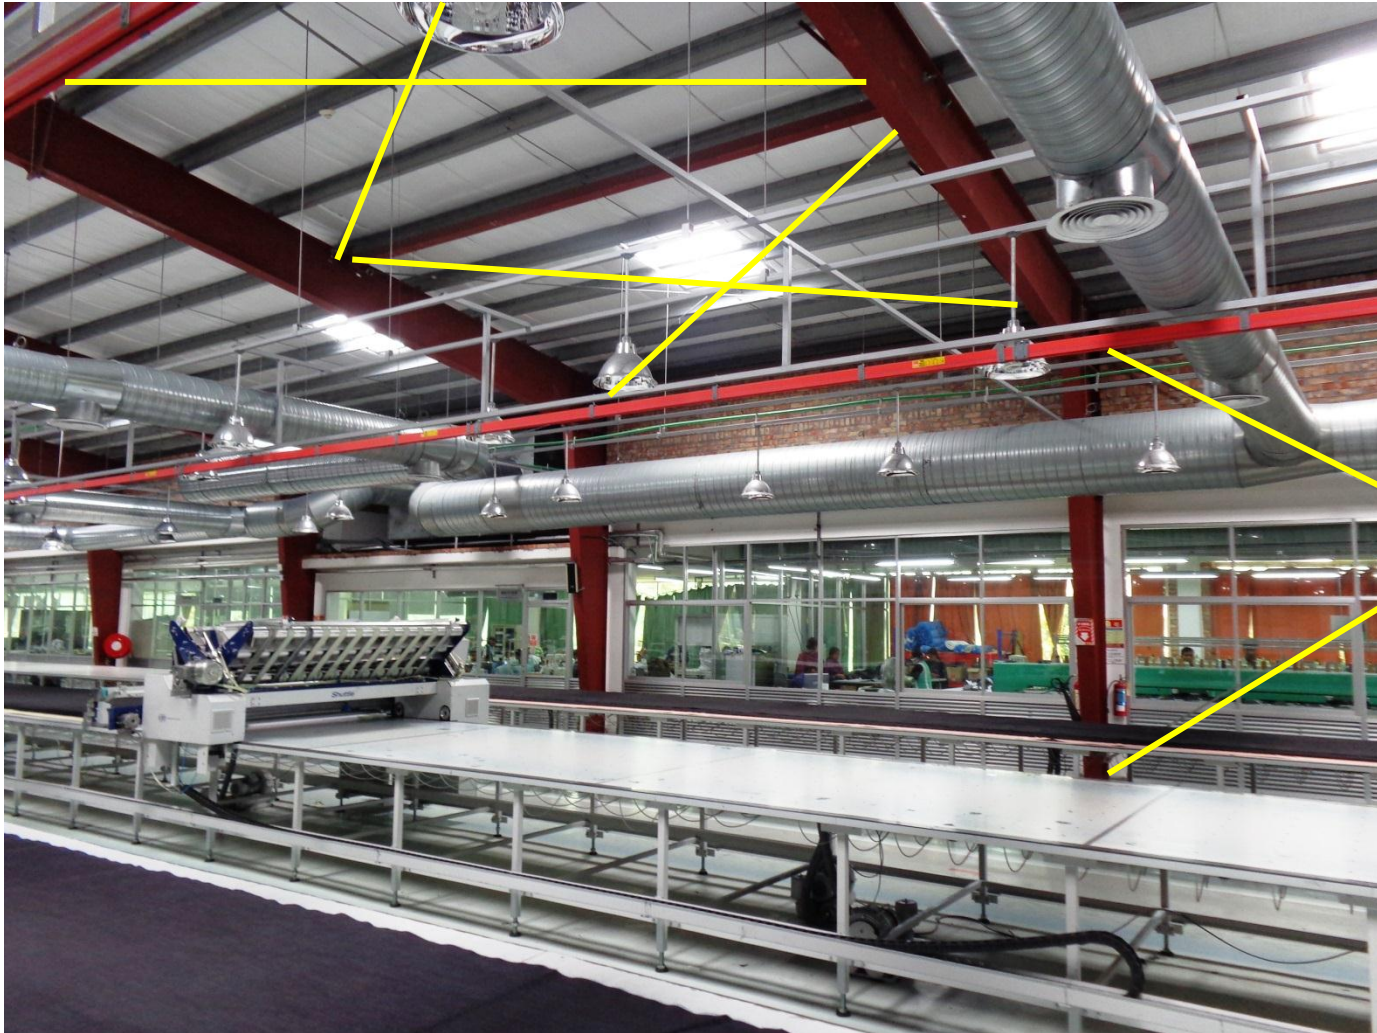
The structure should detailing for adequate lateral restraints for beams and purlins. The building also had horizontal steel wire bracing for the roof diaphragm.

Where we have a concern is that at the end of the horizontal bracing, the vertical bracing is not aligned and does not always have the collecting element at the top.

We require that this item be investigated in a Detail Engineering Assessment
