Knittex Industries Ltd. (10837)

21.APRIL.2014

ACCORD
on Fire and Building Safety in Bangladesh

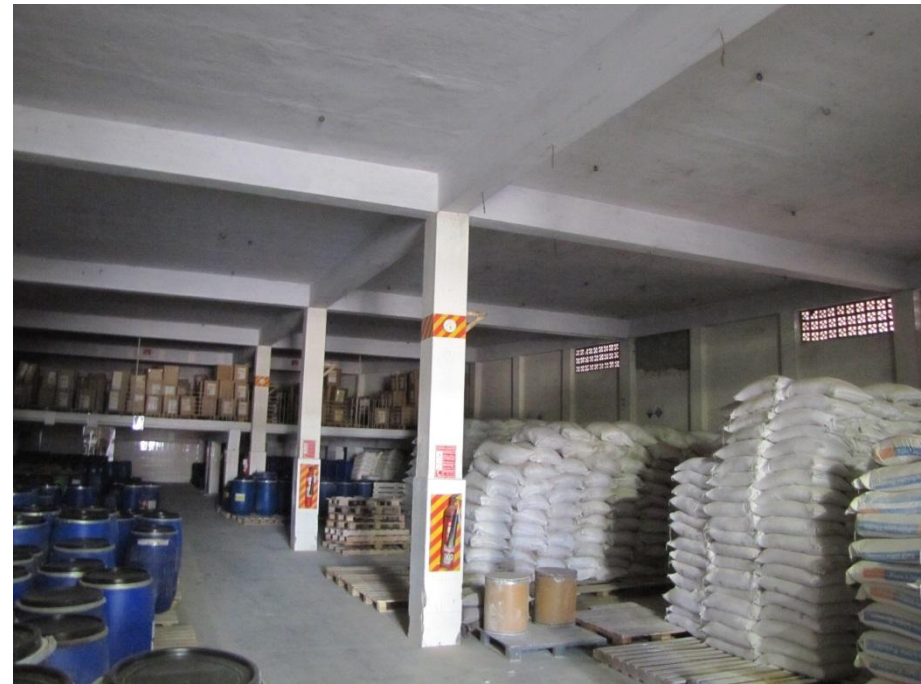
The buildings did not feature any core or shear walls. Stability was achieved through sway action between beams and columns and masonry infill walls.

We require that these items be investigated in a Detailed Engineering Assessment.
