# MG Knit Flair Ltd. (9200)

# MG Shirtex Ltd. (9594)

31/1, Laxmipura, Chandura, Joydebpur

05.APRIL.2014

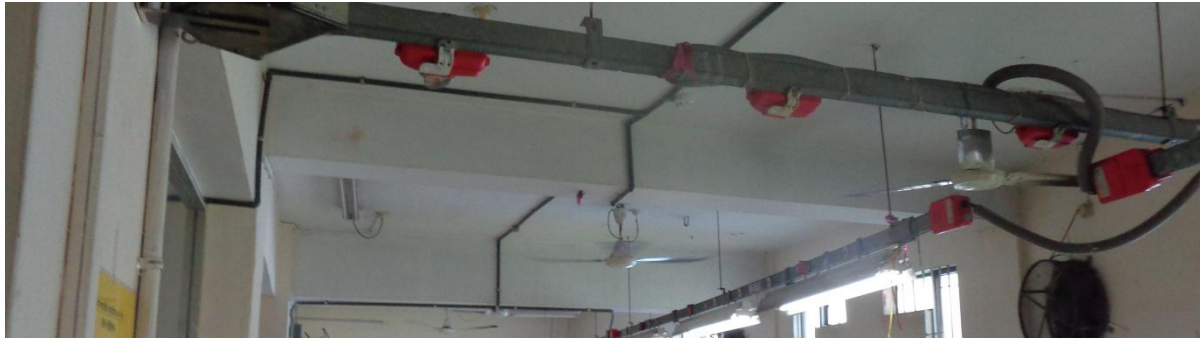
**Poorly Framed Steel Roofs at Day Care/Dining Hall & Rooftop Prayer Area**

There were several short span beams at each floor that are not identified on the beam layout plan. Additionally no beam reinforcing detail is shown for the size of beam observed in this area.

The steel roof framing above the Day Care/Dining & Rooftop Prayer areas appears to be poorly constructed and in poor repair.

| Item No. | Observation | Recommended Action Plan | Recommended Timeline |
|---|---|---|---|
| 5 | Several beams present at each typical floor are not identified on the Structural drawings nor are there details shown for these beams. | Carry out any recommendations put forth by the detailed engineering assessment. | 6-months |
| 7 | Steel framing above the Day Care/Dining Hall and the Rooftop Prayer area is of poor quality and composed of exceedingly light sections. | Either remove the steel roofs or carry out works as recommended by the detailed engineering assessment. | 6-months |
