Kimberly Design(New)

214/3, Technopara, Joydebpur, Gazipur.

7th June 2017

3 **Observations: Child Care & Training Center**

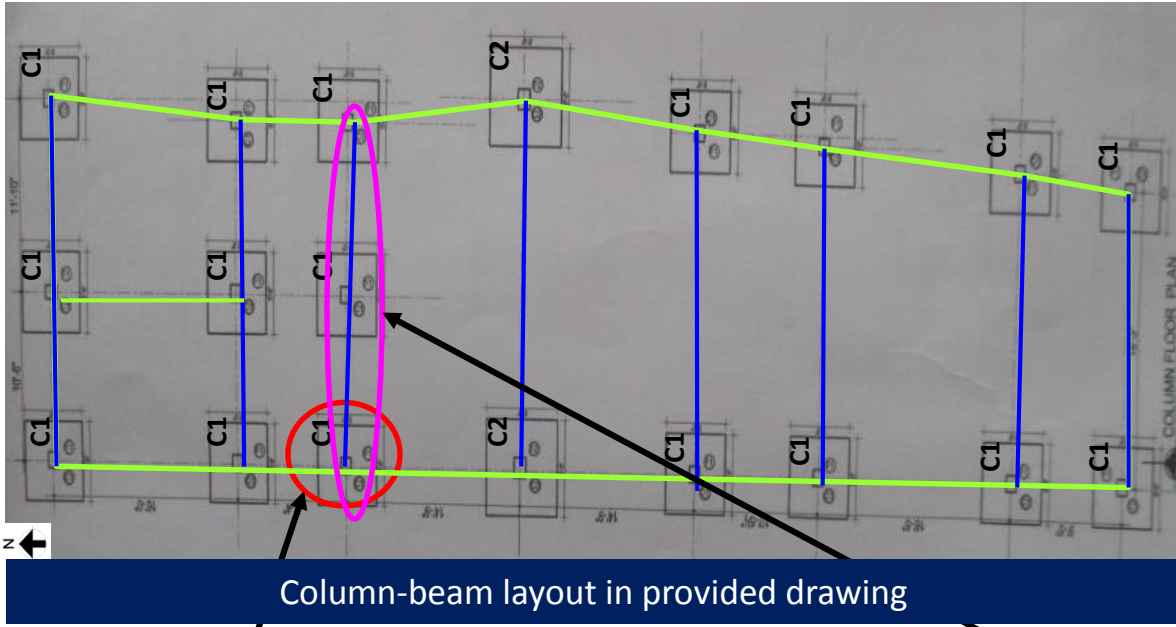
Column-beam layout in provided drawing

Discrepancies between drawings and site observation

Item No.	Observation	Recommended Action Plan	Recommended Timeline
1	(Child Care & Training Center) Discrepancies between drawings and On-site observation	Building engineer to survey the whole building and produce as-built documentation reflecting the as constructed condition.	6-weeks
2	(Child Care & Training Center) Corrosion observed on the exposed reinforcement of roof	Building Engineer is required to investigate the extent of corrosion and suggest necessary repairing action.	6-weeks
3	(Child Care & Training Center) Corrosion observed on the exposed reinforcement of roof	Implement repairing works as per engineer's advice.	6-months
4	(Wastage Room) Missing information in provided drawing	Building engineer to survey the whole building and produce as-built documentation reflecting the as constructed condition.	6-weeks

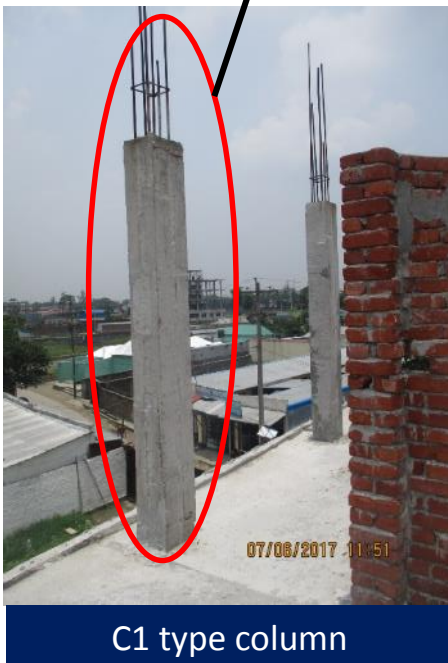
Dimension of C1 type column found 10"x12" instead of 12"x12"
