Texeurop (BD) Ltd. (10029)

Vogra, Joydebpur, Gazipur
(+ 23.983317N, 90.382354E)

11.MAY.2014

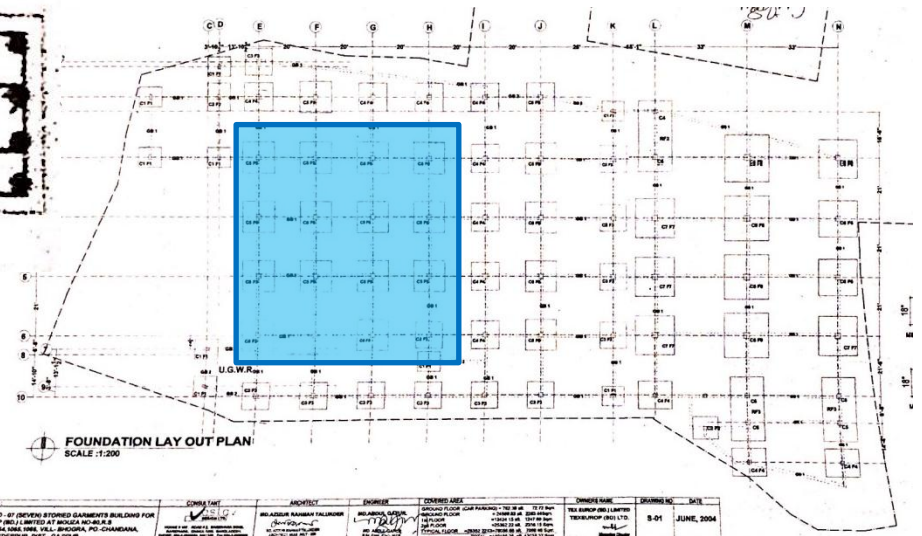
The interior columns, C4 and C5, between grid line E'-I'/2'-6' of Garments Building are supporting the tributary area of 6.30 m x 6.00 m of 8 storeys. The actual condition of column details does not match the details specified in the drawing.

Drawing	On-Site
Size	19"x 19"	18" x 18"
Vertical rebar	12 - φ 25 mm	12 - φ 25 mm
Aggregate	Stone	Brick

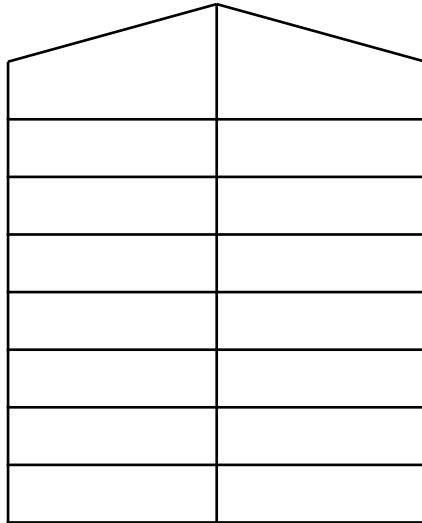
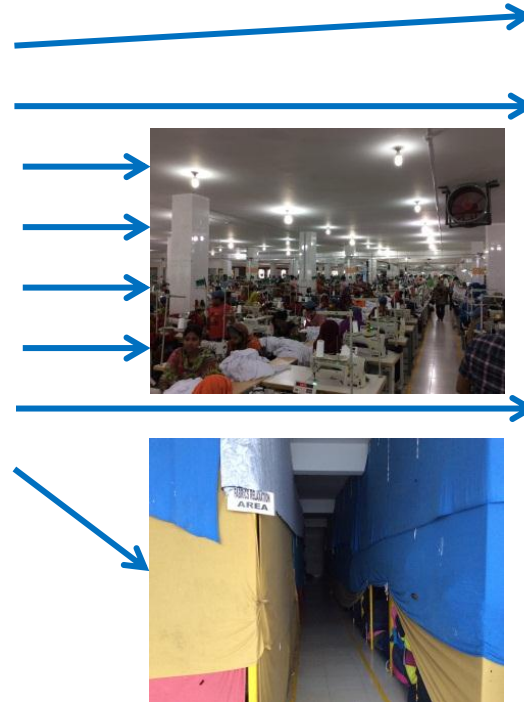
From the result obtained, calculation check of columns between grid line E'-I'/2'-6' appears to be overstressed. Column C4 is indicated that the FoS is **1.14**. And Column C5 is indicated that the FoS is **1.21**.

Remark: Check at ground floor

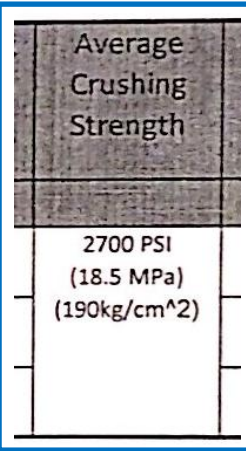
We were provided with copies of compressive strength of concrete with brick chips tested by BUET and certification of steel reinforcement issued by manufacturer. According to those results, the compressive strength of concrete with brick chips is 18.5 MPa and steel reinforcement of grade 60 has been used. For the purposes of this report, we have continued to use the Accord guidelines for pre=2005 construction: the decision whether to adopt the values from the BUET report is left to the Detailed Engineering Assessment.
