# Posmi Sweaters Ltd (10170)

Dhaka Road, Chandona Chowrasta, Gazipur

11.May.2014

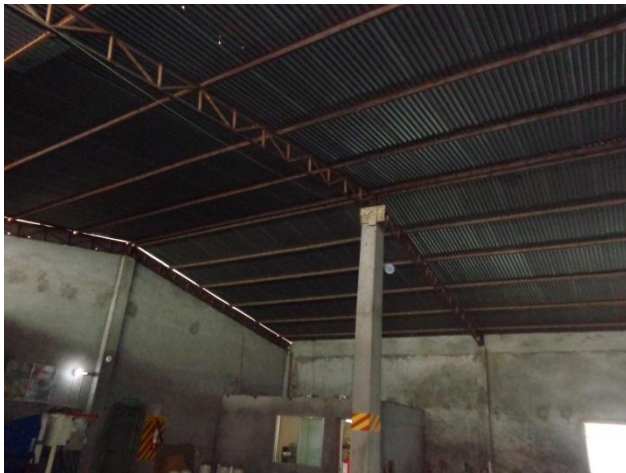
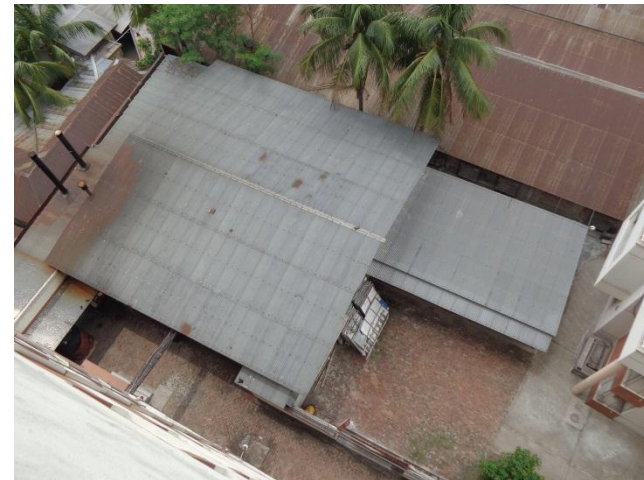
No construction documents were available for any of the structural steel sheds. A design check of all of the structural steel must be included in the Detailed Engineering Assessment. Furthermore, the original technical documents should be located or new As-Built drawings produced.

Item No.	Observation	Recommended Action Plan	Recommended Timeline
7	Documentation not available for the structural steel sheds located on the roof and utility building at ground floor.	The Factory Engineer is to carry out an assessment of the walls and steel roofs of the sheds and evaluate their capacities to resist uplift and lateral forces due to high winds.	6-weeks
8	Documentation not available for the structural steel sheds located on the roof and utility building at ground floor.	If deemed necessary by Factory Engineer, carry out any remedial works recommended.	6-months
9	Exposed slab reinforcement at roof level.	Factory Engineer to provide details to repair the slab and provide adequate cover and waterproof the bars.	6-weeks
10	Exposed slab reinforcement at roof level.	Carry out and complete the remedial works to protect slab.	6-months
11	'Accent' parapet at roof level.	The Factory Engineer must carry out an assessment of the design of the parapet.	6-weeks

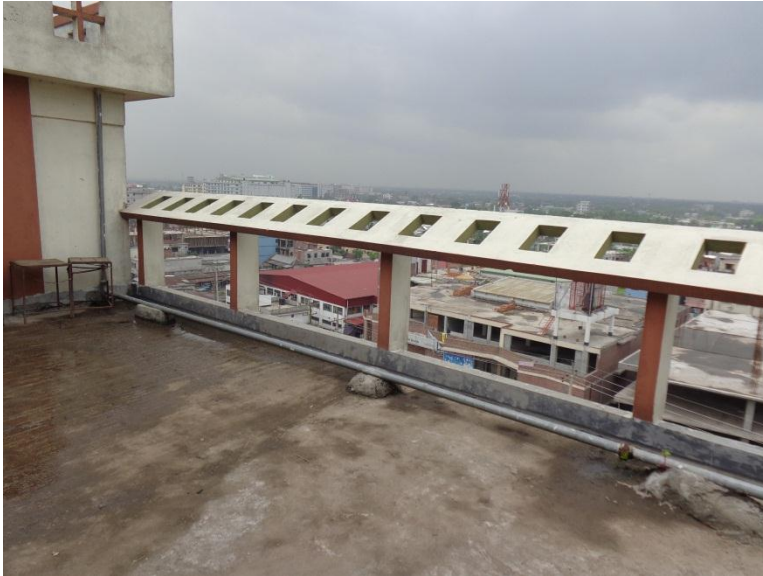
At roof level, reinforcement steel is exposed on the surface of the roof slab. The concern must be corrected immediately in order to protect the reinforcement from corrosion and insure that the slab's strength is maintained.

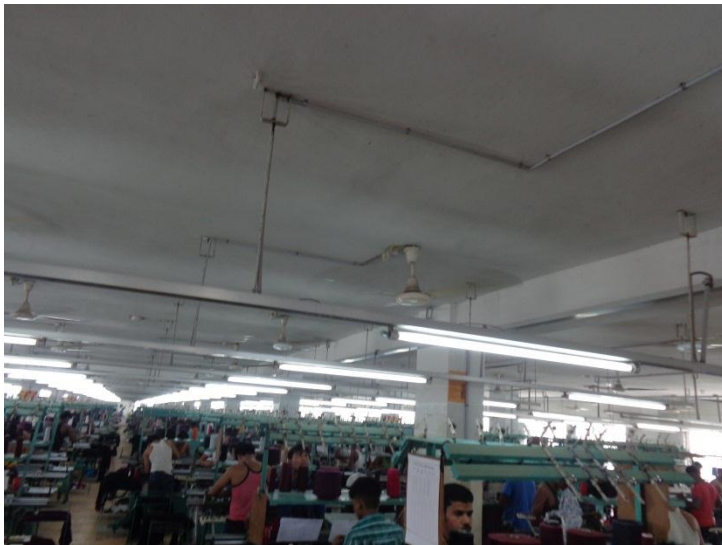
We believe that the intent of the original structural design was to use the main grid line beams to provide some form of lateral stability via moment frame action.

However, as some of the beams are missing and there is one floor built as a flat plate with no beams, then the lateral stability strategy is greatly affected. Under lateral loads the additional loads attracted to columns may cause a risk of local punching shear failure.

We require that the lateral support system is investigated as part of a Detailed Engineering Assessment.
