# M.I.T Apparels Ltd. (9687)

Pathantuly, Godnail, Shiddirgonj, Narayanganj, Bangladesh

12.MAY.2014

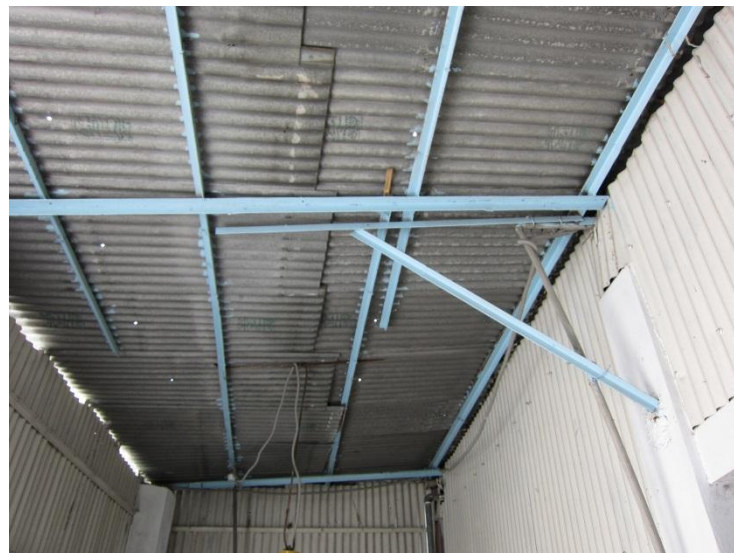
Concerns on the stability system for lateral loading, especially at the joint connection of steel roof truss and reinforced concrete column.

We require that these items be investigated in a Detail Engineering Assessment.

| Item No. | Observation | Recommended Action Plan | Recommended Timeline |
|---|---|---|---|
| 3 | Overall stability system. | Request that the Detail Engineering Assessment of the overall building to be carried out and in particular, stability and foundation aspects should be investigated in detail. | 6-weeks |
| 4 | Overall stability system. | Implement any remedial works found necessary by the DEA. | 6-months |
