# Weldone Apparels Ltd. #10249

Baraidrchalae, Sreepur, Gazipur

12.May.2014

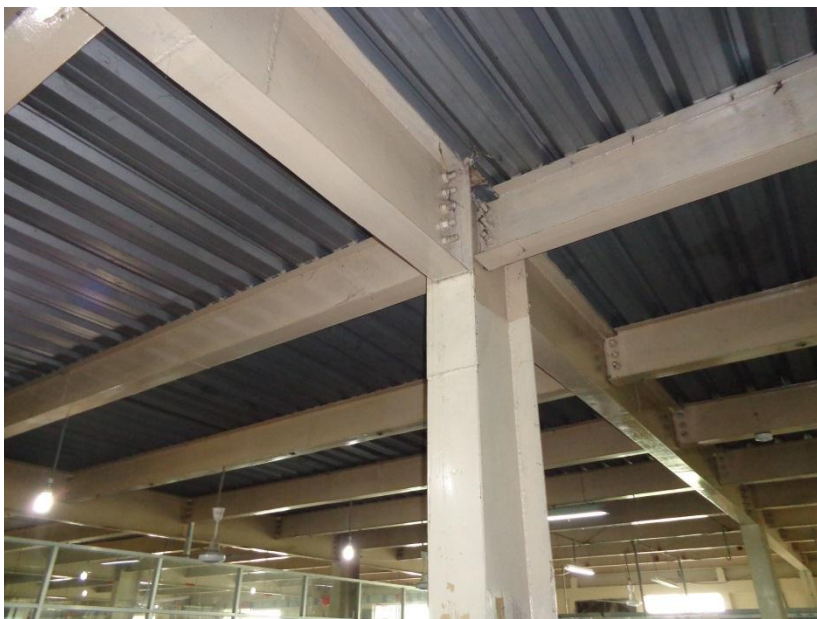
Main building –  
structural system does not provide any lateral load resisting  
system

poor steel detailing at the roof
