# N.A.Z. Bangladesh Ltd. (10232)

5, Bishuya, Kuribari, Mirzapur, Gazipur, Bangladesh

15.MAY.2014

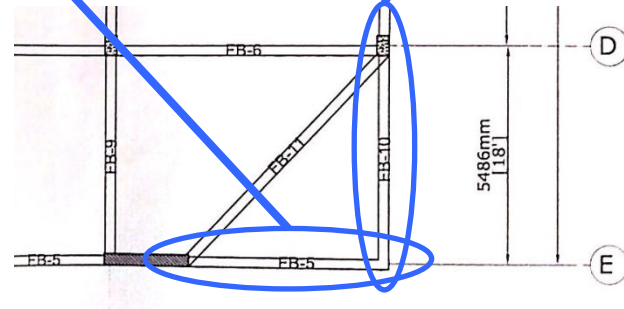
Capacity check of these beams should be carried out.

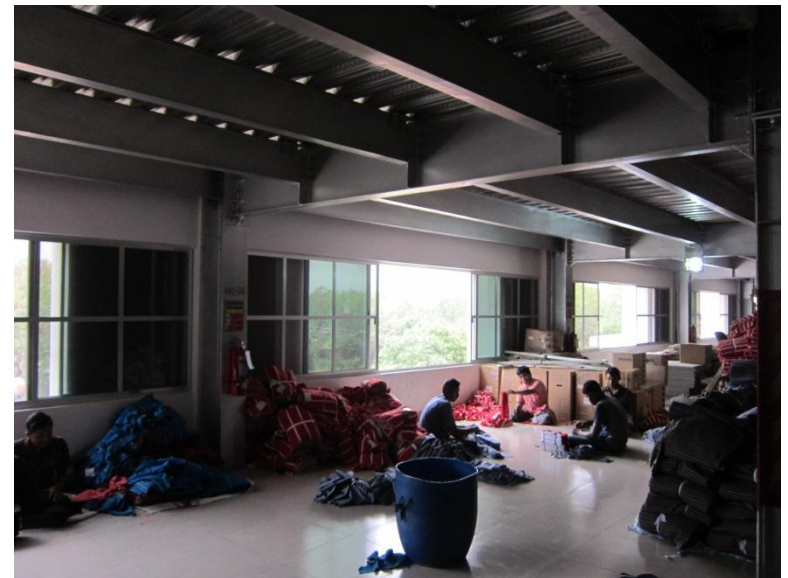
Concerns on the stability system for lateral loading, façade brickwork walls lack of moment capacity in the connections between columns and beams, especially at the joint connection of steel structure.

We require that these items be investigated in a Detail Engineering Assessment.

| Item No. | Observation | Recommended Action Plan | Recommended Timeline |
|---|---|---|---|
| 10 | Overall stability system. | Request that the Detail Engineering Assessment of the overall building to be carried out and in particular, stability and foundation aspects should be investigated in detail. | 6-weeks |
