# Section Seven Limited (9216)

Plot #21-24 (Part), Sector-3, Road-4, South Haliashahar, CEPZ, Chittagong  
(+ 22.287786N, 91.775024E)

19.MAY.2014

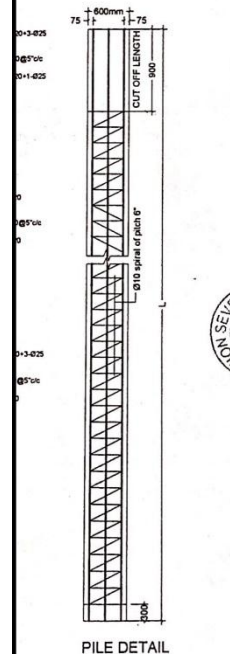
PILE SECTION (P2)  
(L=50'-0")

From the drawings, it was appeared to be one pile of each column, where the size equals to 600 mm in diameter and 15 m long, supporting the interior column in area between grid line 1A-10A/A1-C1 of Factory 1 and the area between grid line 16A-25A/A1-C1 of Factory 2. The tributary area is 10.03 m x 5.85 m of 4 storeys with an exclusion of ground floor which is informed to be slab on ground).

From the calculation, the factor of safety (FoS) appears to be **1.38** (Allowable pile capacity 784.8 kN; received from SI report x 2.50 divided by unfactored column load 1426 kN).

Allowable Pile Capacity (Ton) from Pile Design Chart shown in soil report

| Item No. | Observation | Recommended Action Plan | Recommended Timeline |
|---|---|---|---|
| 1 | Capacity check for piled foundation of Factory 1 and Factory 2. | <p>Factory Engineer to review design, loads and substructure to confirm capacity and suitability for loads applied.</p> <p>Investigate foundation in areas above by excavation and verify pile length by parallel seismic pile testing.</p> <p>Geotechnical investigation in situ and in laboratory.</p> <p>A Detail Engineering Assessment to be commenced.</p> <p>Until this concern is resolved, the loads in the factory, at all floors, must not be increased past the present levels.</p> | Immediate – Now |
| 2 | Capacity check for piled foundation of Factory 1 and Factory 2. | <p>Produce and actively manage a loading plan for all floor plates within this area giving consideration to floor capacity and column capacity.</p> <p>Detail Engineering Assessment to be completed.</p> | 6-weeks |
| 3 | Capacity check for piled foundation of Factory 1 and Factory 2. | Continue to implement load plan | 6-months |
