# MAS Intimates Bangladesh Pvt. Ltd. (9550)

FSFB #1, Karnaphuli Export Processing Zone, North Patenga, Chittagong

20.MAY.2014

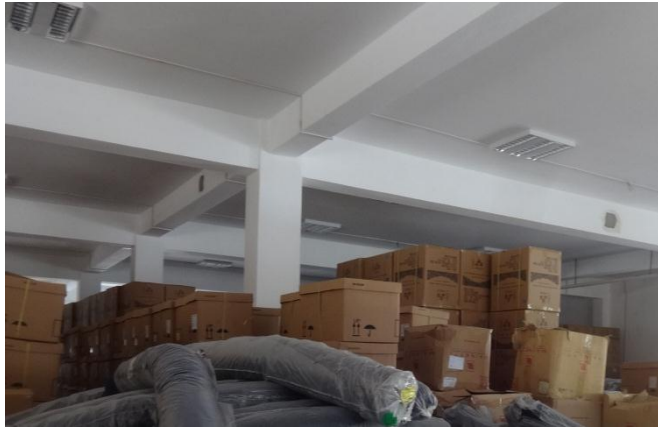
# Overall Stability System

The concrete-framed main factory building and office building gain their stability through rigid beam-column connections (left) and masonry infill walls. However the warehouse building has no evident system of lateral stability in the direction shown on the image below. As mentioned previously, a CUET report has been carried out, but it gives very little consideration to the lateral stability of the warehouse.

It is recommended that the CUET report be updated to include thorough lateral stability analysis of the warehouse and the office, as was done for the factory building.
