# Visual Knitwears Limited (9466)

295, Shafi Complex, Hatazari Road, Jalalabad, Chittagong

21.MAY.2014

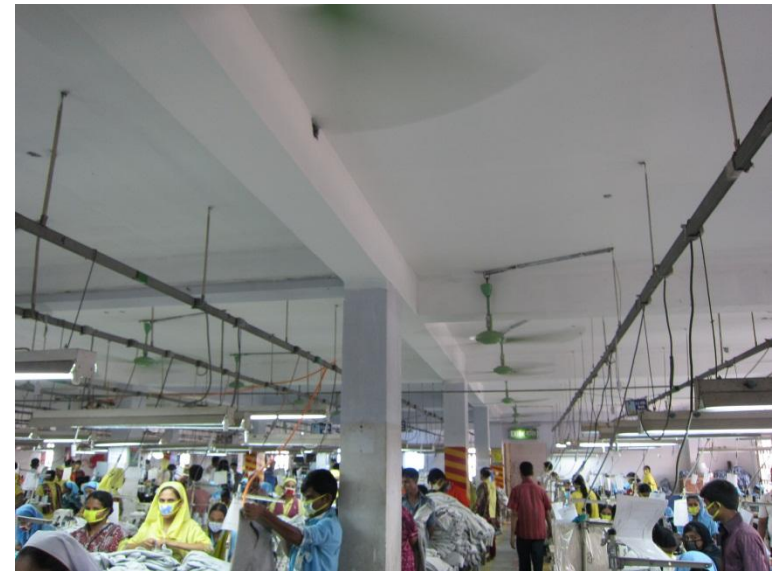
The building does not feature any core or shear walls. Stability is achieved through sway action between beams and columns and masonry infill walls.

We require that these items be investigated in a Detail Engineering Assessment.

| Item No. | Observation | Recommended Action Plan | Recommended Timeline |
|---|---|---|---|
| 11 | Overall stability system. | Request that the Detail Engineering Assessment of the overall building to be carried out and in particular, stability and foundation aspects should be investigated in detail. | 6-weeks |
