# Faiza Industries Ltd.

R.S - 425, Baimail, Konabari, P.O.- Kashem Cotton Mill, Thana- Joydebpur,, Gazipur 1346  
(24.006652, 90.337365)

15<sup>th</sup> June 2017

# Observations

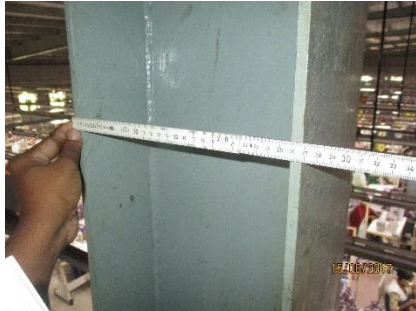
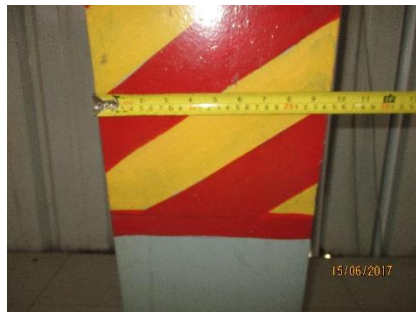
Column, main beam & sub-beam sizes were not fully matched with provided drawings. Building engineer is required to survey the as built condition and produce as built drawings.

| Item No. | Observation | Recommended Action Plan | Recommended Timeline |
|---|---|---|---|
| 1 | (Production Shed)<br>Discrepancies between drawings and on site condition | Engage an Engineer to produce an “as constructed” drawings which reflect the actual site dimensions with complete structural information. | 6-weeks |

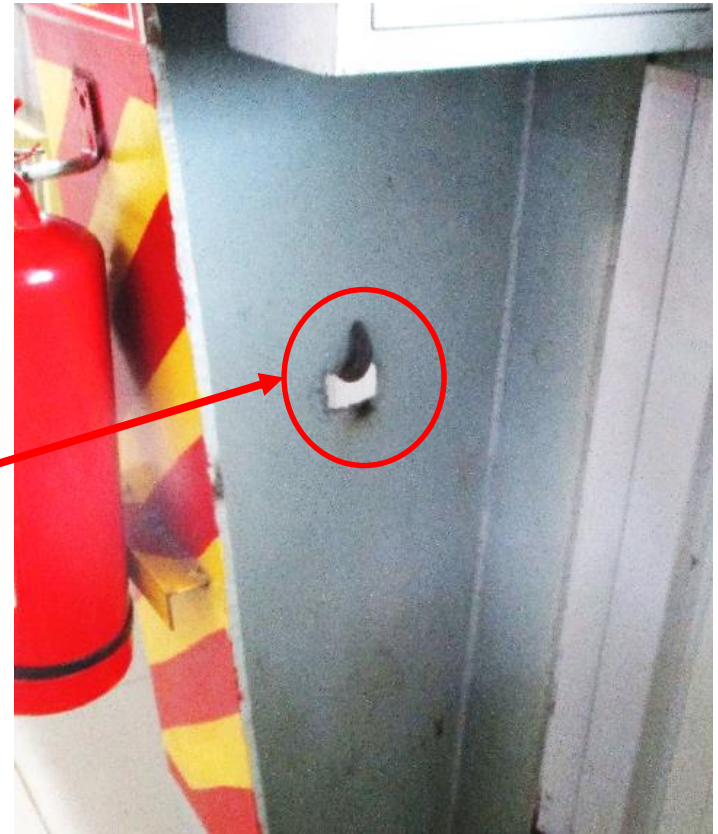
Loose bracing were observed during inspection. Cable bracings were not properly connected with column.

| Item No. | Observation | Recommended Action Plan | Recommended Timeline |
|---|---|---|---|
| 4 | (Production Shed)<br>Loose and poor connection of bracing. | Upgrade the connection of bracings. | 6-weeks |
| 5 | (Production Shed)<br>Loose and poor connection of bracing. | Tighten loose bracings. | 6-weeks |
